# **FINAL REPORT**

## **FATALITY ON BOARD SRS NYK ISABEL IN BUSAN ANCHORAGE, SOUTH KOREA ON 4 MAY 2019**

**MIB/MAI/CAS.064**

**Transport Safety Investigation Bureau  
Ministry of Transport  
Singapore**

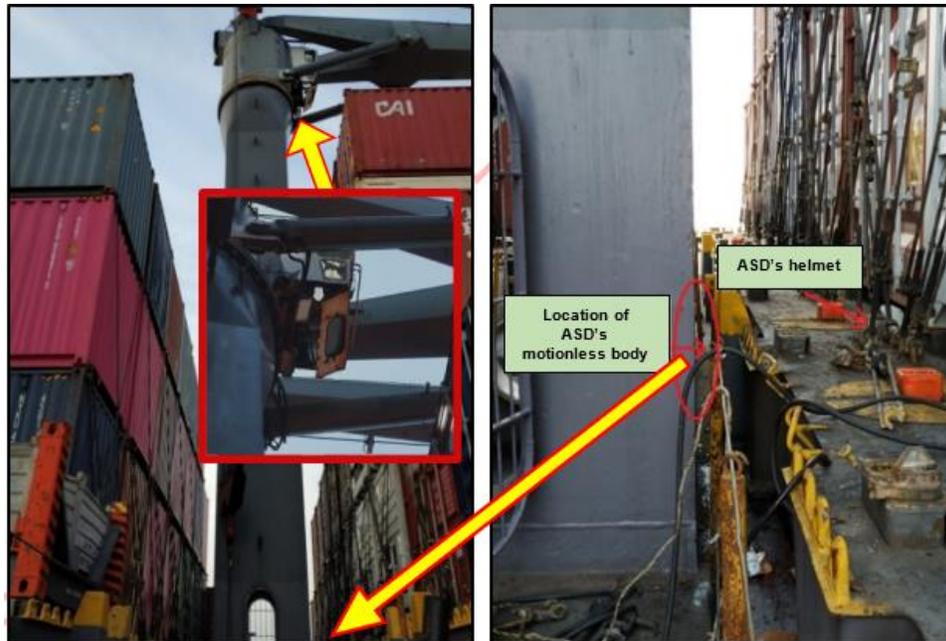
1.1.5 Both the DC and OS then made their way towards no.3 crane and found the ASD1 lying motionless below the crane, on the cross deck. Looking up, they saw that the floor plate of the crane cabin had broken off and hanging from the frame of the crane cabin<sup>6</sup> (see **figure 1**).

Figure 1: (Left picture) No.3 crane with dislodged floor plate shown with yellow arrow (right picture) location (cross deck) where the body of ASD1 was discovered

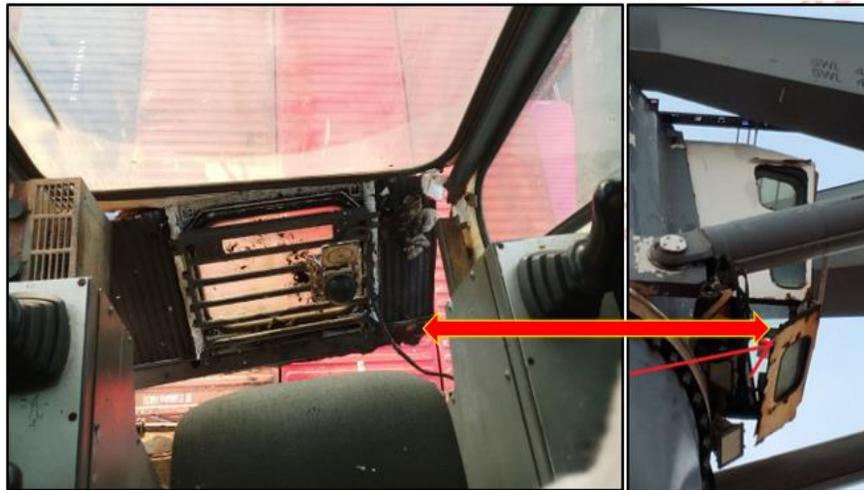
Figure 2: Photographs taken on the day of occurrence showing the broken-off portion (hanging) of the floor plate of no.3 crane cabin

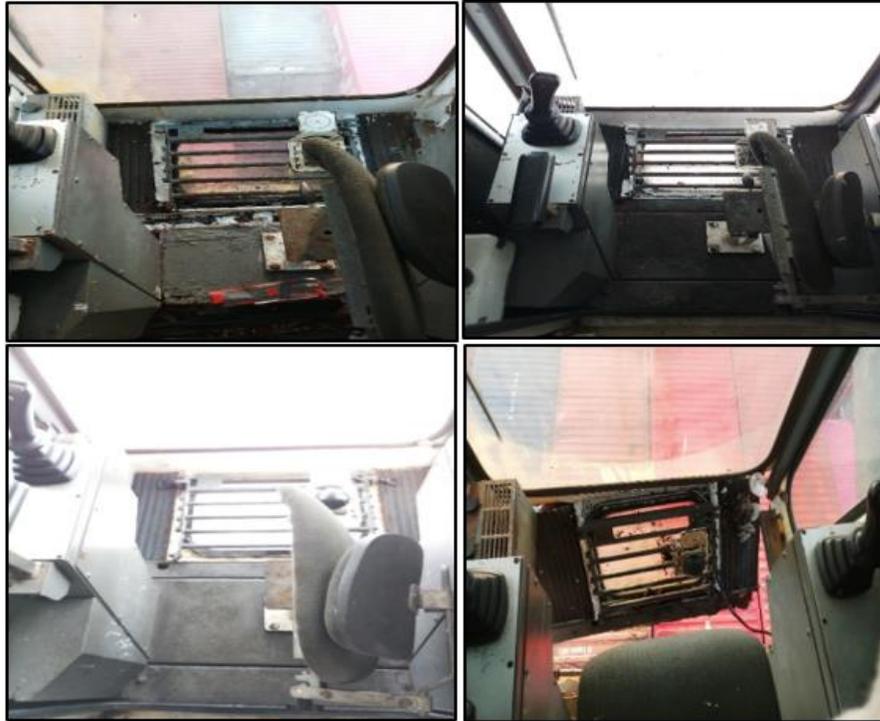
Figure 3: Condition of the floor plate taken from inside the cabin for each respective crane cabin. (clockwise from top left) – crane no.1, no.2, no.3 and no.4

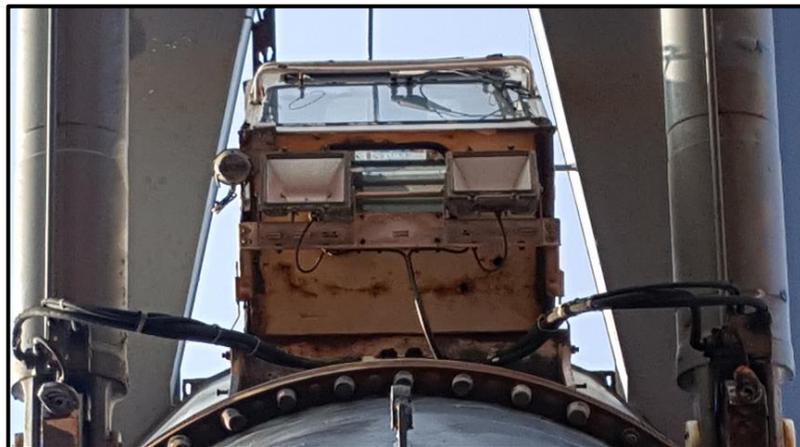
Figure 4a: Exterior of crane no.1 showing some corrosion on the floor plate

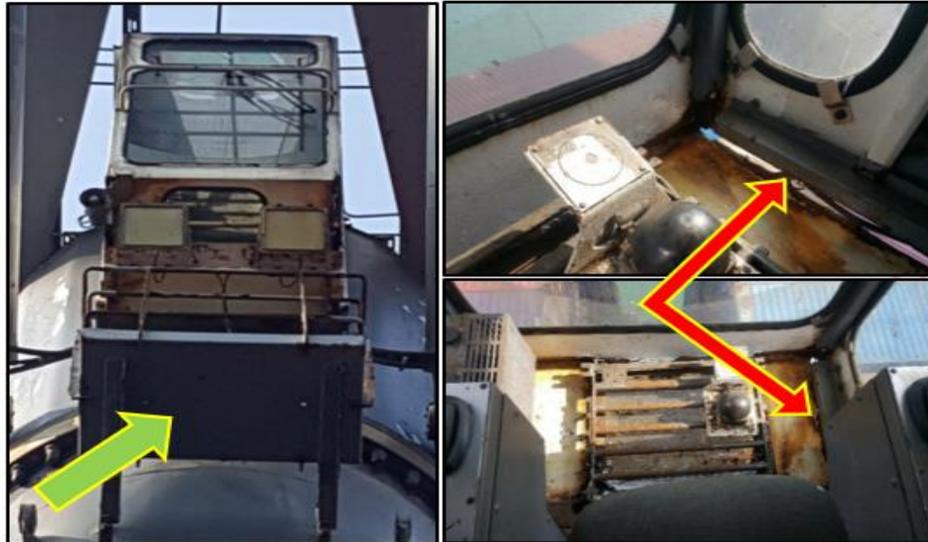
Figure 4b: External and internal photographs of crane no.2. Severe corrosion on the right-hand-side of the floor plate which had separated from the main cabin frame (red arrows). These photographs were taken after the rubber mats were removed and the area was de-rusted by the crew. Inspection platform (green arrow) – details in paragraph 1.5.6

- 1.4.7 An inspection platform (annotated by a green arrow in **figure 4b**) is fixed on the base column for all cranes. According to the crane manufacturer, this inspection platform was to be used for a visual inspection which could be carried out with simple means. To facilitate a close-up inspection from the outside, the crane had to be swivelled over this platform.
- 1.4.8 According to the operating manual, a portable ladder<sup>13</sup> was then to be mounted on the crane column by authorised and trained personnel to access the inspection platform (see **figure 7**).
- 1.4.9 The investigation team also noted the Company’s views of this portable ladder being unsafe for its crew to access the inspection platform and thus an external inspection using this platform had not been carried out by the ship’s crew.

4.1.2 Fixed ladders were installed<sup>24</sup> (in a shipyard) on the crane columns for the access to the inspection platform from the cross deck (see **figure 13**).

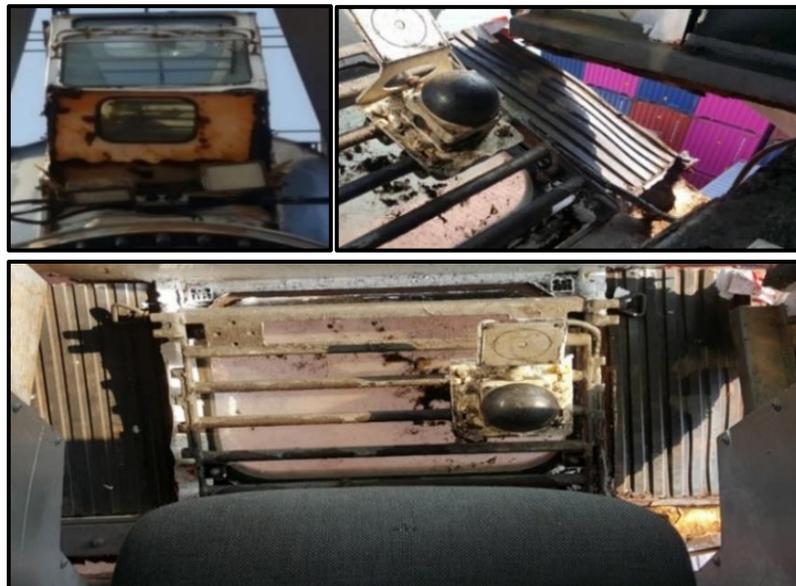
Figure 4c: External and internal photographs of crane no.3 cabin (clockwise from top-left) - the corroded condition of the floor plate, the sheared off right-side portion of the floor plate, and the plan view of the sheared floor plate

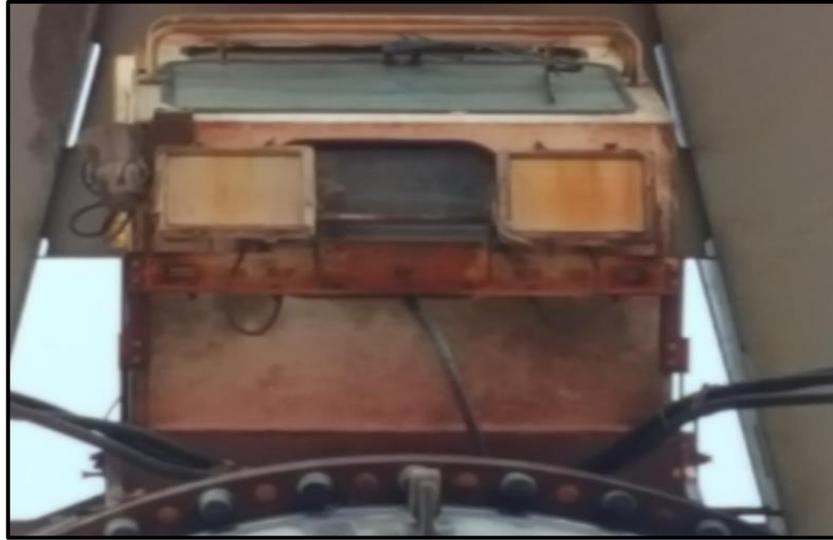
Figure 4d: External photograph of crane no.4 cabin displaying condition of the floor plate

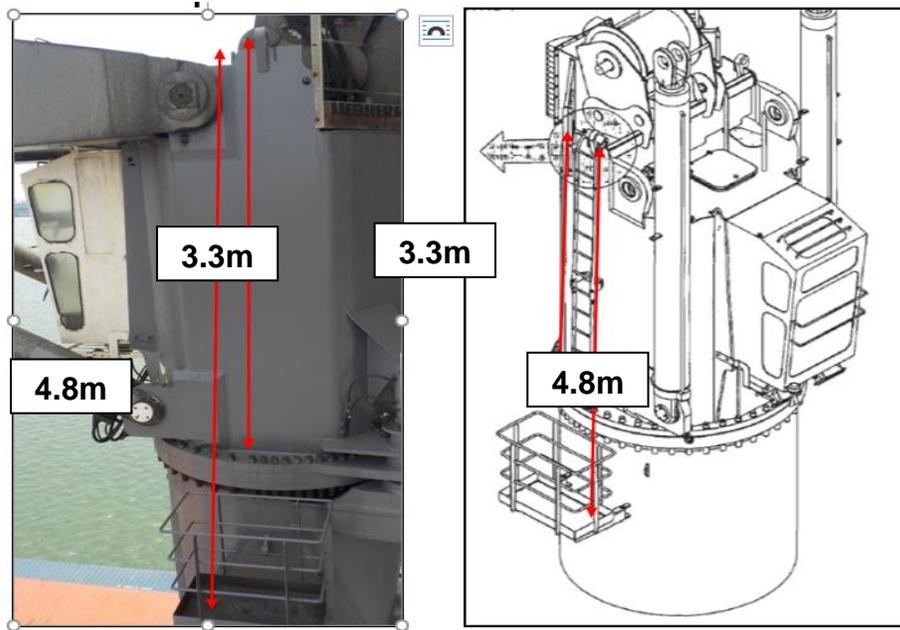
Figure 7: Image on the left shows the location where the portable ladder was to be mounted. Image on the right shows how the portable ladder was to be mounted –  
*Source: The Company*

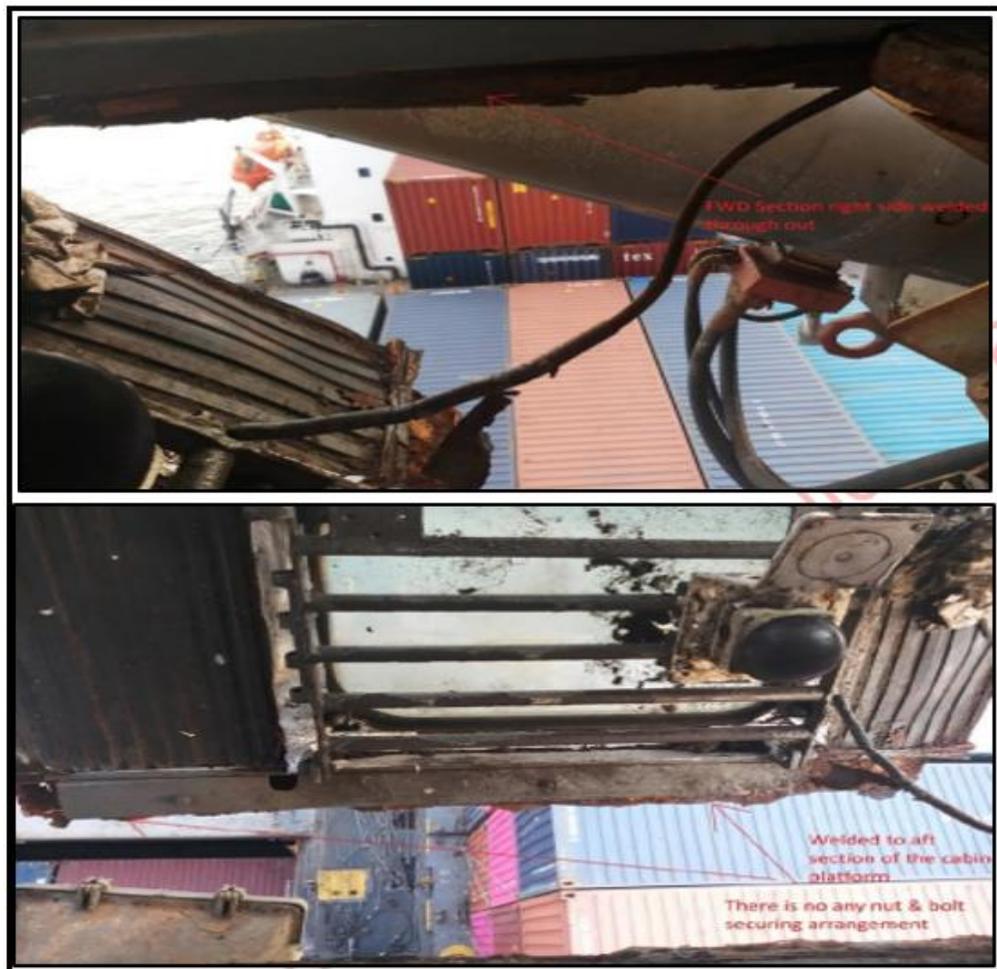
Figure 8: Internal photographs of no.3 crane cabin's floor plate contained in the document – annotations from the manufacturer

<sup>16</sup> The floor plate had sheared off from the welding joint.

1.6.2 The document stated that the floor plate was welded to the aft section of the cabin floor . The document further stated that corrosion along this welded joint(s) of the floor plate of the crane cabin was the cause for the thinning of the original uniformed thickness (3mm) and thus a weakened material.

2.1.2 As evident from the photographs of the crane cabin (see **figure 8**) submitted to the manufacturer by the Company after the accident, the welded edges or the crevices of the cabin floor had suffered severe pitting corrosions.

2.2.2 The floor plate which was 3mm in thickness had, as a result of the pitting corrosion, thinned down and weakened at the welded joints. It was highly probable that this deterioration, i.e. severe corrosion at the edges and welded joints had occurred over a long period of time. Since the rubber mats were glued to the cabin floor, the welded joints which were concealed underneath had gone unnoticed, despite the multiple times that various personnel had entered the crane cabin.

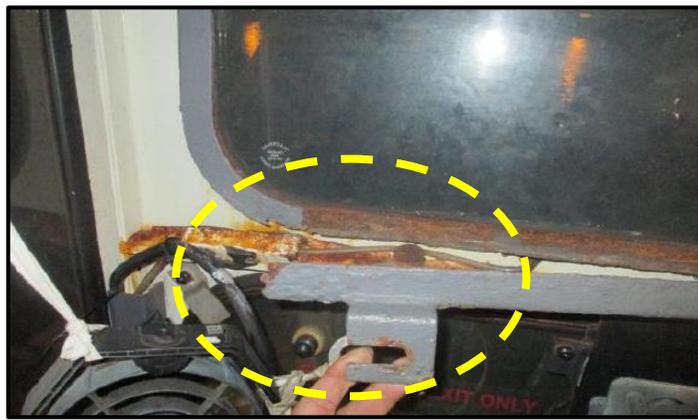
Figure 9b: The corroded window seal and locking frame during the inspection in October 2016 (circled yellow by TSIB)

- 2.3.7 The crane manufacturer's inspection report in October 2016 stated possible water ingress from the broken window seal in no.3 crane cabin. However, the report did not indicate whether the welded joints between the floor plate and the cabin main frame had been inspected during that inspection (see paragraph 1.6.3). After the inspection, the crane manufacturer provided a quotation list to the Company which included the frames associated with the crane cabin. There was no accompanying report specifying any consequential risk if these frames were not replaced or the urgency to replace the crane cabin (as a whole) due to the water ingress.

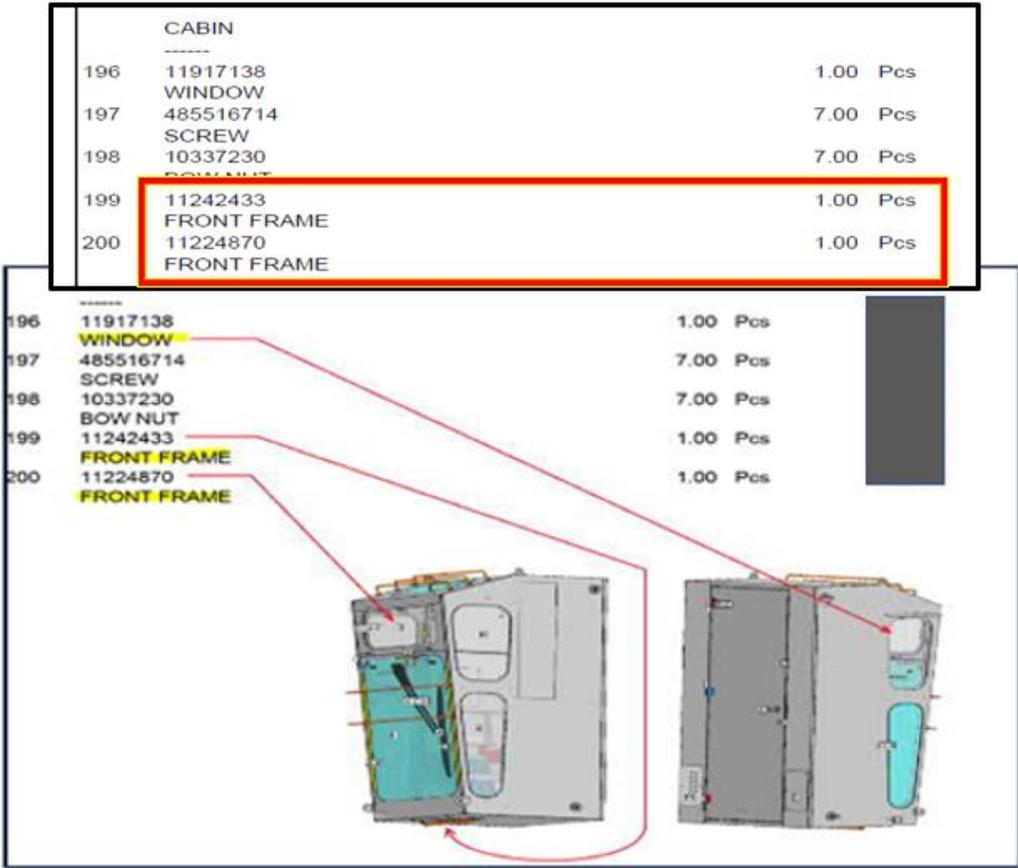
Figure 10: Extracts of the repair invoice dated 17 November 2016 offered to the Company by the crane manufacturer on the replacements of the (window) frames. Red arrows annotated by the crane manufacturer for the investigation team – Source: crane manufacturer.

1.6.5 The Company, on the other hand, expressed that there was no mention of a consequential risk if the frames were not replaced and confirmed that there was no quote for a crane cabin, as a whole. The Company further confirmed that even if the frames were replaced, there would be no change to the existing floor plate and that replacing the floor plate would typically be only performed in a drydock in consultation with the crane manufacturer.

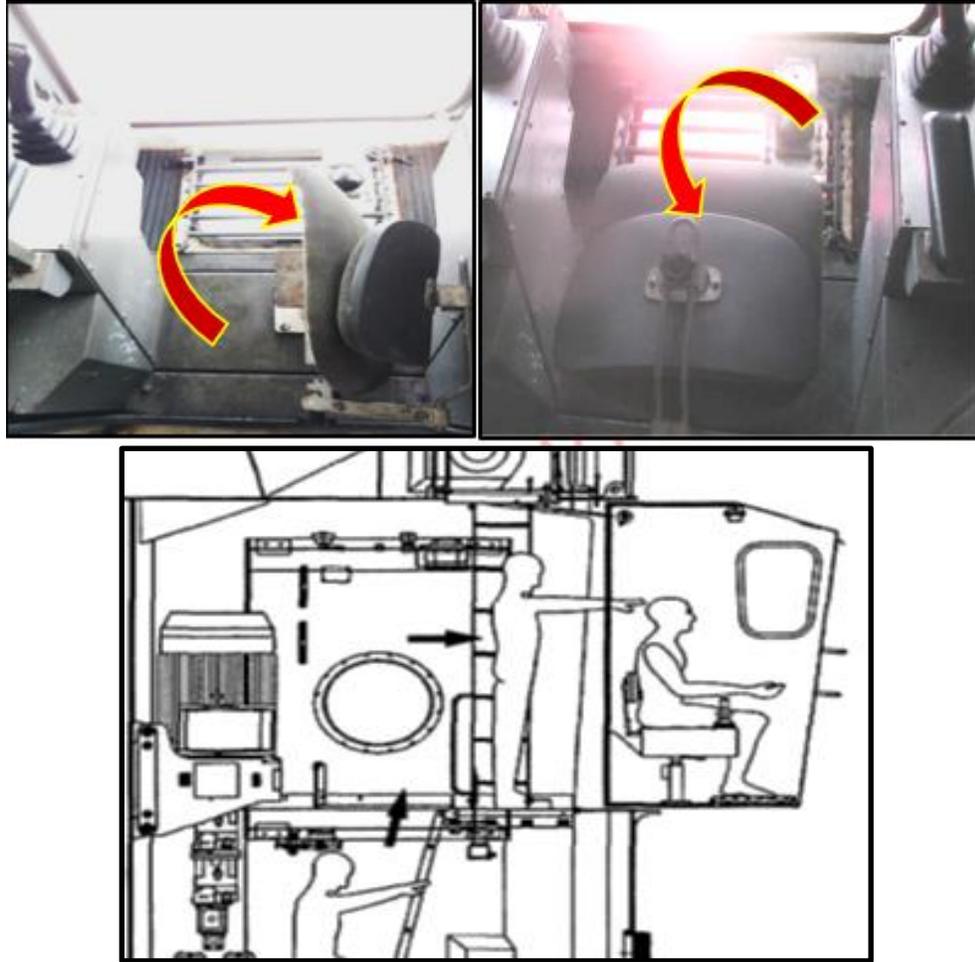
Figure 11: (Top left picture) seat lifted sideway for operator to move forward, (Top right picture) seat put down for the operator to be seated, (bottom picture) operator entering the cabin from the rear and seated for operating the crane – annotated by TSIB

2.4.2 The design of the seat in the crane cabin was such that it required the operator to get past a lifted seat and stand temporarily on the floor plate. The investigation team opined that while the cabin floor might have been designed to take the load of a person, there was a risk to the operator standing on it, as there was no secondary load bearing support structure underneath the floor plate. Hence, there is room for improvement<sup>22</sup> for the design of the crane cabin to avoid a single failure path.

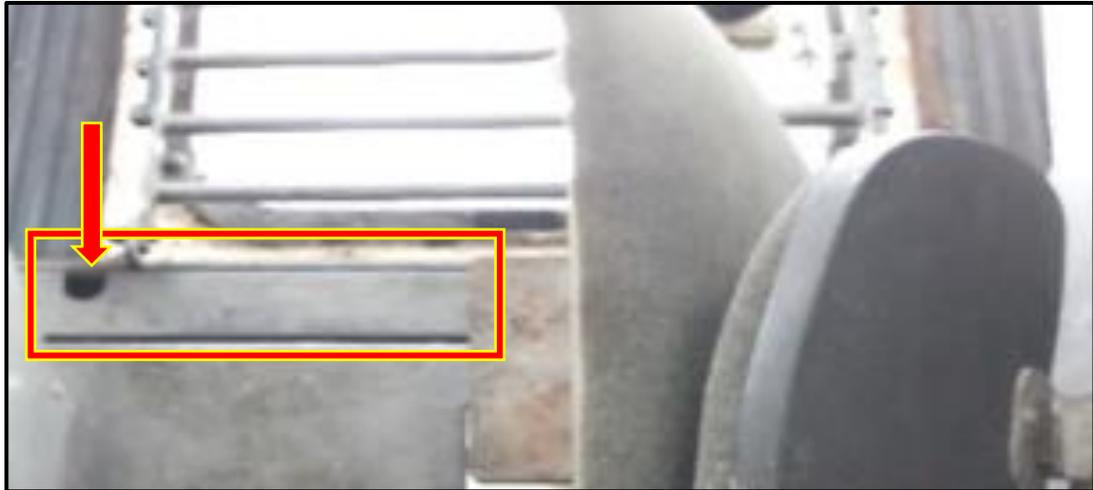
Figure 12: The red arrow shows the access for the removable panel

might have been noticed. Similarly, the removable panel (see **figure 12**) if labelled could have been used to inspect the condition of the welded joint of the cabin floor.

5.2.1 To consider including the scope of visual inspection for crane cabins in the operating manual with the requirements of removing rubber mats and lifting of inspection panel for corrosion checks . **[TSIB-RM-2020-35]**
