**FINAL REPORT**

**FATALITY ON-BOARD THE  
BULK CARRIER STELLA ANNABEL  
AT SEA  
ON 18 JANUARY 2017**

**MIB/MAI/CAS.013**

**Transport Safety Investigation Bureau  
Ministry of Transport  
Singapore**

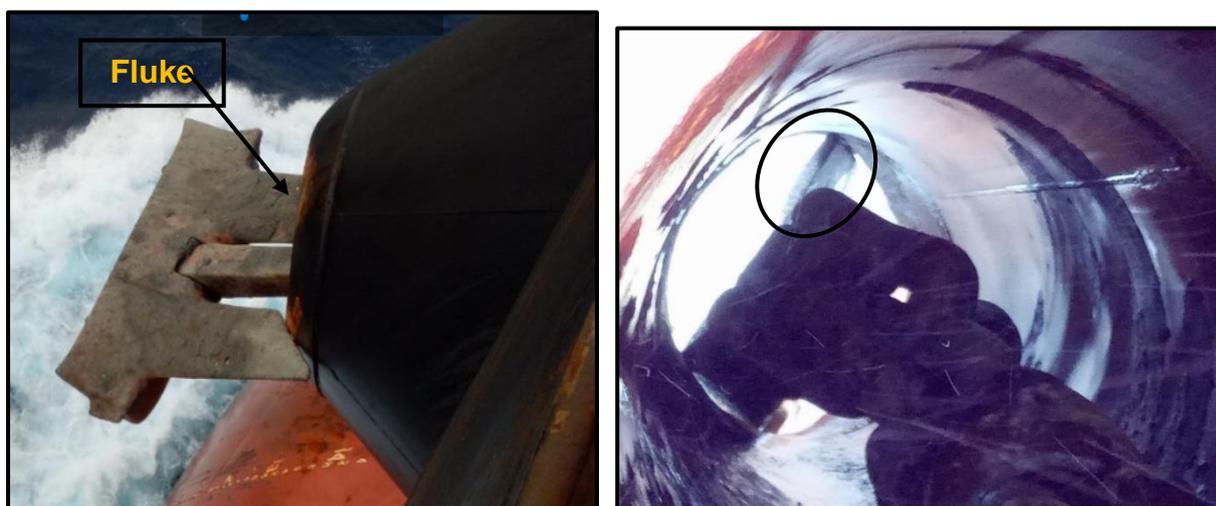
- 1.1.1 On 16 January 2017, the bulk carrier Stella Annabel weighed her port anchor for departing Hong Kong Anchorage and bound for Dampier, Australia, for loading of cargo. The Bosun was operating the anchor windlass for heaving the anchor and the Chief Officer was overall in-charge of the anchor station. At about 1610H, the Chief Officer reported to the bridge that the anchor was aweigh and it was subsequently sighted out of the water at about 1650H.
- 1.1.2 While bringing the anchor home<sup>4</sup>, the Chief Officer noted that the flukes were stuck (i.e. as opposed to being at an angle against the shank under normal operations) and he verbally (and hand) signaled for the Bosun to stop heaving.
- 1.1.3 The Bosun continued heaving the anchor until one of the flukes entered the hawse pipe and got stuck (see Figure 1).

Figure 1: One of the flukes of the port anchor stuck inside the hawse pipe (Image on the right fluke viewed from inside the hawse pipe)

2.1.2 It could not be established why the Bosun continued to heave until the fluke got stuck in the hawse pipe. An uncoordinated heaving of the anchor could not be ruled out.

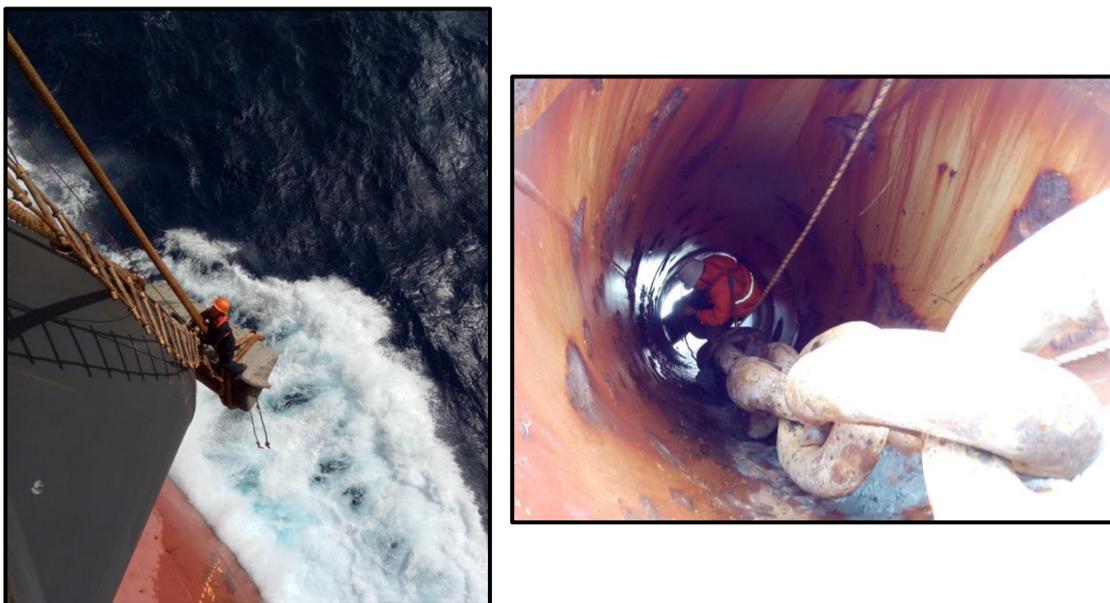
- 1.1.6 The Master then decided to try using a mooring rope to free the anchor. On his instructions<sup>6</sup>, at about 1030H the Bosun was first tasked to enter the hawse pipe to inspect the anchor fluke. A Jacob’s<sup>7</sup> ladder was then rigged over-side under the Chief Officer’s supervision to pass a mooring rope over the crown of the port anchor with a view to use the winches to pull the anchor downwards. This method was also not successful until the end of the day in freeing the stuck port anchor fluke (see **Figure 2**).

Figure 2: Bosun working over-side to fix a mooring rope over the crown of the anchor. (Image on the right shows Bosun inspecting the anchor fluke from inside the hawse pipe on Day 1)

2.2.3 The above listed non-routine activities are considered to be unsafe activities and required considerable planning and detailed risk assessments. However, there were no risk assessments done for the first two items listed.

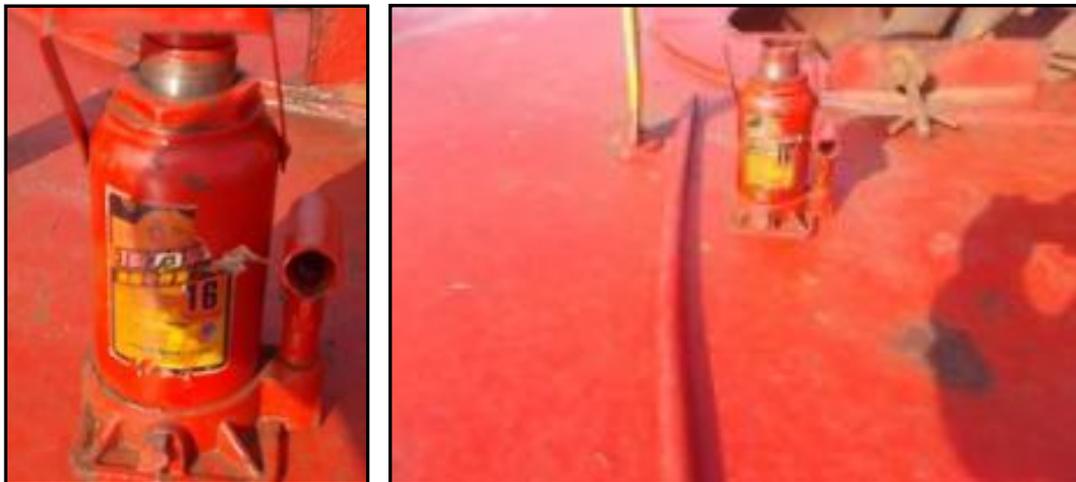
- 1.1.10 On 18 January 2017 at about 0800H, in the presence of the Chief Officer, Chief Engineer, Bosun, Able Seafarer Deck (ASD) and Ordinary Seaman (OS), the Master instructed the Fitter to weld<sup>10</sup> a support to the hydraulic jack below the bow stopper and use a long pipe to free the stuck anchor fluke. This attempt was unsuccessful as the long pipe was bent and damaged during the jacking up process.

Figure 3: The hydraulic jack and long pipe (bent as a result)

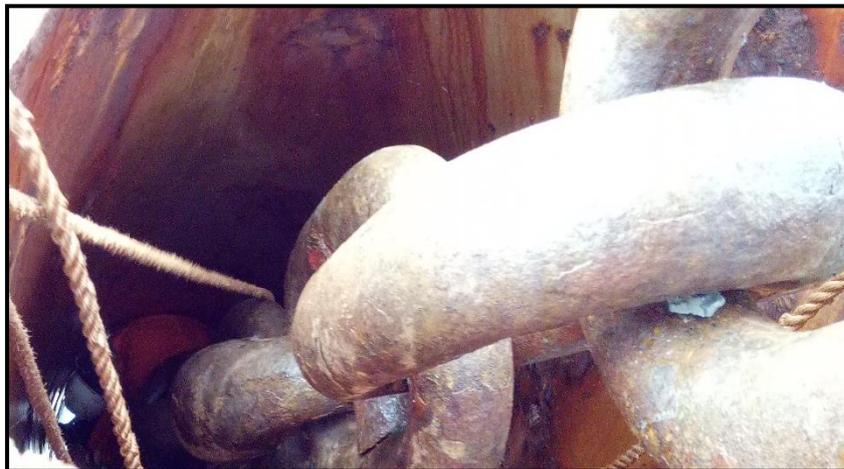
- 1.1.11 Based on witnesses' accounts, the Master then indicated a position inside the hawse pipe where he wanted the hydraulic jack to be positioned and instructed the Fitter to enter the hawse pipe and to weld another support for the hydraulic jack.
- 1.1.12 The Fitter duly followed the Master's instructions at about 1350H and exited the hawse pipe uneventfully around 1430H after welding a support for the hawse pipe. This hot work activity too was not known to the Company.
- 1.1.13 At the instructions of the Master, the Bosun entered the hawse pipe at about 1500H to position the hydraulic jack against the anchor chain and started operating the jack to move the anchor chain. In this process, the anchor chain moved with a jerk and trapped the Bosun against the inner (upper) wall of the hawse pipe at around 1510H (see **Figure 4**).

Figure 4: Bosun trapped between the anchor chain and the upper part of the hawse pipe

- 2.2.5 The hazard of releasing and jumping of anchor chain was classified as moderate risk. Even with the risk control measures in keeping the chain tight with extra lashing on the chain to prevent its movement, the investigation team is of the view that the shipboard senior officers did not fully appreciate the risks and the severity of the injury, and the crew were instructed to perform an unsafe act by entering the hawse pipe to free the fluke while the vessel moved and swayed<sup>14</sup> to seas and swells.
