**FINAL REPORT**

**CREW FATALITY**

**KOTA BAKAT AT**

MIB/MAI/CAS.046

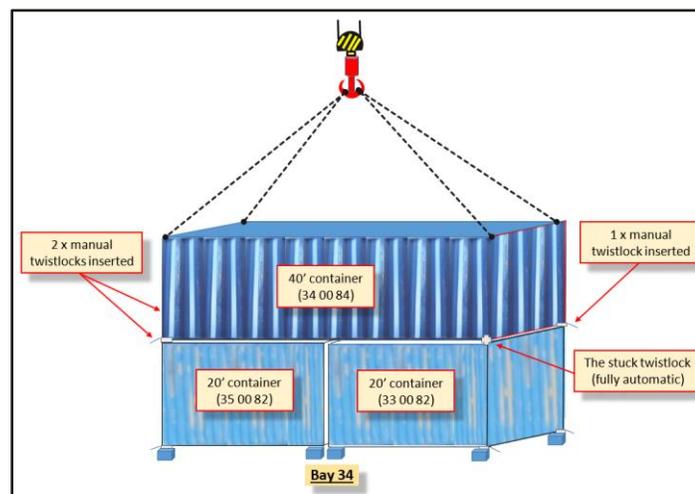
- 1.1.10 The Chief Officer instructed the shore foreman and the shore cargo supervisor to secure (lock) the forward port side of the 40' container with one twistlock (manual locking type<sup>16</sup>) which was locked to 20' container (33 00 82), and similarly to secure the aft of the same container with two twistlocks for both port and starboard side<sup>17</sup> which were locked to another 20' container (35 00 82) (see **Figure 2**). Once satisfied that the three twistlocks had been manually locked in place, the Second Officer was instructed to inform the shore foreman to lift up the 40' container to check if the stuck twistlock had been freed up.

Figure 2 - Illustration of the twistlocks used before gas-cutting

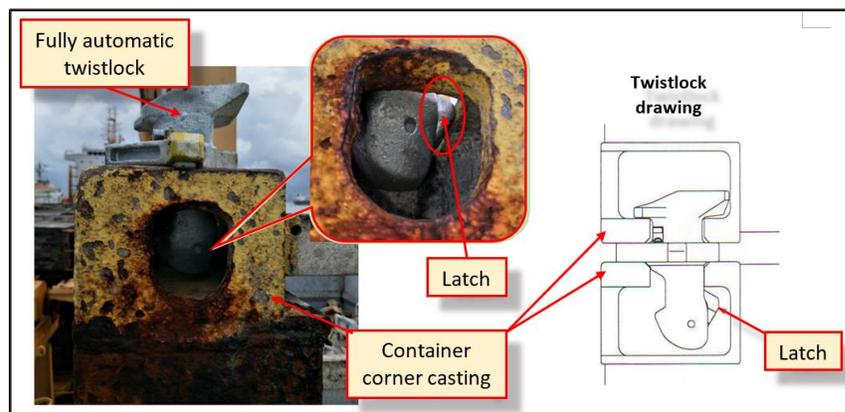
- 1.1.14 At about 1245H, the Bosun took the gas cutting torch and went up the portable ladder (three to four steps) next to the stuck twistlock, and started to cut the inner latch of the twistlock (see **Figure 3**).

Figure 3 – Illustration of the twistlock and part to be cut off with the gas torch  
(Photo taken on a sister ship "Kota Bakti")

1.5.10 Inspection of the stuck twistlock revealed that the spring and other components had been bent and also showed signs of being cut by a gas-cutting torch.

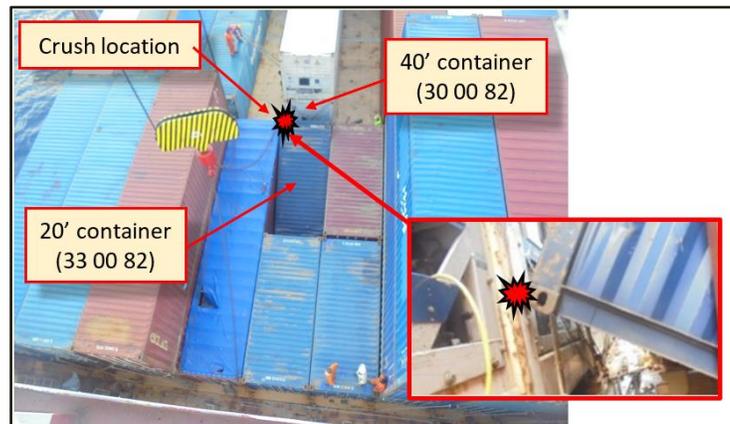
- 1.1.18 At about 1300H, according to the Bosun he was almost at the end of finishing the cutting of the stuck twistlock. All of a sudden, the 40' container (34 00 84) jerked and came out of the stowed position together with the forward 20' container (33 00 82)<sup>19</sup>. The Bosun instantly jumped off the ladder and suffered some minor injuries to his left elbow.
- 1.1.19 The 20' container hit the unsuspecting ASD2 (who was in the vicinity) and crushed his upper body against the port side frame of another 40' container (30 00 82) located one bay forward (see **Figure 5**).

Figure 5 – Top view of accident site after removal of the 40' container (34 00 84). Inset shows the location where the ASD2 was crushed.  
(Photo source: the ISM Manager)

- 1.1.20 The crew on-site saw that the frame of the 20' container struck ASD2 in the upper part of the torso and the head. An immediate assessment by the ship's crew showed ASD2 had passed away on the spot.

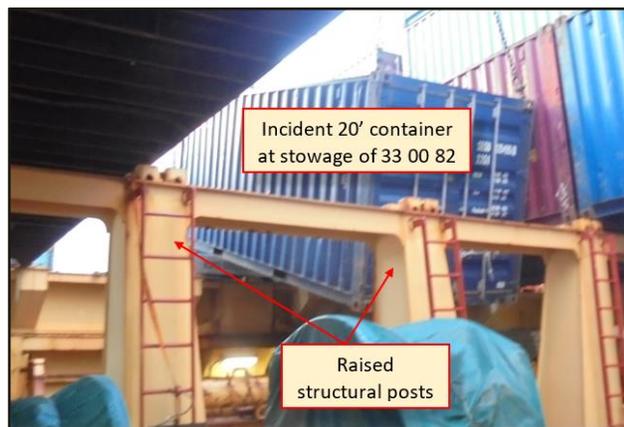
Figure 6 - View of the structural posts and the incident 20' container  
(Photo source: the ISM Manager)

1.2.4 The 20' container (33 00 82) that struck the ASD2 was stowed at bay 33, and was secured with two manual locking twistlocks at the forward end at the bottom onto the hatch cover. Due to the limited space available for access, twistlocks for securing that container at the aft end were available but did not lock the container. The stuck twistlock preventing the discharge of the 40' container was above the 20' container at bay 34.

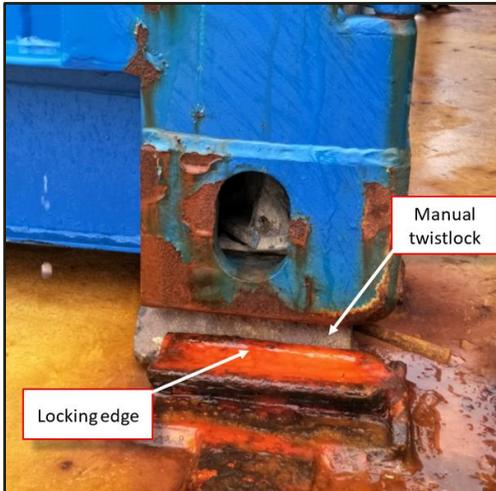
- 1.5.9 The investigation team's visit on the sister ship Kota Bakti indicated that some welded tracks for sliding the manual twistlocks on the hatch covers were found to be in poor condition due to corrosion. The locking edges (see **Figure 10**) of the welded tracks had become thinner over a period of time due to wear and tear. Information obtained by the investigation team revealed that on KB the locking edges of the welded tracks on the hatch cover that the two manual twistlocks of the 20' container (33 00 82) were attached to was found sheared-off after the accident.

Figure 10 - Condition of welded tracks on hatch cover with a manual twistlock slid in  
(Photo taken on a sister ship "Kota Bakti")

2.2.3 As there were only two twistlocks securing the 20' container at the forward end (see paragraph 1.2.4), when additional lifting force was applied during the gas-cutting of the stuck twistlock, the 20' container eventually broke away from the locking edges (which may have been corroded and worn out) of the hatch cover.

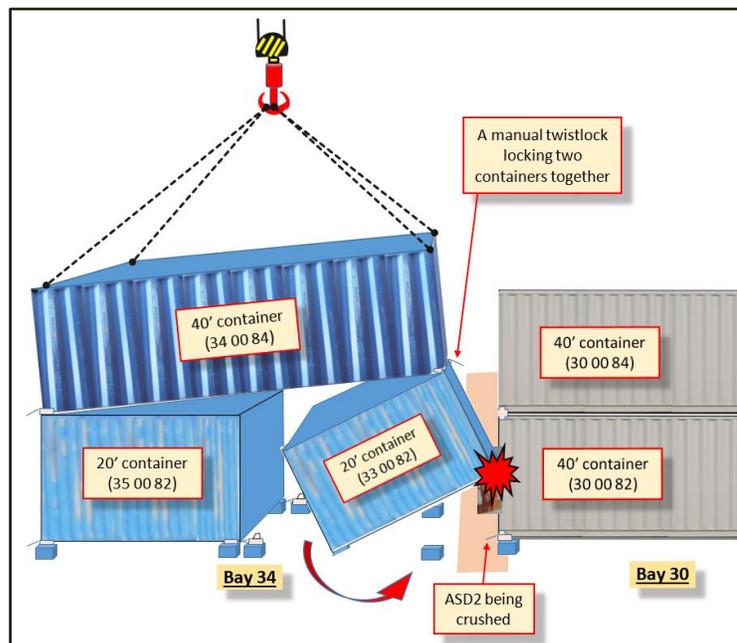
2.1.1 ASD2 was hit by the 20' container (33 00 82) connected to the 40' container above it, which had a stuck twistlock and three manual twistlocks. The 40' container was attached to four taut lifting chains of the ship's cargo crane which was at an angle to the containers (crane jib head not vertically above the containers). While attempting to free the stuck twistlock by cutting it with a gas-cutting torch, the resultant forces (in an upward direction at an angle towards ASD2) of the taut lifting chains had likely caused the two manual twistlocks securing the 20' container to the hatch cover to shear off the worn locking edges of the welded tracks and came loose.

2.1.2 The sudden jerking out the 40' and 20' containers at the end of gas-cutting when the stuck twistlock was freed, indicated that there had been upward forces acting on the 40' container by the taut lifting chains. With the resultant forces acting on the two containers and the twistlock serving as a pivot, in all probability, resulted in the 20' container (33 00 82) being lifted up from the hatch cover and swung in the direction of the unsuspecting ASD2 (see **Figure 12**).

Figure 12 - Illustration of containers' most likely movement at the time of accident (not to scale)
