# **Final Report**

## **DEATH OF CREW DANUM 175 AT PASIR PANJANG TERMINAL, SINGAPORE ON 21 DECEMBER 2020**

TIB/MAI/CAS.098

Transport Safety Investigation Bureau  
Ministry of Transport  
Singapore

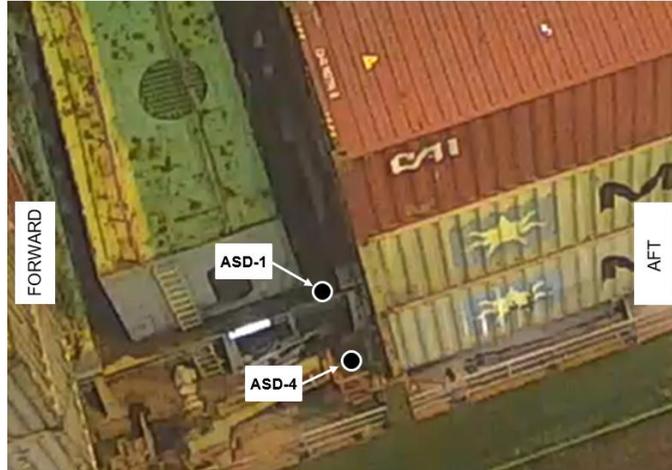
Figure 1 - Image captured by the terminal crane's CCTV showing the position of the two ASDs at about 0302h.

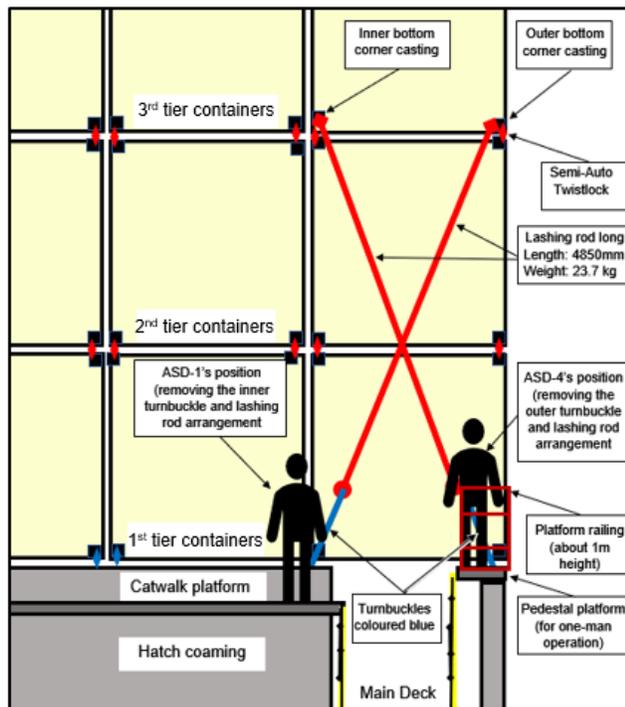
- 1.1.10 The ASD-1 began loosening the inner turnbuckle of the lashing rod, while the ASD-4 ascended to the pedestal platform to loosen the outer turnbuckle of the lashing rod. See **figure 2** – illustration of the position of the two ASDs.

Figure 2 - Illustration showing the positions of the two ASDs as viewed from the forward section of D175.

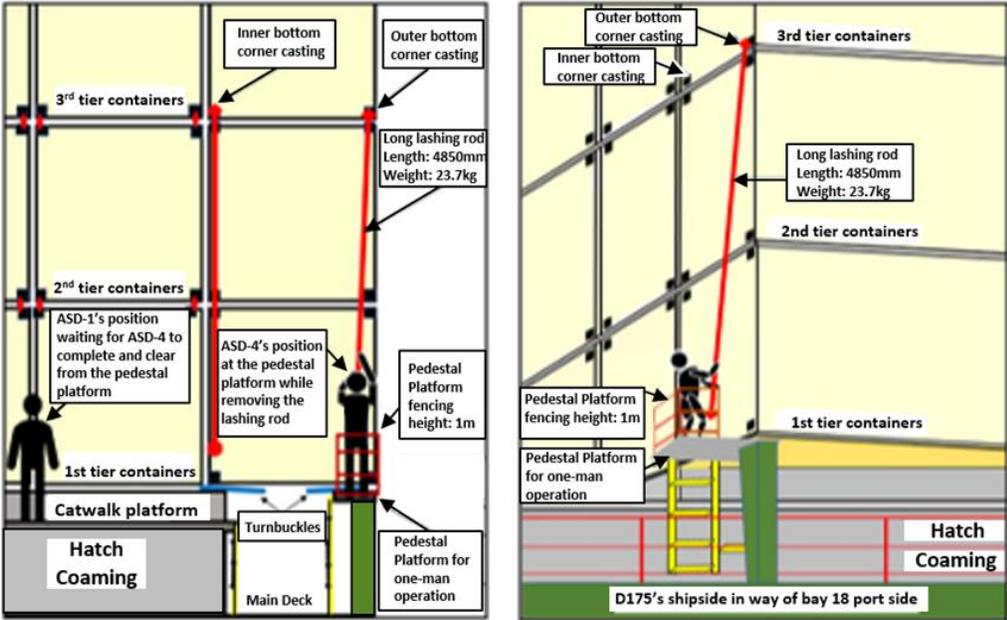
- 1.1.13 From the CCTV footage it was established that at about 0304H, after exchanging the lashing rod, the ASD-4 could be seen struggling to remove the swivel head from the bottom corner casting of the 3<sup>rd</sup> tier container. In doing so, the ASD-4 was continuously looking upwards and manoeuvring the swivel head to unlatch it from the container bottom casting. According to the ASD-1, it took ASD-4 several<sup>11</sup> minutes before the swivel head was unlatched.

- 1.1.14 The CCTV footage further revealed that at about 0307H, the ASD-4 managed to remove the swivel head of the lashing rod (see **figure 3**).

Figure 3 - Illustration showing the removal operation of the lashing rod viewed from different angles.

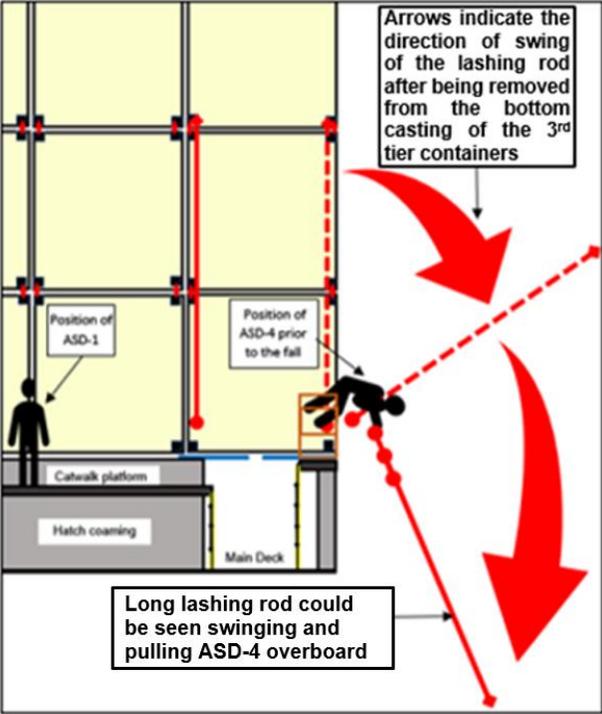
1.1.15 The ASD-1 recalled that, immediately after the swivel head of the lashing rod had been removed, the ASD-4 was seen lowering the lashing rod. From the CCTV footage it was established that as the rod was removed, it swayed sideways towards the berth, and in a quick succession, the lashing rod gathered a downward momentum (inertia) pulling the ASD-4 (who was still holding the lashing rod) overboard<sup>12</sup>, through the gap between the pedestal platform fencing<sup>13</sup> (railing) and the container. See **figure 4** showing the illustration of the fall.

Figure 4 - Illustration showing the ASD-4's falling overboard holding the lashing rod. (Not to scale)

- struggling to remove the lashing rod for about 3-4 minutes. This continued effort may have contributed to tiredness, which likely included weakening of the ASD-4's arms. When lowering down the lashing rod, the weakened arms may have caused the ASD-4 to lose control<sup>36</sup> of the lashing rod's downwards momentum.

- 2.1.6 A body restraint, such as a safety belt<sup>38</sup> or full body harness<sup>39</sup> could have prevented the fall.
- 2.1.7 The ASD-4 was also not wearing a personal floatation device. After the fall he was sighted to be on top of the berth fender for a brief duration, before slipping into the sea. Although the fall from the pedestal platform to the berth fender of about 8.5m did not result in serious injuries (as noted in the autopsy report), the ASD-4 may have been unconscious as a result of the fall, which affected his ability to stay afloat. A floatation device could have improved his chance of survival when he slipped into the water.

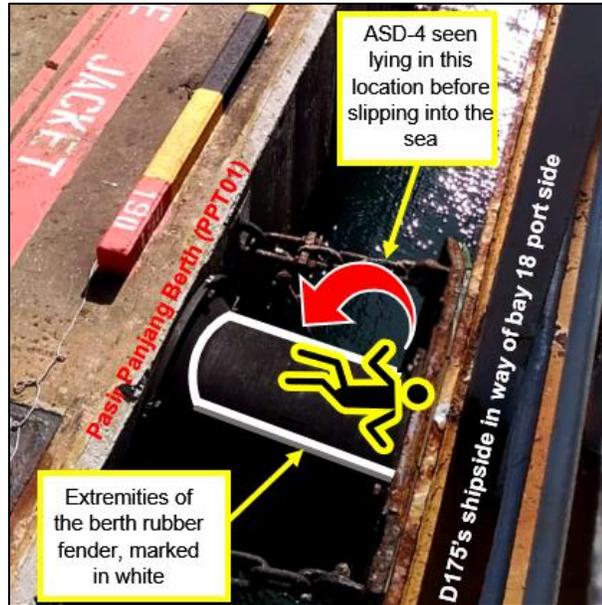
1.1.16 Seeing that the ASD-4 had fallen overboard, the ASD-1 shouted and rushed to the shipside railing and saw the ASD-4 lying motionless on top of the fender briefly before slipping into the sea between the berth and the shipside (see **figure 5**)

Figure 5 - Illustration showing the ASD-4's position after falling overboard before slipping into the sea as indicated by the direction of the red arrow (*Not to scale*)

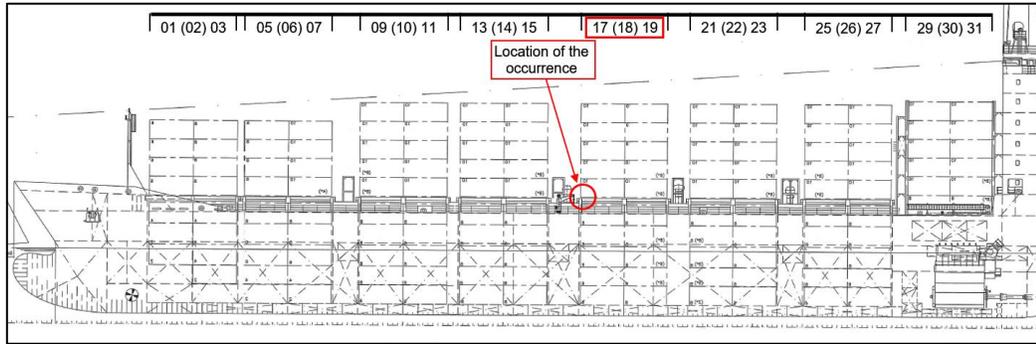
Figure 6 – Port side view of the vessel showing the location of the occurrence circled in red. (Not to scale)

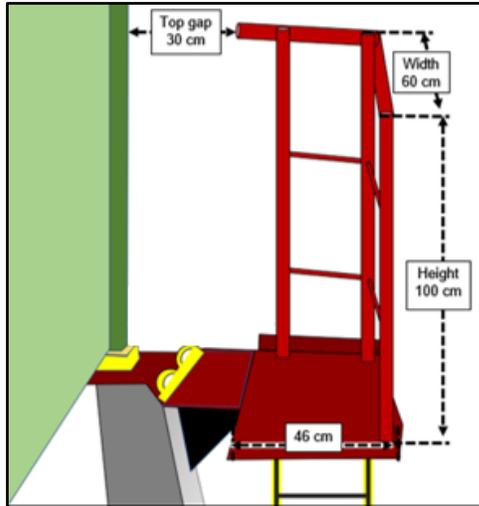
Figure 7 – Illustration showing the dimensions of the pedestal platform and its fencing at bay 18 port side (*Not to scale*)

1.9.2 The Company confirmed that since taking over the safe management of the ship<sup>33</sup>, there were no records of modification to the design or damage to the pedestal platform or its fencing.

<sup>33</sup> The ship was bought second-hand, the 'top gap' of about 30cm at the railing was as at the time of taken over.

- 2.2.4 The pedestal platform was designed for a single man operation and unlashing at the location was deemed unsafe by the LF, the specialist in lashing/ unlashing operation. When the LF told the CO that it was dangerous to unlash containers at the outboard rows and communicated the terminal's SWP to the CO, it should have triggered the CO, and the ship's crew, of the need to conduct a JSA. Accordingly, a JSA/ RA to address the need for donning the appropriate PPE such as the safety belt/ harness (secured with a line taut to strong point) and floatation device would have been identified.

4. Changes and modification to the design of the pedestal platform to provide an adequate and safe standing area for two-man operation to carry out lashing/ unlashing of containers completed on the 2 Feb 21.
