# **FINAL REPORT**

## **FATAL INJURY ON BOARD THE BULK CARRIER ASIA ZIRCON I AT THE PORT OF NANSHA ON 8 FEBRUARY 2018**

**MIB/MAI/CAS.033**

**20 September 2019**

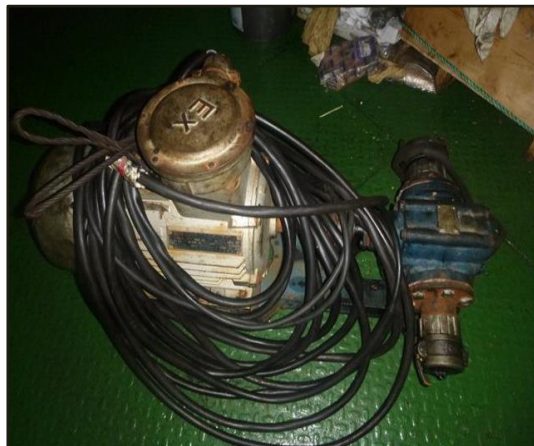
Figure 1 – Portable pump intended to be used for sludge discharging  
(Photo source: the ISM Manager)

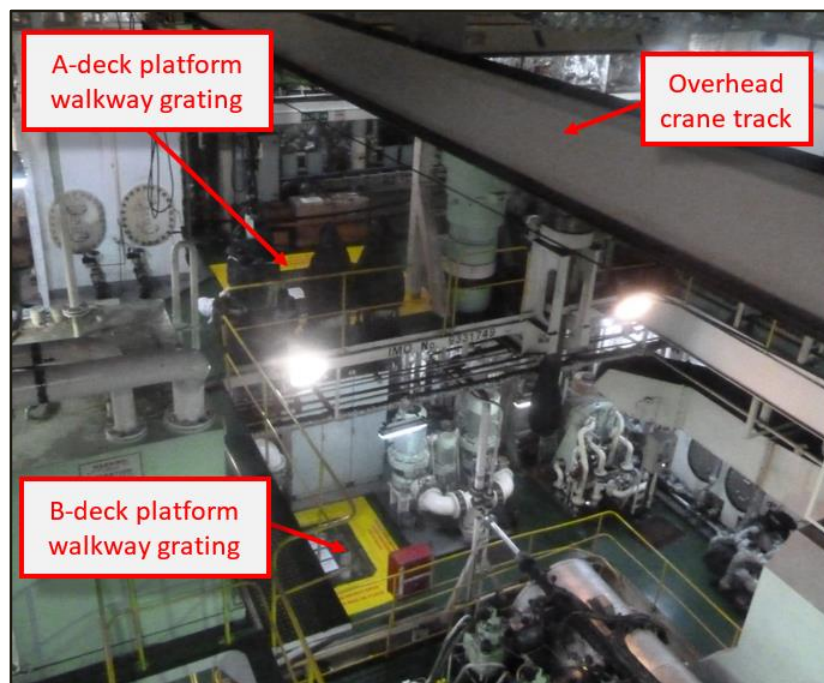
1.3.2 The second deck in the engine room was a mid-platform B-deck (see **Figure 2**). Similar to A-deck walkway, there was a grating on B-deck walkway (located right below the A-deck grating at a height of about 4.35m). Both the A-deck and B-deck walkway gratings were opened by the Fitter and the GPT. No temporary fencing nor notices were placed to warn others of the two openings along the walkways.

Figure 2 - Engine room forward portion layout after the occurrence  
(Photo source: National Transportation Safety Committee<sup>16</sup>)

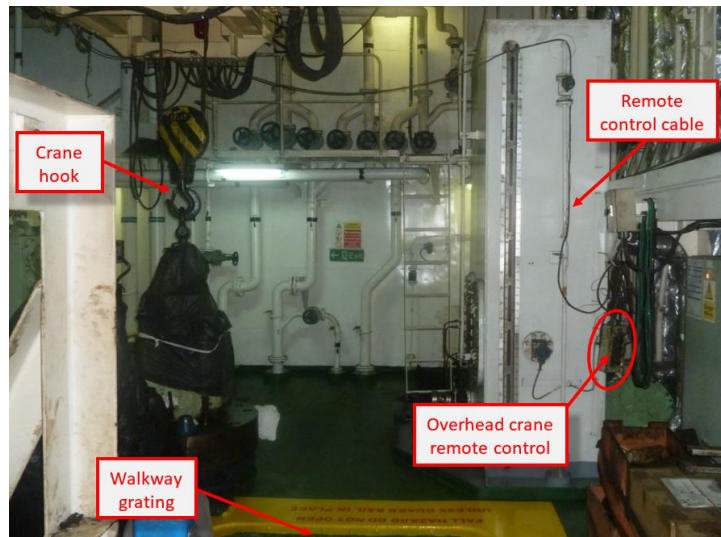
deck platform. The walkway grating at this deck was in a close proximity. Next to this walkway grating (and opening), was a bulkhead where the remote control for the overhead crane and associated cables were stowed (see **Figure 3**).

Figure 3 – A-deck platform overview  
(Photo source: the ISM Manager)

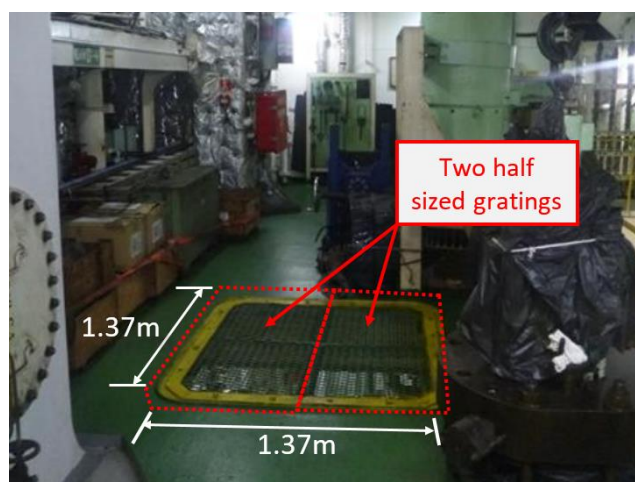
1.4.1 The purpose of the walkway openings at A-deck and B-deck platforms was to facilitate lifting or lowering of heavy items onto different decks using the engine room overhead crane. These walkway openings were typically covered with two half-sized gratings which were normally kept closed and bolted when not in use to prevent falling of personnel. The square opening was about 1.37m (length) x 1.37m (width) (see **Figure 4**). The dimensions and design of the openings and gratings were the same at both A-deck and B-deck platform.

Figure 4 – Bolted grating at A-deck platform  
(Photo source: the ISM Manager)

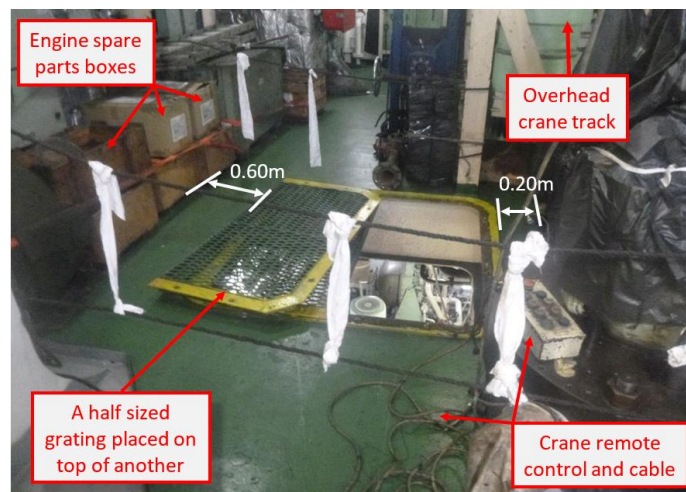
- 1.5.2 At the A-deck, on one side of the walkway opening, a width of about 0.6m passage was available between a few wooden spare parts boxes and the unopened grating. On the other side, a spare main engine cylinder head was stowed along the walkway, leaving only a width of about 0.2m of passage (see **Figure 5**).

- 1.5.3 At the time of accident, after the gratings at A-deck and B-deck were opened, there was neither temporary fencing in place nor warning signs posted around both openings at both platform decks. There was no specific means or arrangement to guard the two openings along the walkways.

Figure 5 - View of the A-deck walkway opening and surroundings  
(Note: the rope with white cloth tied as fencing was done after the accident)  
(Photo source: the ISM Manager)

- 2.1.4 After viewing the location of the Oiler's safety helmet and ear muffs, the investigation team was of the view that it was thus very likely that the Oiler fell through the partially opened grating on A-deck, falling past the opening on B-deck and landing onto the tank top. A fall from a height of more than 9m would have resulted in serious head injuries. The cause of his fall could not be established with certainty, but a slip, trip, walking into the opening in a rush or a fall due to a medical event<sup>28</sup> could not be ruled out.

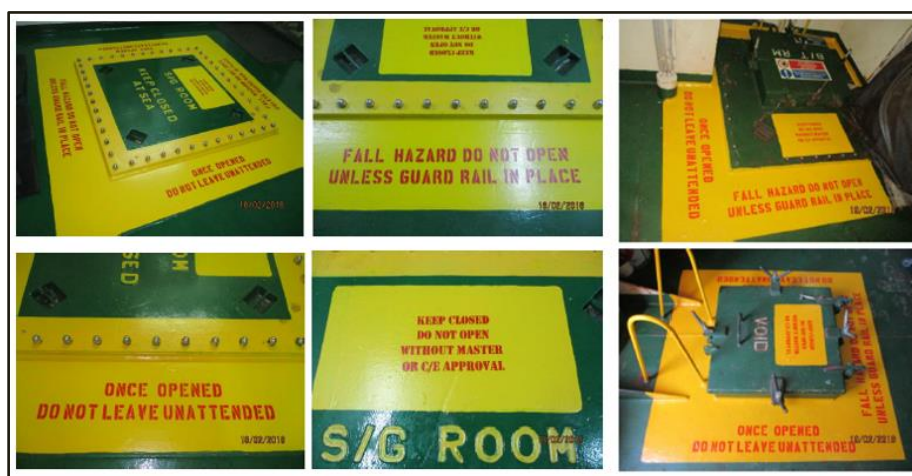
Figure 6 - Fall hazard warnings marked at various access openings  
(Photo source: the ISM Manager)

- 4.1.5 A fleet-wide Fall Hazard Identification Project was carried out to identify and address fall hazards in its fleet of ships (see **Figure 6**).
