FINAL REPORT

FATAL INJURY AT SEA ON BOARD TANKER BOW SUN ON 8 AUGUST 2018

MIB/MAI/CAS.048

**Transport Safety Investigation Bureau
Ministry of Transport
Singapore**

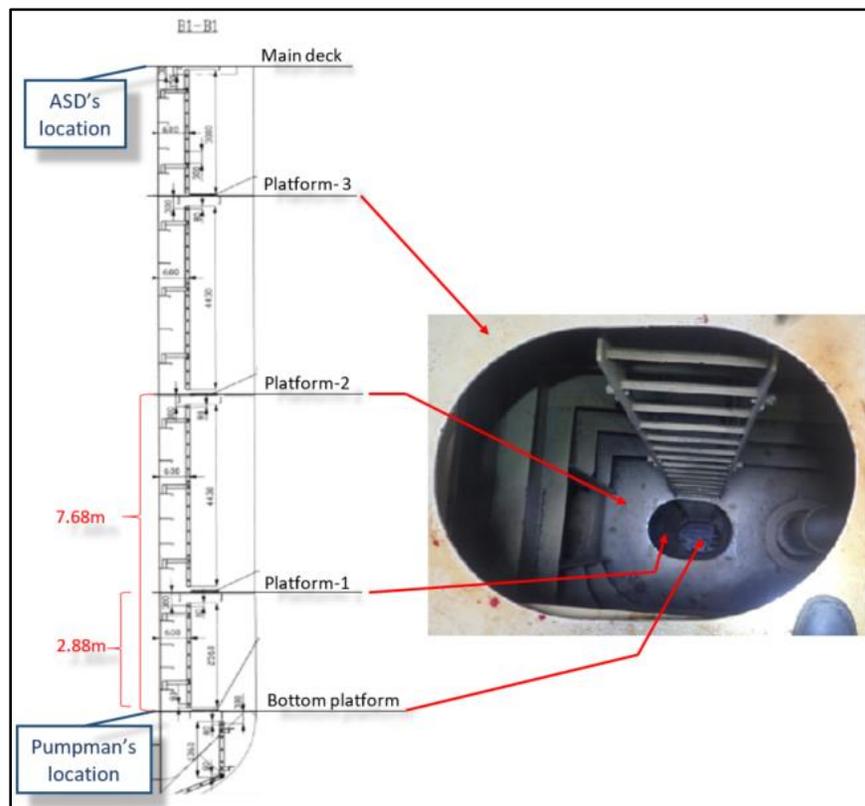
1.2.4 Inside 7WBT-P, a vertical ladder, located at the side of the manhole, which extended through three platforms provided direct access to the bottom platform. The estimated height from the bottom platform (where the Pumpman was found unconscious) to the main deck was about 16m, to platform-2 was 7.7m, and to the platform-1 was about 3m (see **figure 1**).

Figure 1 – Overview of the 7WBT-P with drawing and picture
(note: the photo was taken on another day after the occurrence from platform 3)
(Source: the ISM Manager)

1.2.5 There was no lighting fitted inside the tank. A clear line of sight to the bottom platform along the vertical ladder would likely be possible only when the outside natural light was bright. Portable lights/torchlights would be needed to perform work inside the tank.

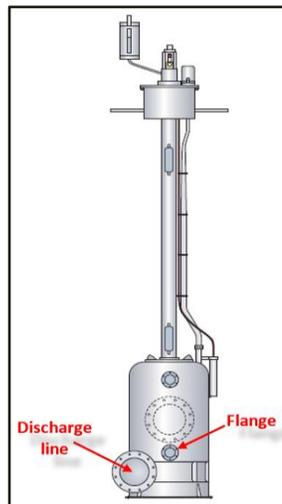
- 1.4.1.5 A sacrificial anode was fitted on the casing of the pump to minimise corrosion, which was secured by a flange. The ASD recalled being informed by the Pumpman that this flange could be the cause of the loss of suction. (see **figure 2**).

Figure 2 – Drawing of the ballast pump and location of the flange, annotated by TSIB
(Source: the ISM Manager)

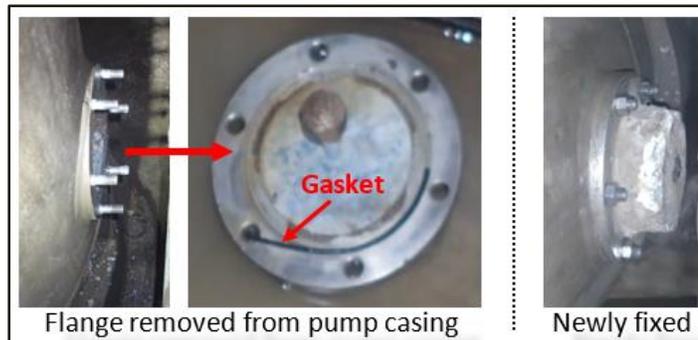
- 1.4.2.1 The flange was about 10cm in diameter and weighed about 6kg. Six holes on the flange were used for bolting it onto the pump casing. The diameter of each hole was about 1.4cm. An inspection of the flange after the occurrence indicated that the rubber O-ring (gasket) attached to the flange was broken²⁹ (see **figure 3**).

Figure 3 – Removed flange and newly fixed after the accident
(Source: the ISM Manager and DSB’s investigators³⁰)

²⁹ It could not be established whether the gasket had broken because of the fall, or during its removal from the pump casing or was already broken due to wear and tear.

⁴⁰ Post-accident inspection of the flange indicated that the gasket of the flange was broken. Assuming that the gasket was found broken when the flange was removed from the pump casing, it had likely prompted the Pumpman to remove the flange from the tank for replacing the gasket at the ship's engine room workshop.

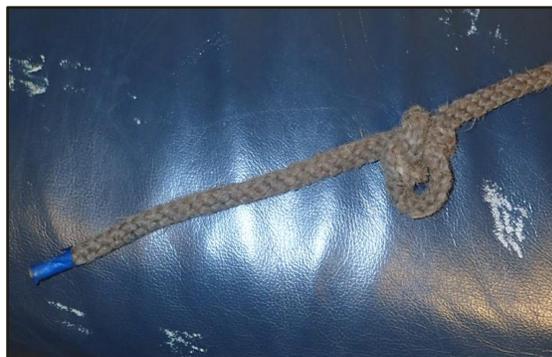
- 1.4.3.1 The rope in use was of a man-made fibre (likely polypropylene) type about 10mm in diameter. An inspection of the rope confirmed that it was intact and a knot existed about 30cm from the end. It could not be established how the rope was secured to the flange by the Pumpman before instructions were given to the ASD to heave up the rope. (see **figure 4**).

Figure 4 – The rope in use with a knot (type of knot unidentifiable)
(Source: the ISM Manager)

- 2.2.3 In this occurrence the rope in use did not part (refer to **figure 4**) which means that the flange had come off from the knot. For a Bowline knot to fail, the end

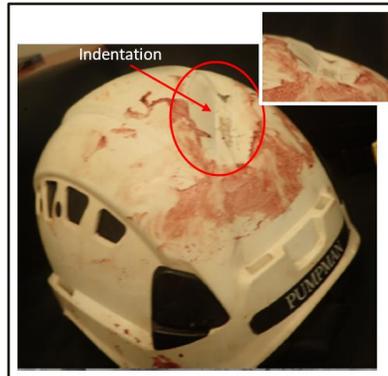
1.4.4.1 The Pumpman was wearing personal protective equipment as per the Company's SMS while inside the water ballast tank, which comprised the work coveralls, safety helmet fixed with a torchlight, personal gas detector, and safety shoes issued by the Company. A set of safety harness was also donned. The safety helmet³¹, found on the grating of the bottom platform, was not cracked but had an inward indentation of about 2cm (see **figure 5**).

Figure 5 - the indentation of the Pumpman's helmet, viewed from two angles
(Source: the ISM Manager)

³¹ According to the Company, the helmet used by the Pumpman was a model which met the European standard EN 12492 (the shock absorption test included the ability to protect the head against falling objects at weight of 5kg at a height of 2m).

- 2.1.3 Although the safety helmet used by the Pumpman was certified to protect against falling objects, the impact force of the 6kg flange from a height of more than 5m (the ASD recalled heaving the rope for about 6-8m before tension was lost) had exceeded the certification requirement of the helmet. The high impact force had caused an inward indentation on the safety helmet which resulted in the fatal injuries of the Pumpman.

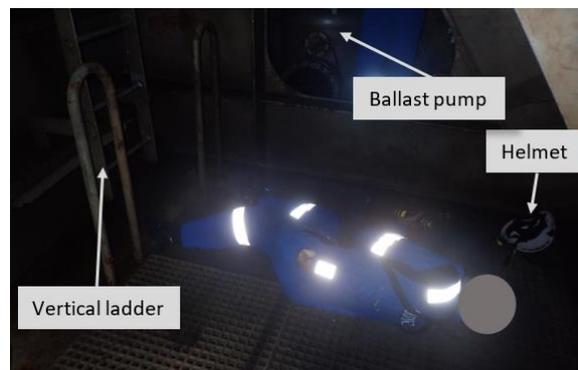
1.4.5.1 When the rescue team reached the bottom platform, the Pumpman was noted to be lying on the right side, on the grating slightly away from the vertical ladder and the safety helmet was less than a metre away (see re-enactment in **figure 6**).

Figure 6 - Re-enactment of the Pumpman's position (*Source: the ISM Manager*)

- 2.1.4 Prior to the occurrence, other than the shout to heave the rope, there was no other communication between the two crew members. Although the ASD recalled that the Pumpman was away from the manhole prior to heaving up the rope, based on the location where the latter's body was noted after the occurrence, it was deemed probable that the Pumpman was either approaching the vertical ladder for climbing up or commenced climbing the vertical ladder to exit the tank, while the rope was being heaved up by the ASD.

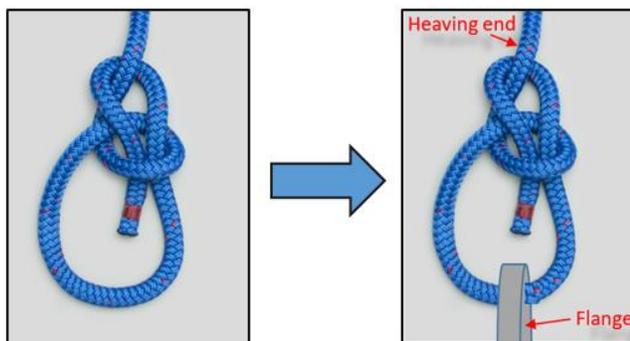
- 2.2.2 At sea, it is common for objects to be lifted and to be tied with a Bowline (see **figure 7**) knot, which is a relatively simple, commonly used and an effective knot⁴¹.

Figure 7 – A Bowline knot if used to tie the flange, annotated by TSIB
(Source: Open source on seamanship techniques)

(indicated in the **figure 7** with a red tape) would have to come out of the securing loop twice and end up as a single rope (without any knotted portions). In this case, the rope was found to have a knotted portion, about 30cm from the end and thus it is unlikely that a Bowline knot was used to secure the flange.
