Final Report

FATALITY OF FITTER ONBOARD SEA PRAJNA AT SEA ON 15 NOVEMBER 2022

TIB/MAI/CAS.133

Transport Safety Investigation Bureau
Ministry of Transport
Singapore

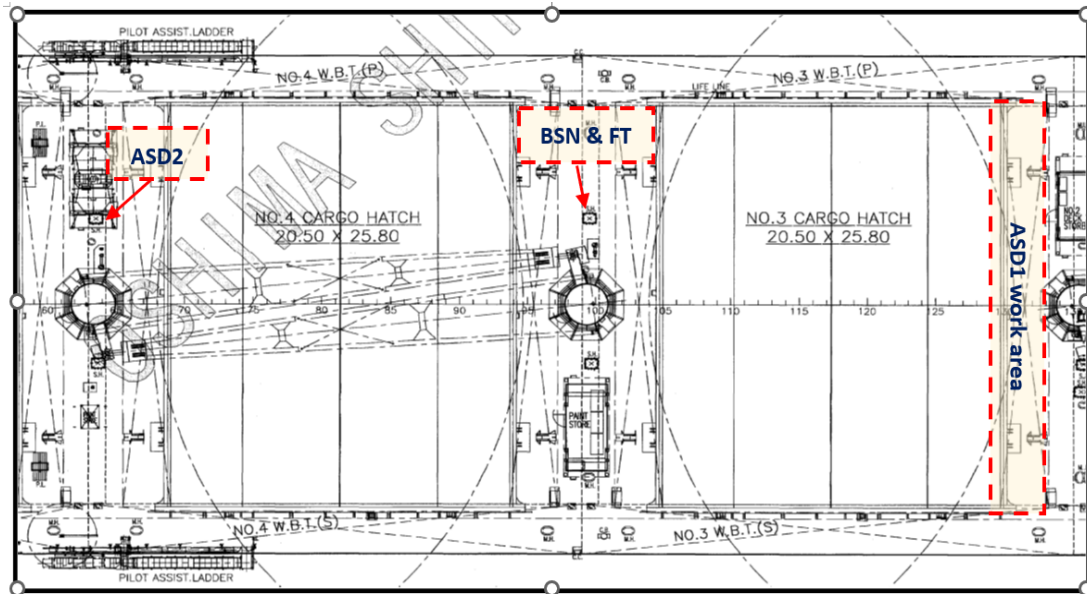
- 1.1.6 Between 0900H and 0930H, the deck crew (BSN, ASD1, ASD2 and FT) commenced their assigned jobs. The BSN supervised⁸ the welding work carried out by the FT at the portside booby hatch⁹, aft of CH3. The ASD2 was assigned the painting of the portside booby hatch, aft of CH4. The ASD1 was assigned the grinding and cutting of corroded and damaged D-rings¹⁰ and cleats at the forward of CH3 (see **figure 1**).

Figure 1: From the GA Plan of SP - Locations of the deck crew according to each crew's assigned job. *Source:* The Company – annotations by the TSIB.

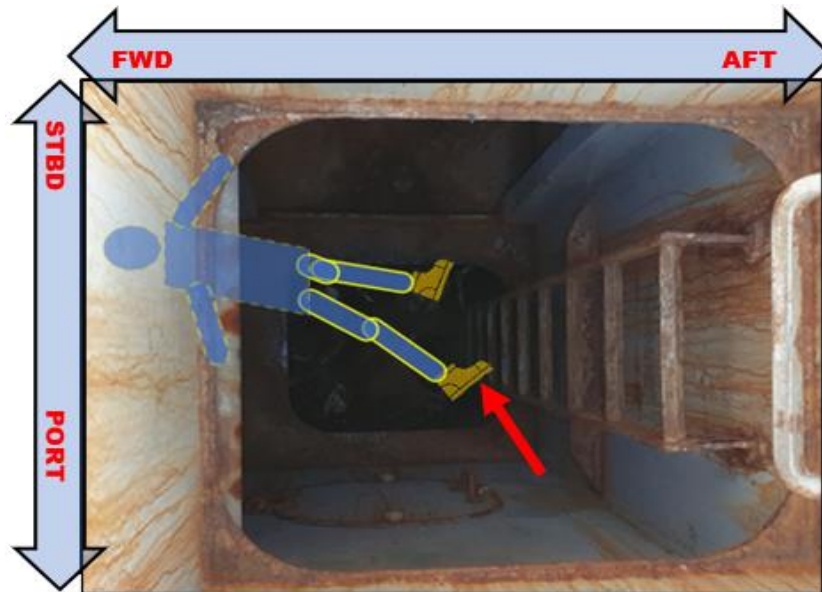
- 1.1.9 The BSN returned to the work location (CH3 aft) between 1145H and 1150H but did not see the FT. The BSN saw that the welding equipment was still powered, the FT's helmet was on the deck beside the booby hatch, and the area did not appear as tidied up (as the FT usually would on completion of his work). Puzzled for not being able to find FT, the BSN looked down the booby hatch and saw that the FT lay inside the CH3. The orientation of FT's body was such that one of his feet was stuck on the vertical ladder and the other foot resting on the pile of scrap metals. The rest of the body was not visible from the main deck (see **figure 2**). The BSN shouted to both the ASDs and reported to the bridge via the portable walkie-talkie that the FT had fallen into the cargo hold.

Figure 2: The FT was discovered inside the cargo hold as viewed from the booby hatch. Red-coloured arrow points to the right foot (with black coloured safety boot) that was on the vertical ladder. The dotted outline shows the portion where the FT's upper body was not visible looking from the main deck – *Illustration not to scale. Source: The Company – annotations by the TSIB.*

- 2.1.4 The FT may not have expected the atmosphere to be oxygen deficient and deemed the cargo hold safe for entry or may have thought that it would be a quick job in retrieving the fallen object from the cargo hold swiftly. As the FT entered the booby hatch via the ladder, the FT likely entered to a hypoxic zone and collapsed on the pile of scrap metals.

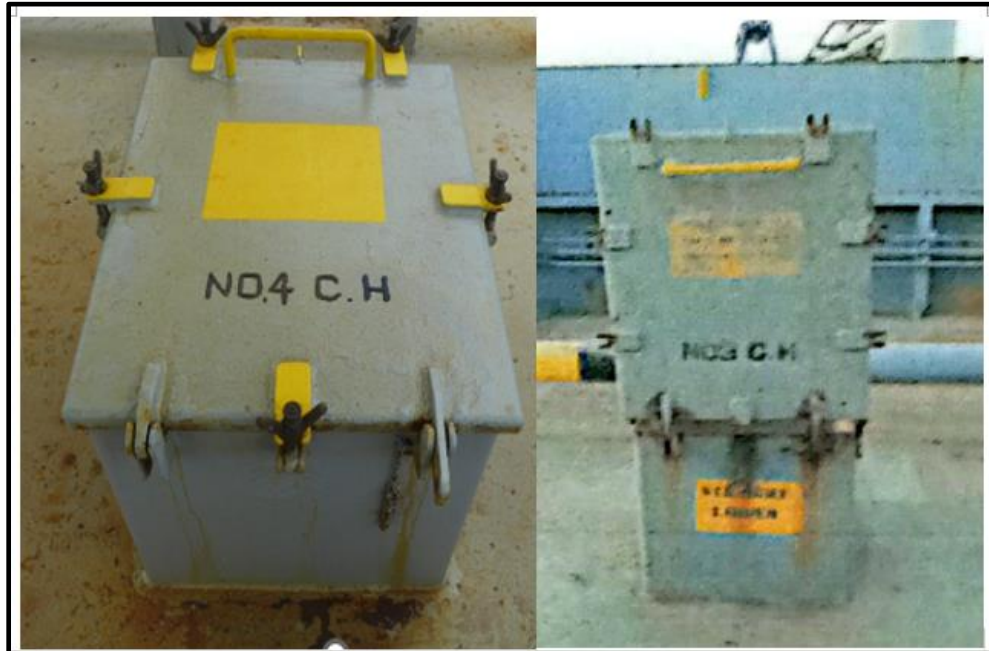
- 1.3.1 The booby hatches onboard SP were of the same design, with each booby hatch cover having five sets of butterfly nuts and bolts to lock the four sides of the hatch for watertightness. The booby hatch cover was painted with the words “RESTRICTED AREA” with a yellow-painted background. There was no other sign or notice in the vicinity indicating that the cargo hold was an enclosed space (see **figure 3**).

Figure 3: The left picture shows the (incomplete) painted top surface of the booby hatch cover, aft of CH4, after the welding maintenance work was completed at an earlier date. The right picture (provided by the Company) shows the original, pre-maintenance condition of the booby hatch, aft of CH3.

5.1.1 To consider putting in place physical barriers such as rope or chains across the opening to prevent accidental entry into any enclosed space. **[TSIB-Recommendation RM-2023-10]**

5.1.2 To consider posting signage(s) and poster(s) in conspicuous places onboard to caution ship's crew and other personnel about enclosed spaces and the need to follow established safety protocols. **[TSIB-Recommendation RM-2023-11]**

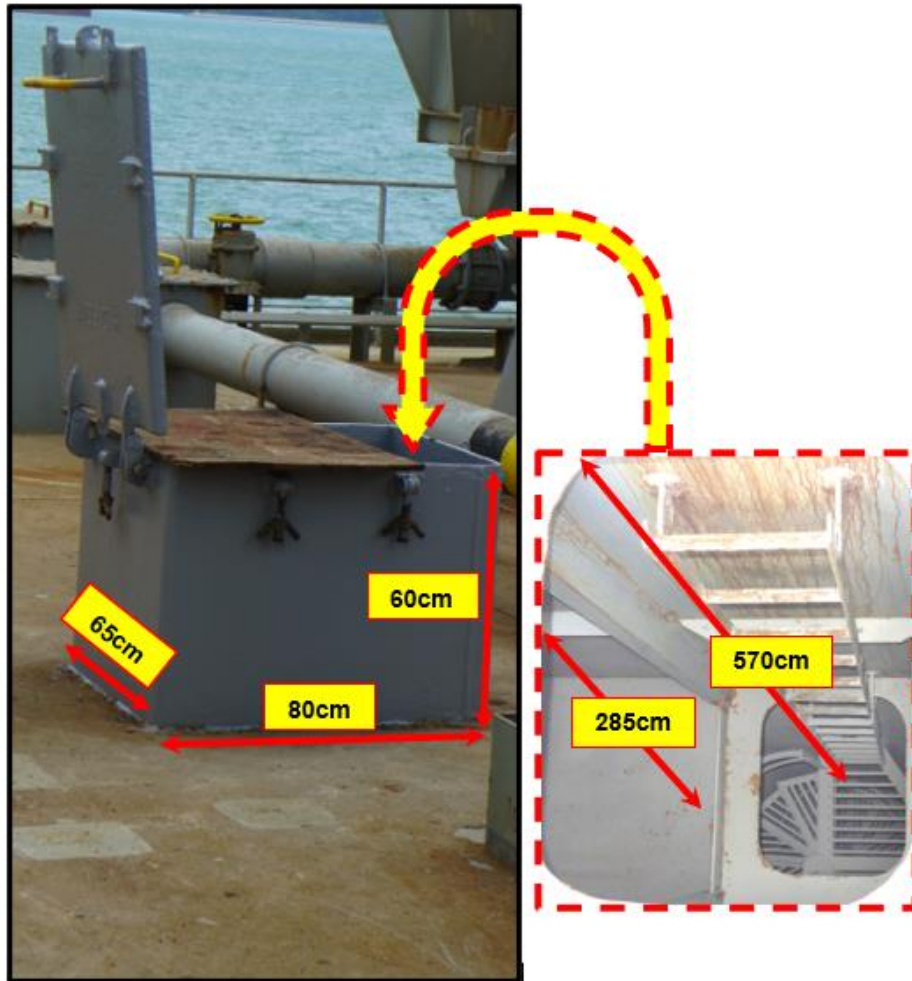
- 1.3.2 Access to the cargo hold from the booby hatch was via a vertical ladder from the main deck, which ends to an intermediate platform (grating-type) before connecting to a spiral ladder²⁴. The top surface of the steel scraps (where the FT was found) loaded inside CH3, covered the intermediate platform and was about 5.7m from the hatch cover (see **figure 4**).

Figure 4: Dimensions of the portside aft booby hatch, aft of CH3
Source: The Company – annotations by the TSIB.

- 2.1.2 Considering the height of the booby hatch (60cm) and an opening of 65cm by 80cm, which was also partially covered by a wooden plank, and noting the absence of any apparent physical injury on the FT (despite not wearing helmet), the investigation team ruled out that the FT accidentally fell from the main deck into the cargo hold. From the items recovered surrounding the area where FT had been working, the pair of sunglasses which were reportedly being used by the FT to assist in his welding work (together with the welding shield) were not found.

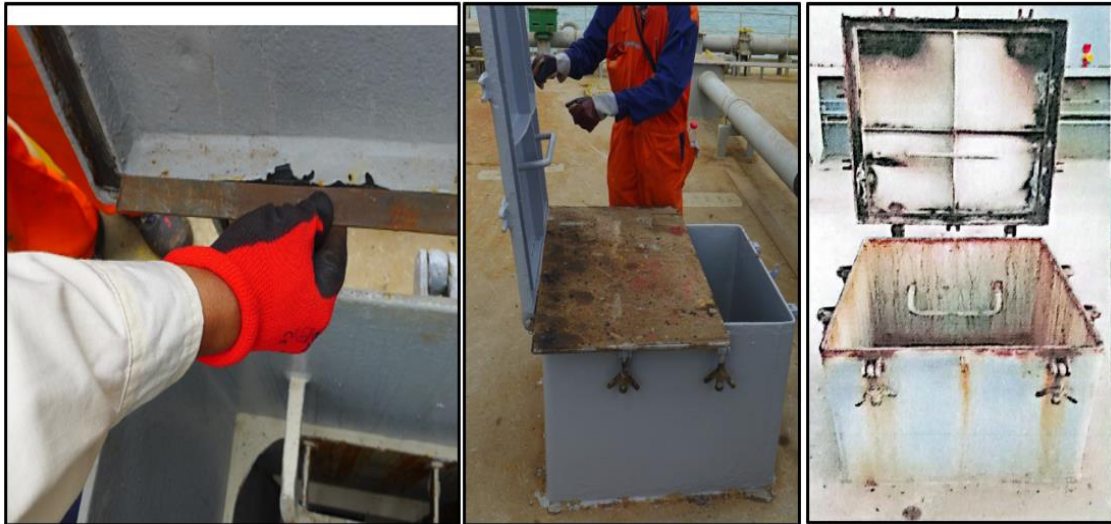
1.3.5 The welding work for the booby hatch cover was for the replacement of the corroded “lips” of the hatch cover, where rubber seals were secured to maintain watertightness of the cargo hold. The task involved cutting the corroded pieces and grinding the surface before welding the fabricated pieces (see **figure 5**). As a safety precaution to prevent embers and sparks during welding from entering the cargo hold, a plank (wet wood) was used to partially cover the opening.

Figure 5: The picture on the left shows an example of the replacement metal piece to be welded at the lip. The centre picture shows the wet wooden plank covering the opening. The picture on the right shows the completed welding by the FT on the booby hatch, aft of CH3.

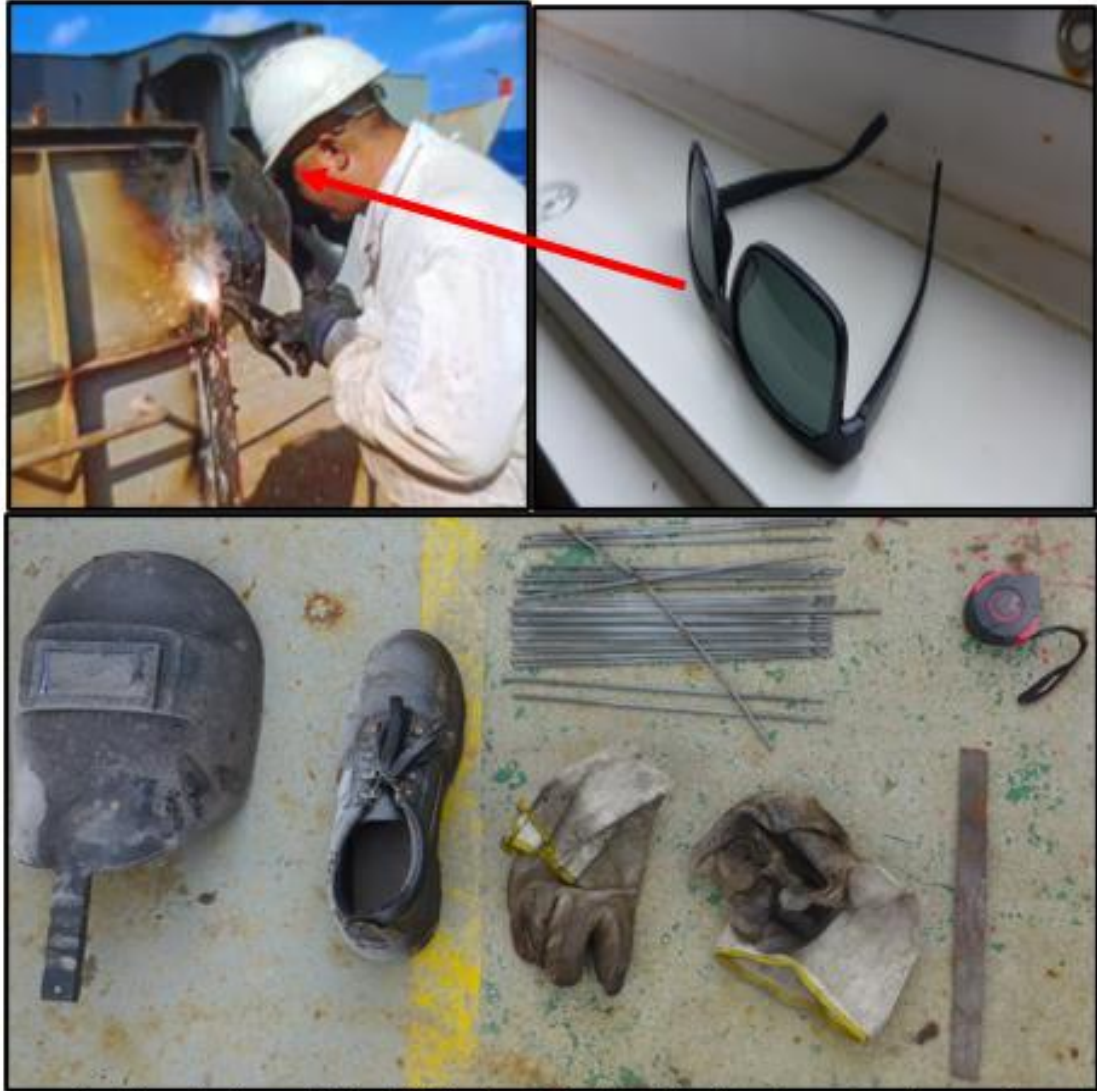
1.3.6 The tools used by the FT are shown in **figure 6**, which include a pair of sunglasses²⁶ in addition to a welding safety shield. One safety shoe was found inside the CH3 while the other safety shoe was still worn on the FT’s foot. At the time of recovery, the FT was wearing leather gloves.

Figure 6: The picture²⁷ of the FT before the occurrence.
Source: The Company (annotated by the TSIB)

- 2.1.3 The investigation team considered that in all probability, while welding, an item such as the pair of sunglasses, might have fallen into the cargo hold through the booby hatch. The FT then likely attempted to retrieve the item by entering the cargo hold via the vertical ladder. The atmospheric condition (see 1.4.4) measured a day after the occurrence, confirmed that CH3 was deficient in oxygen. It is, therefore, highly probable that the scrap metals loaded in CH3 had caused the depletion of oxygen from the hold's atmosphere to levels which would not have sustained life.
