ELECTROCUTION OF WELDER ON BOARD THE CONTAINER SHIP SOUTHERN LILY AT SEA ON 23 JULY 2018

TIB/MAI/CAS.084

Transport Safety Investigation Bureau
Ministry of Transport
Singapore

29 March 2021

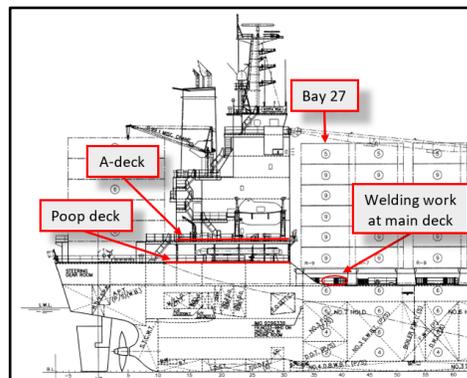
1.2.3 At the time of occurrence, the location where the Welder was working was sheltered by 40-foot containers loaded above. The ASD was working at A-deck (lifeboat deck) which was one deck above the poop deck (see **figure 1**). Bay 27 was located at the last cargo hold in front of the accommodation. The locations between the ASD and the Welder were blocked by the 40-foot containers at that bay.

Figure 1 – SL's General Arrangement Plan annotated by TSIB with the two locations
(Source: The Company).

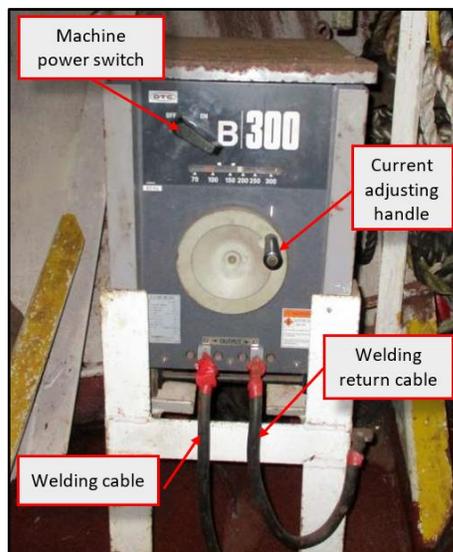
Figure 2 – The welding machine inside forecastle store used at the time of the occurrence - annotated by TSIB
(Source: The Company)

2.2.3 The welding machine was an AC output type with a maximum no-load voltage of 80V which was more than three times higher than the recommendation by COSWP (at 25V). The Company could not provide an explanation why the recommendations by the flag Administration and the COSWP had not been taken into consideration. Had a VLD been fitted, the outcome of this occurrence may have been different.

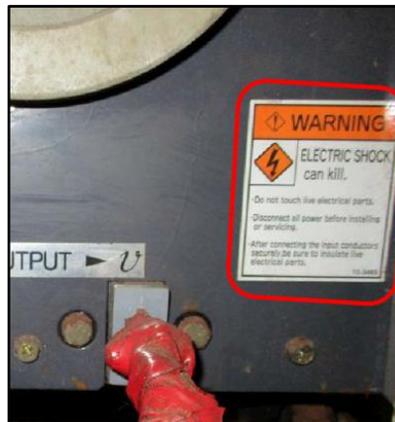
- k) Do not wrap weld cables around your body; and
 - l) Turn off power switch when not in use.
- 1.4.4 Additionally, there was a safety warning sign cautioned “Electric shock can kill” which was pasted on the welding machine (see **Figure 3**), and another warning which stated not to touch live electrical parts.

Figure 3 – Warning sign - annotated by TSIB in red
(Source: The Company)

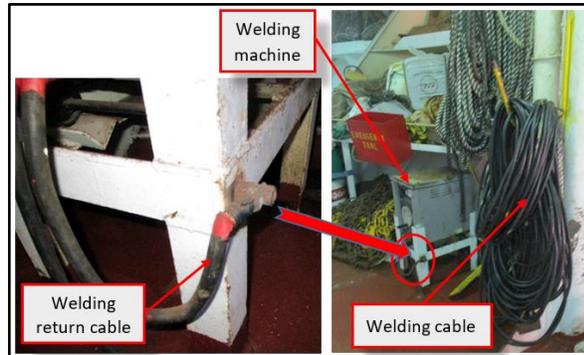
to ship's structure when the machine was installed. The welding return cable²⁶ was permanently connected to the storage rack (see **figure 4**) and appeared to have been in place since installation.

Figure 4 – View of welding return cable and welding cables - annotated by TSIB
(Source: The Company)

- 1.8.5 The COSWP recommended that a go-and-return system using two cables from the welding set should be adopted. The welding return cable should be firmly clamped to the workplace (workpiece). The return cable of the welding set and each workpiece should be separately earthed to ship's structure. The use of a single cable with hull return as onboard SL is not a recommended practice (see paragraph 1.4.5).

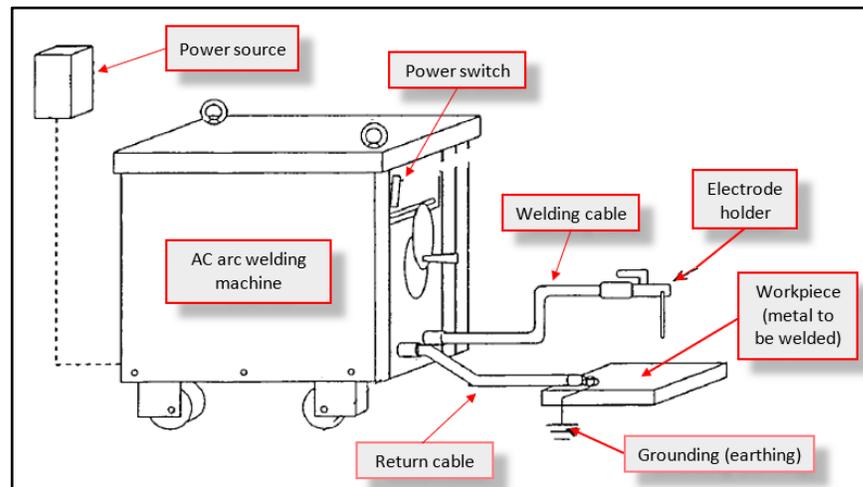
1.4.6 Apart from the welding cable, a typical set-up (see **figure 5**) would require bringing the welding return cable (workpiece lead cable) to the work site and be clamped to a workpiece. This was to limit the hazard of exposing to electric current to a smaller area. The setup on board SL was not like this according to the Company.

Figure 5 - Illustration of a typical welding set-up contained in the user manual -
annotated by TSIB
(Source: The Company)

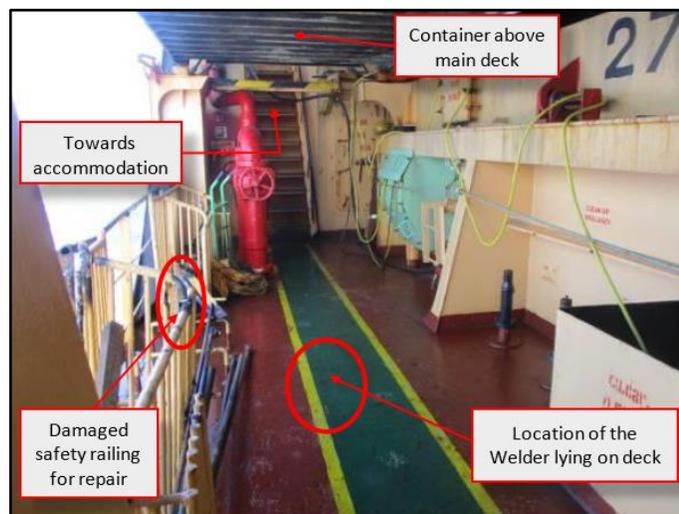
1.5.2 The Welder was alone and hence no one witnessed how the occurrence happened. When the Master discovered the unconscious Welder, (see **figure 6**), the overall which the Welder was wearing were found to be damp. The electrode lead cable holder was about half a metre away from his body. The welding cable was seen laid along the main deck passageway from the forecastle store, and there was no welding return cable seen at the work site.

Figure 6 – View of the work site (taken after few hours of the occurrence) – annotated by TSIB
(Source: The Company)

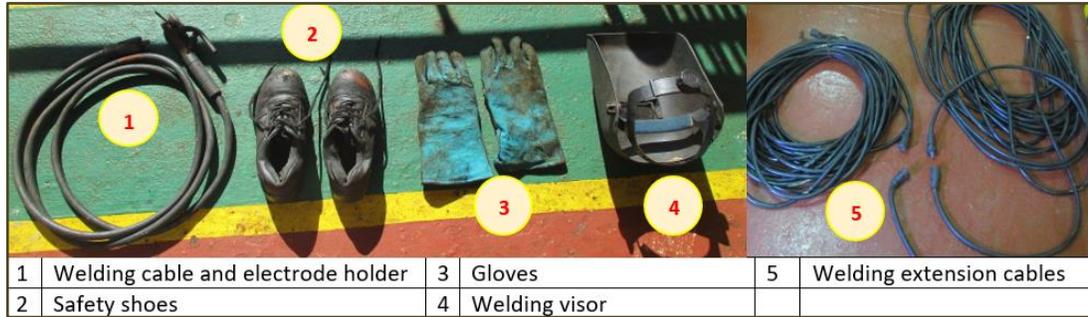
1.5.3 The working gears used by the Welder were not noted to be defective or broken. The insulation of the electrode holder and welding extension cables were found intact. The personal protective equipment (PPE) used by the Welder, such as gloves and safety shoes too were intact and not broken (see **figure 7**).

Figure 7 – Welding cables and PPE reportedly used by the Welder
(Source: The Company)

2.1.2 The insulation of the electrode holder and welding extension cables were found intact and the Welder had reportedly worn proper PPE like gloves. It is likely that the electrocution had resulted from external factors.

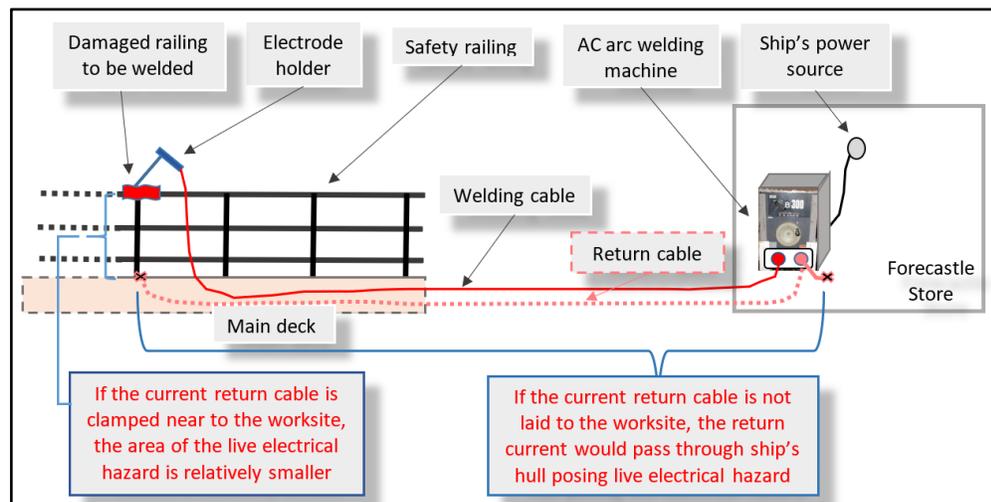
2.5.1 The go-and-return system using two cables (welding and return cables) for welding tasks is a good safe working practice as recommended by COSWP. It is noted that the ship's hull was used by default to form the electric circuit for carrying out welding works on board SL. This arrangement exposed the person performing welding to electric current to a larger area, as opposed to the go-and-return system which limits the exposure to electric current to a smaller area (see **figure 8**).

Figure 8 – Illustration on the scenarios of laying and not laying the welding return cable to the worksite.

2.5.2 As the welding return cable was permanently connected to the storage rack, the Welder had likely continued with the same setup after joining the ship.

Though this unsafe practice did not directly contribute to the occurrence, the investigation team views this to be an important point so that the hazards associated with this setup are understood by the ship's crew.
