FINAL REPORT

MAN OVERBOARD FROM THE CONTAINER SHIP MAERSK PATRAS IN ST. LAWRENCE RIVER ON 19 MAY 2019

MIB/MAI/CAS.065

**Transport Safety Investigation Bureau
Ministry of Transport
Singapore**

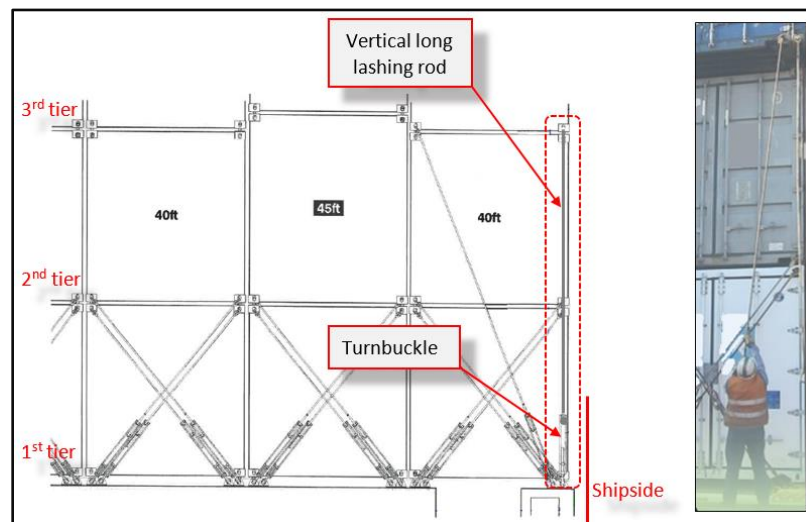
1.1.7 At about 0930H, the ASD1 recalled¹¹ seeing the Second Officer removing a vertical long lashing rod¹² from the third-tier container at the outermost row of the port side. At that time, the turnbuckle of the long lashing rod had been removed by the Second Officer and the Second Officer was attempting to stabilise the rod (see **figure 1**).

Figure 1 – Viewed from the bow - location of the vertical long lashing rod (on left picture) (Source: the Company) – annotated by TSIB; and illustration of removing the long lashing rod (picture on the right) (Source: Marineinsight.com)

1.1.8 Soon after, the Second Officer was seen unable to control the rod and started swaying towards the seaside before falling into the sea while holding the rod. At that time, MP was still doing about 15 knots and was about two nautical miles from Escoumins pilot station.

a result of sleep inertia would have likely caused the Second Officer to underestimate the difficulties in controlling the long rod. Consequently, the Second Officer lost balance when the rod swayed towards the seaside and causing the Second Officer to fall into the water through the opening on deck.

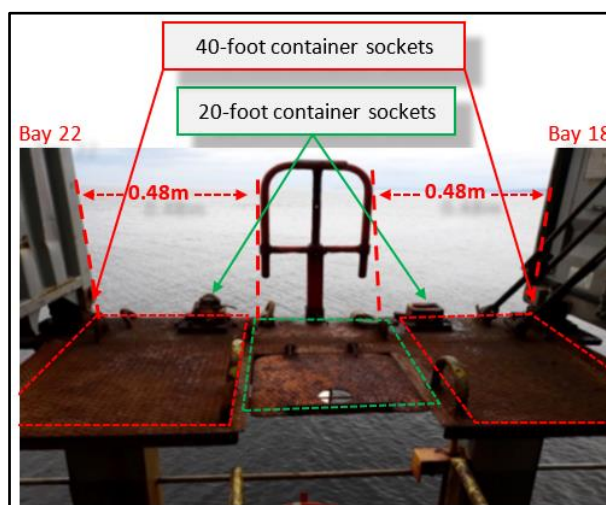
- 1.2.3 At the cross deck on the port side between bay 18 and bay 22, three platforms were used for lashing or unlashng operation (see **figure 2**). The platforms in red dotted boxes were for lashing and unlashng 40-foot containers loaded at bay 18 and bay 22 respectively. The platform in green dotted box was for lashing and unlashng 20-foot containers loaded at both bays. A permanent safety railing erected at the ship side was to guard a person performing operations while standing in the green dotted box, from falling. Gaps of about half a meter each without any fencing²² existed when both bays (18 and 22) were loaded with 40-foot containers. These gaps would not exist if 20-foot containers were loaded. 40-foot containers were loaded at bay 18 and bay 22 at the time of the occurrence.

Figure 2 – View of the cross deck on the port side between bay 18 and bay 22
(annotated by TSIB)
(Source: the Company)

2.2.2 The RA required safety lines to be rigged at openings as a risk control measure to prevent falling overboard, there were no such safety lines rigged at the two openings between bay 18 and bay 22 (refer to figure 2). According to the additional control measures listed in the RA, a toolbox meeting pertaining to the unlashng task was also required to be done on-site. While it is unclear of the need for the toolbox meeting to be carried out on-site, the review of the RA should be done on-site as the conditions on board at the time of carrying out the current task could be different from the 2017's which may result in different hazards.

- 3.4 While unprotected openings had been identified as hazards with appropriate control measures in the RA, the unprotected openings were not installed with safety lines as required by the RA.

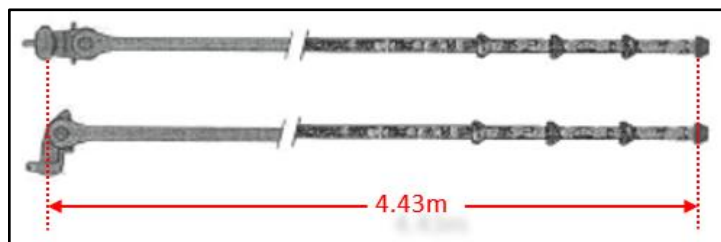
1.4.2 The long lashing rod was used for the third-tier containers at the outermost rows of each bay on deck, had a length of 4.43m and weighed at 22.5kg (see **figure 3**).

Figure 3 – Different views of the long lashing rod – annotated by TSIB
(Source: the ISM Manager)

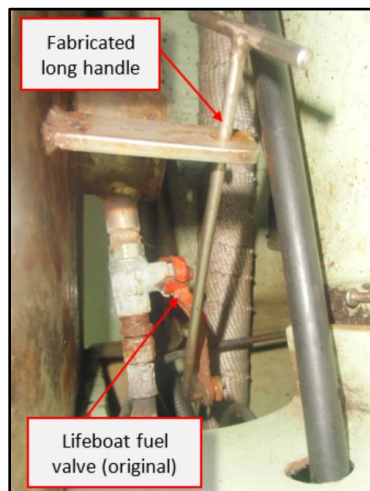
- 1.7.5 While carrying out the SAR operations, the crew reported that the engine of the port lifeboat had tripped twice. After hoisting the port lifeboat on board, the crew found that the fuel valve controlling the fuel supply from the tank to the engine was partially open, causing the engine to trip. The fuel valve was in an

inconvenient location as such a long metal rod had been fabricated⁶² for ease of opening/closing it (see **figure 6**).

Figure 6 – View of the long metal rod fabricated for ease of opening/closing the fuel valve (Source: the Company)

- 2.8.2 The modification of the port lifeboat fuel valve with a long metal rod, while had made it easier for the crew to operate the valve, had introduced a hazard which resulted in tripping of the engine as a result of the valve being insufficiently opened. The modification of such life-saving appliances has an implication on safety and the lifeboat maker should have been consulted for a suitable solution.

- 3.14 The improper modification done on the fuel valve had resulted the lifeboat engine to trip twice during the search.
- 3.15 The grip securing the self-activating smoke signal attached to the MOB lifebuoy did not release.

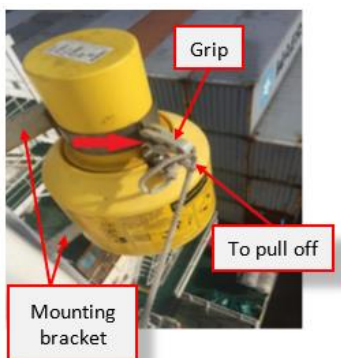
- 1.7.6 After confirming that the Second Officer had fallen overboard, the Master activated the quick release of the MOB lifebuoy unsuccessfully. It was found out later that the self-activating smoke signal, which was attached to the MOB lifebuoy with a lanyard, when deployed, got stuck at the mounting bracket on the ship's structure and resulted in the MOB lifebuoy hanging in the air.

- 1.7.7 A closer inspection of the unit was carried out after the occurrence and it was noted that the plastic grip securing the smoke signal to the mounting bracket was still in place, preventing the smoke signal from being released (see **figure 7**), i.e. the lanyard attached to the lifebuoy did not pull the grip off to release the smoke signal from the bracket. A new set of MOB lifebuoy with self-activating smoke signal was replaced during the port stay in Montreal.

Figure 7 – View of the self-activating smoke signal mounted on ship's structure
(Source: The Company)
