FINAL REPORT

FATAL INJURY ON BOARD THE BULK CARRIER CAPE INDIA AT SEA ON 28 OCTOBER 2019

MIB/MAI/CAS.073

**Transport Safety Investigation Bureau
Ministry of Transport
Singapore**

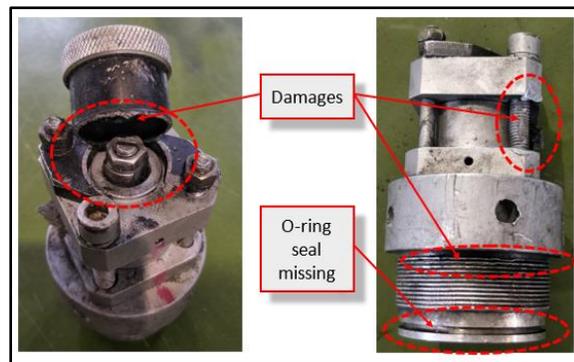
Figure 5 – Damaged pressure relief valve (annotated by TSIB)
(Source: the ISM Manager)

1.5.2 An inspection of the FCS by the ship’s crew documented that the metal jubilee clip securing the air outlet filter housing (AOFH) was broken and found on the floor few metres away from the BA compressor. The AOFH was found near the entrance of the FCS and had broken up into many pieces. The pressure relief valve, separated from the AOFH, was lying in a damaged condition on the floor. The O-ring seal which was to prevent leaks during charging operation was missing from the thread section of the AOFH (see **figure 5**).

- 1.6.2 The pressure relief valve from Cape India's BA compressor was found to have malfunctioned. Blackish particles were seen internally after the valve was dismantled. A test was carried out to verify the pressure relieve valve setting of the BA compressor on Cape Europe. The test revealed that the valve activated at 305bar (30.5MPa), and the pressure was maintained at this reading when continue running the BA compressor.

- 3.2 The pressure relief valve of the BA compressor had malfunctioned, likely caused by the excessive amount of lubricating oil, and allowed pressure to continue building up in the AOFH.

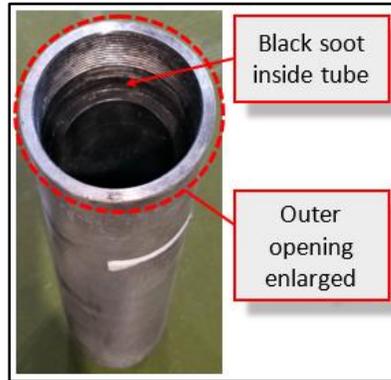
Figure 6 – Damaged AOFH (annotated by TSIB)
(Source: the ISM Manager)

1.5.3 The opening of the AOFH, connected to the pressure relief valve, was noted to have expanded by about 2.5mm in diameter. There was no crack to the AOFH and some black oily particles and soot deposits could be seen sticking to the inner surface (see **figure 6**).

1.6.7 The laboratory test concluded that Cape India's air filter unit had expanded at the filter housing's thread section. Consequently, the pressure relief valve was ejected from the AOFH. The expansion of the AOFH was a result of internal over pressure which reached beyond the pre-set pressure relief value of 300bar (or 305bar as tested on Cape Europe) and a malfunctioning of the pressure relief valve. The O-ring seal inside the air filter unit lost the sealing ability, causing compressed air to leak into the threaded area and ejecting the pressure relief valve and AOFH from the compressor.

- 3.3 When pressure build-up in the AOFH, the air leaked into the threaded section of the AOFH and expanded the threaded section which was made of thinner and lower tensile strength material.

- 3.4 The expanded threaded section caused the pressure relief valve to be ejected out of the AOFH. The force created had also caused the AOFH to break off from its secured position.

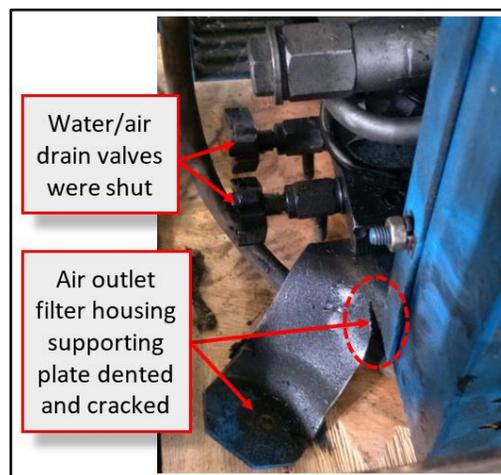
Figure 7 – View of metal supporting plate and water/air drain valves
(annotated by TSIB)
(Source: the ISM Manager)

- 1.5.4 The metal plate supporting the AOFH was bent downwards and cracked at the side. Both air and water drain valves were found in shut position. Soot and oily particles could also be seen all over the corner of the air compressor (see **figure 7**).

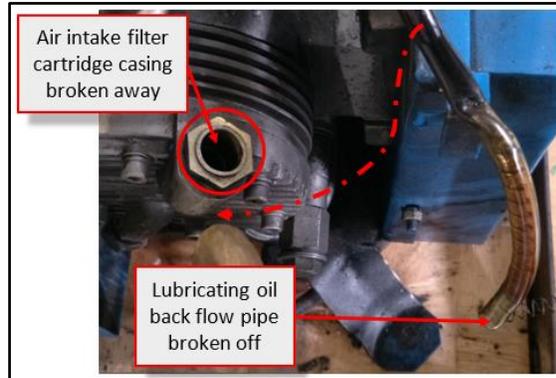
Figure 8 – View of air intake filter cartridge and lubricating oil pipe (annotated by TSIB)
(Source: the ISM Manager)

- 1.5.5 The air intake filter cartridge casing, besides the AOFH, had broken off and was found on the floor few metres away. The lubricating oil flexible pipe had also broken off (see **figure 8**).

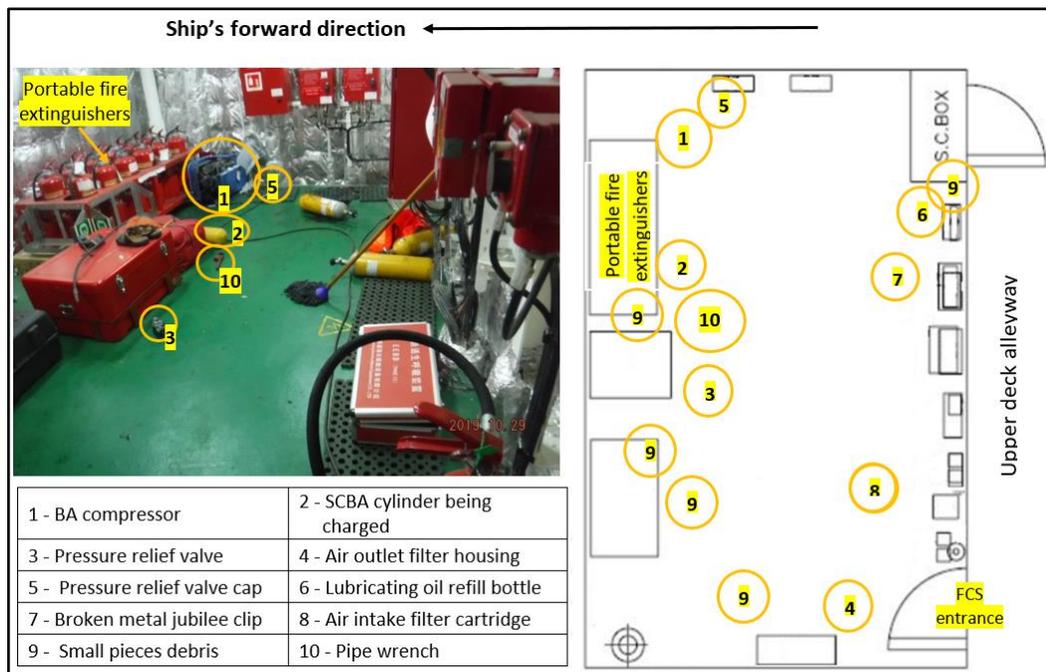
Figure 9 – View of FCS after the occurrence (relevant portions annotated by TSIB)
(Source: the ISM Manager)

1.5.6 Soot and oily burnt particles could also be seen on the rubber floor mat placed below the BA compressor. Many other small pieces of debris from the BA compressor were strewn all over the places in the FCS. A pipe wrench was found on the floor. One air cylinder was connected to the BA compressor using a flexible charging hose, another three air cylinders were loosely lying on the floor (see **figure 9**).

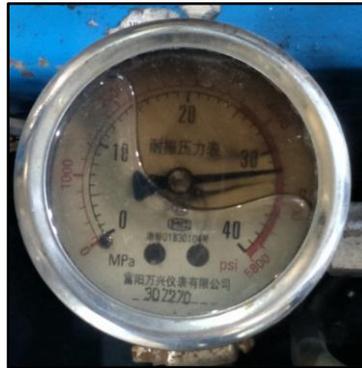
Figure 10 – Pressure reading on the air compressor gauge

1.5.7 The BA compressor pressure gauge read at about 32MPa (320bar) (see **figure 10**).

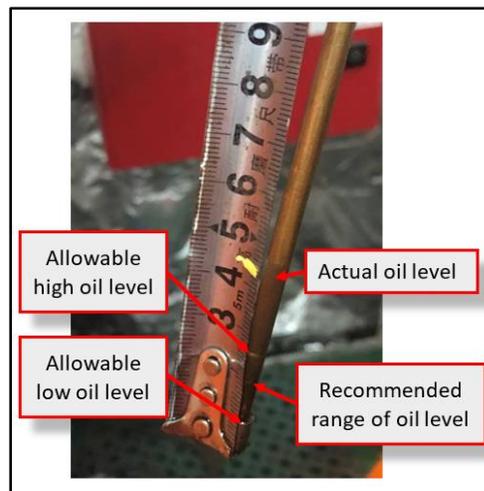
Figure 11 – Dip stick level after the occurrence
(Source: the ISM Manager)

1.5.8 A marking on the dip stick indicated the allowable low and high level of lubricating oil to be filled in the BA compressor. The level of lubricating oil level measured after the occurrence was found to be 2cm higher than the allowable high oil level marking (see **figure 11**).

2.2.1 There were no records of any inspection or maintenance carried out on the BA compressor, other than an air quality check. It was evident that an excessive amount of lubricating oil had been filled (about 2cm higher than the allowable high oil level marking) in the BA compressor. Correlating the carbon deposits accumulated over a period and the excessive oil, it was possible that this overfilling of lubricating oil had contributed to the failure of the pressure relief valve.

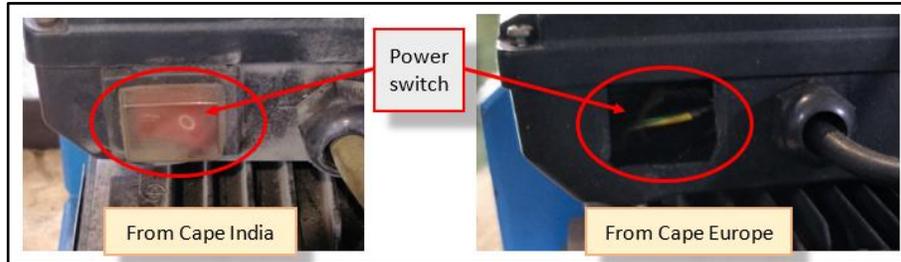
Figure 12 – Power switch on the BA compressor

1.5.9 The power switch of the BA compressor was fitted at the right rear end. To switch on/off the BA compressor, the operator would have to lean over the main body of the BA compressor to reach the right rear end. On Cape Europe, this switch was absent⁴⁷ and the power was directly controlled from the plug end at the alleyway outside the FCS (see **figure 12**).

2.4.3 Having an electrical power switch located at the rear end would create hazards to the user in having to lean over a running compressor to reach the switch. It could not be established whether the switch on Cape Europe had been removed for safety reasons. The investigation team opined that even if the switch was removed, it should have been replaced with an alternative arrangement for use in an emergency, as recommended in the COSWP.

- 3.10 The design of the electrical power switch location at the rear end for the BA compressor would create safety hazard for the user to turn off the power. There was also no other emergency stop switch fitted for easy access.
- 3.11 There was a delay of about two and half hours between the arrivals of the ship and the rescue party at the rendezvous position, there is room for improvement among the stakeholders in ensuring timely arrival of the rescue party.
