Final Report

Death of a crew

SRS Asian Triumph

TIB/MAI/CAS.140

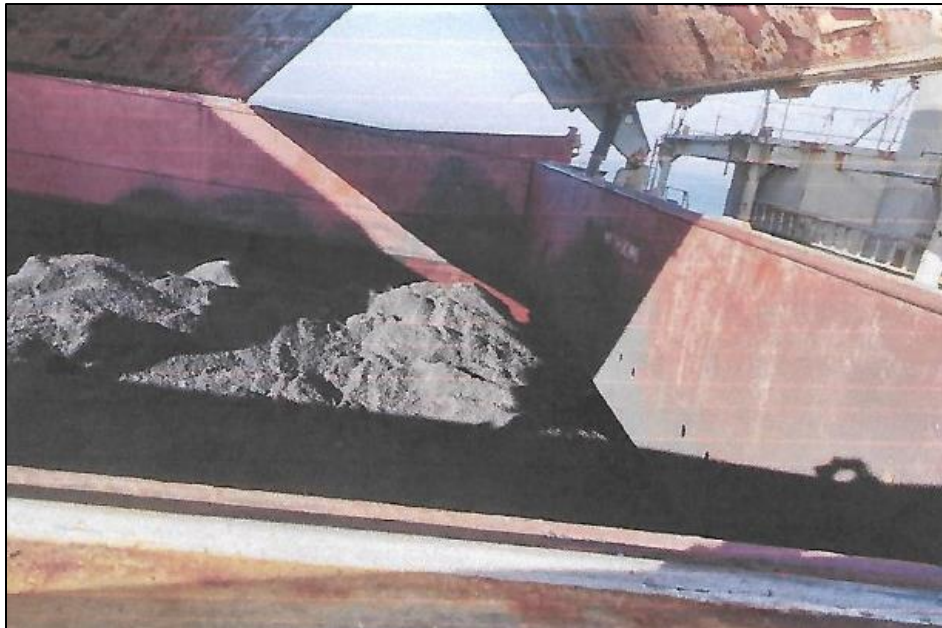
- 1.1.12 At about 1305H, the OS entered cargo hold #2 while the DC remained outside of the manhole, standing by to hoist the samples up. In the meantime, the DC observed the BSN and ASD-B leaving the manhole of cargo hold #5.
- 1.1.13 According to the DC, like the previous cargo holds #1 and #4 there was nothing unusual about the loading condition of cargo hold #2. See **figures 3**.

Figure 3 - Loading condition inside cargo hold #2 (hatch in open position) at the time of the occurrence. *Source: The Company.*

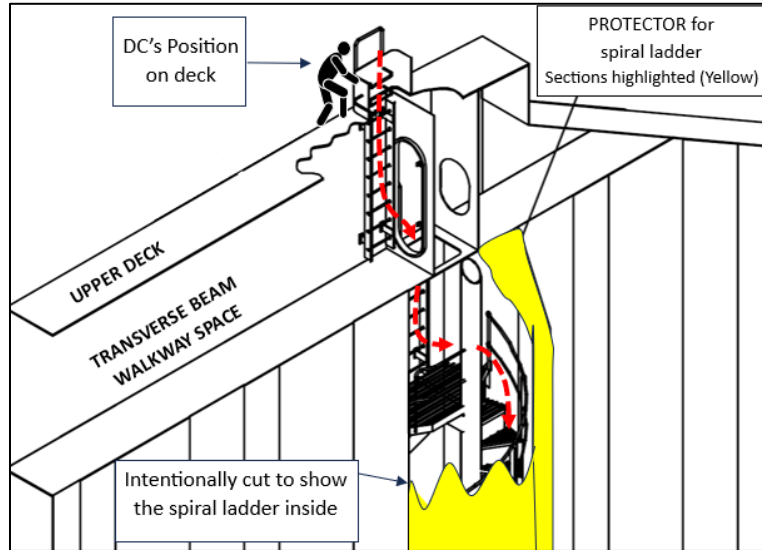
- 1.1.14 Upon recollection, the DC observed the OS descending the vertical ladder to the transverse beam walkway¹² space, and subsequently using the spiral ladder to collect the cargo samples. The OS displayed no difficulties during this operation, see **figure 4**.

Figure 4 - Depicting the DC's position and route taken by the OS (marked red dashes). *Source:* The Company. Annotation by TSIB

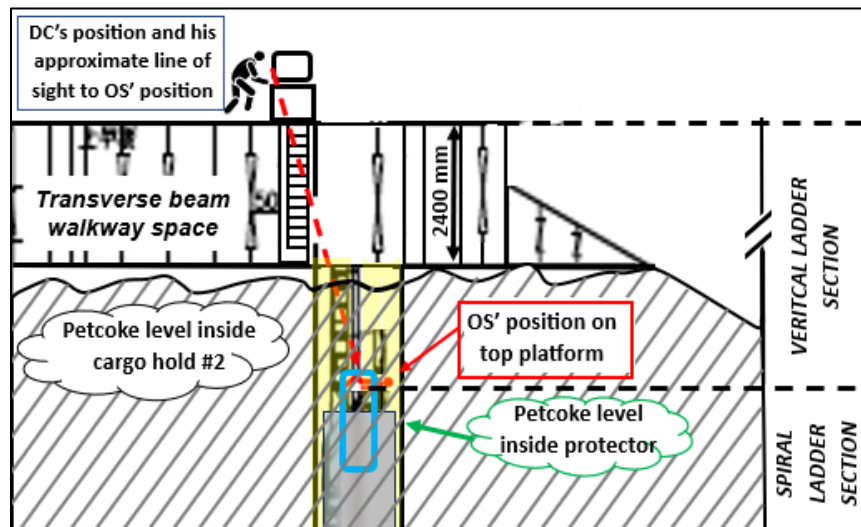
- 1.1.15 After the OS collected the cargo samples, he instructed the DC to hoist the bucket up. The OS then proceeded to climb the spiral ladder followed by the vertical ladder. Upon reaching the third or fourth step of the vertical ladder from the top platform, the OS suddenly called for assistance. Subsequently, the OS fell (from height about 1-1.5m) and collapsed onto the platform, see **figure 5**.

Figure 5 - Presentation of cargo level inside cargo hold #2 and inside the protector (coloured yellow). Not to scale. *Source:* The Company. Annotation by TSIB

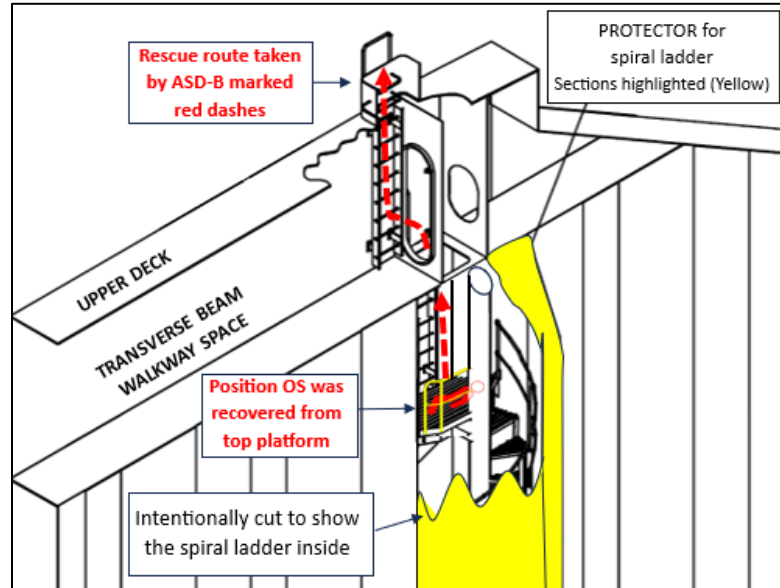
Figure 6 - Depicting the rescue route taken by the ASD-B (marked red dashes). *Source:* The Company. Annotation by TSIB

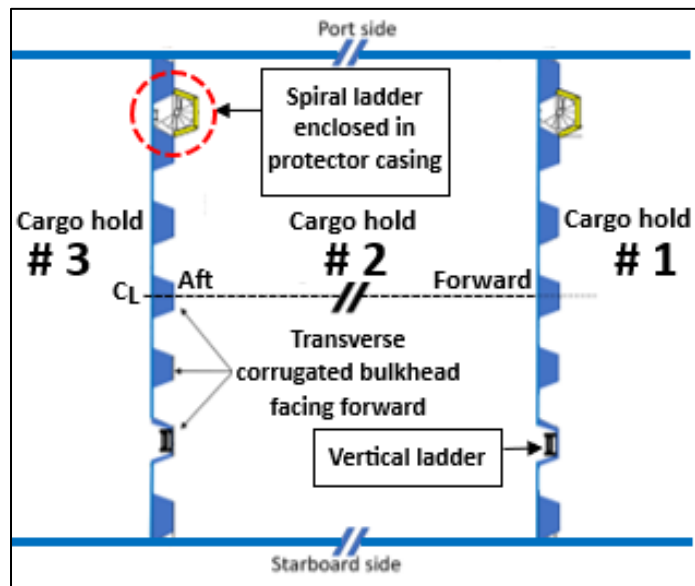
1.3.4 **Figure 8** depict view from the top of cargo hold #2 with the vertical ladder at the starboard side forward section and the spiral ladder at the port side aft section.

Figure 8 - Depicting cargo hold #2 showing the location of the occurrence site (circle in red dash) as viewed from the top. Not to scale *Source: The Company.* Annotation by TSIB.

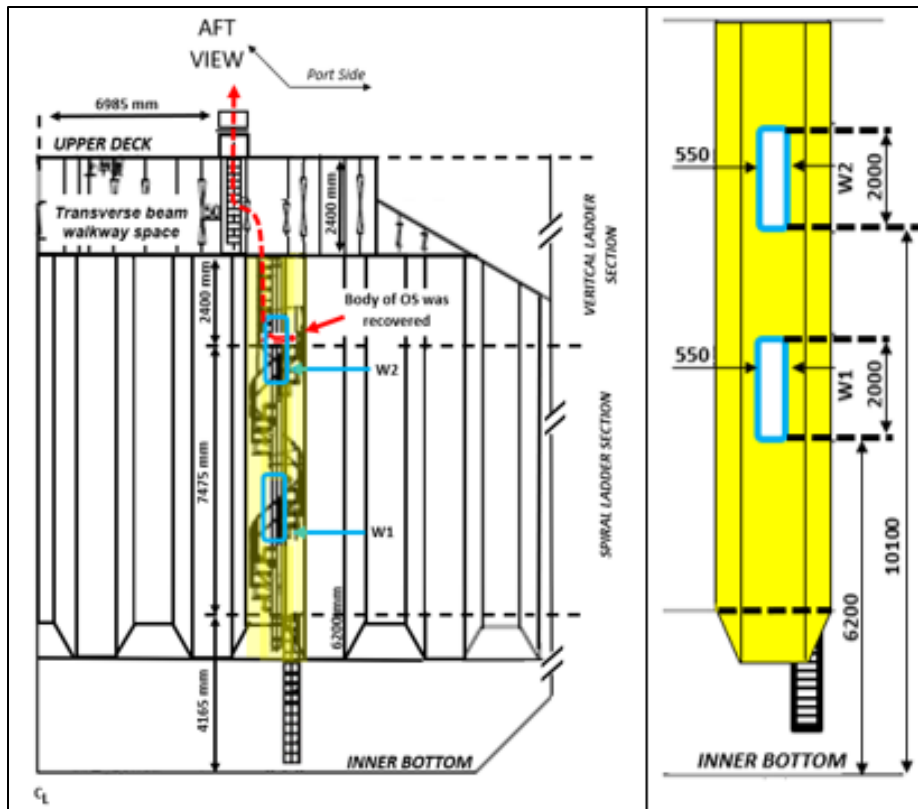
- 1.3.8 To facilitate this, each protector is fitted with two openings (W1 and W2) for cargo loading. At the time of the incident, both W1 and W2 were fully covered by cargo inside the cargo hold #2, and the cargo level within protector was roughly more than half of the W2 opening, see **figure 10**.

Figure 10 - Depicting the protector for the spiral ladder. Not to scale. *Source:* The Company. Annotation by TSIB

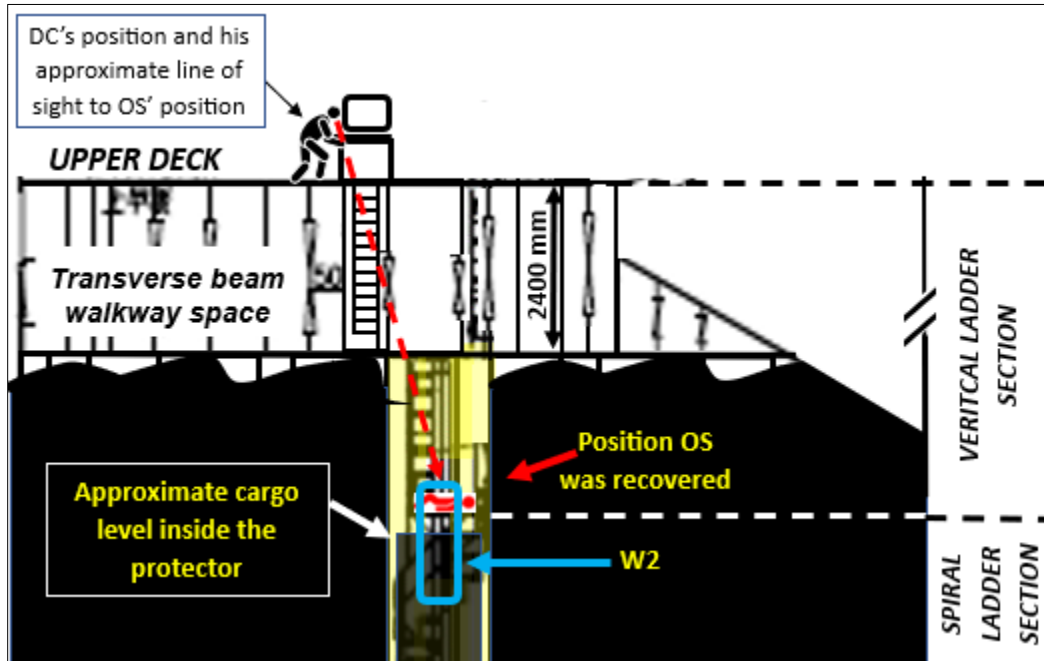
1.4.3 **Figure 13** depicting the position of a person standing-by on deck during the collection of cargo samples process. This was the position of the DC at the time of the occurrence.

Figure 13 - Depicting the position of the DC outside the manhole and the position where the OS was recovered. Not to scale. *Source:* The Company. Annotation by TSIB.

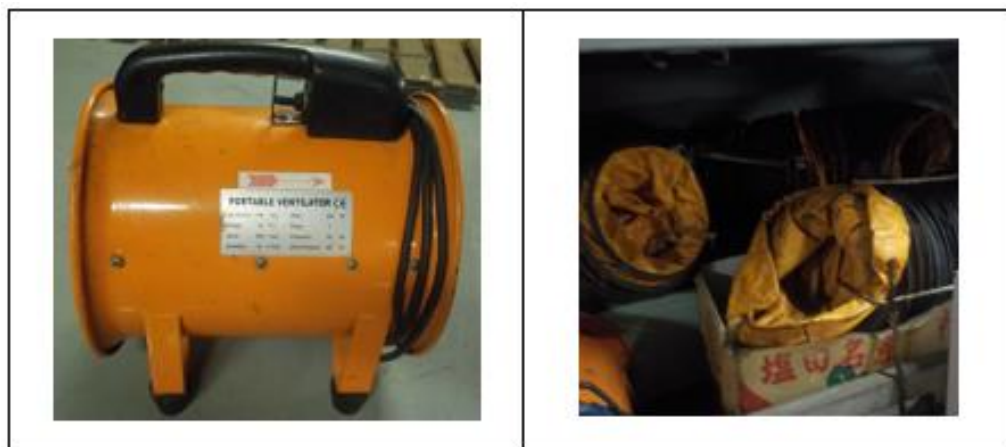
1.4.4 The means of ventilation system for the spaces (transverse beam walkway and the protector) relied on a portable fan and ventilation duct tubing, see **figure 14**. On the day of the incident the ventilation fan was not utilised.

Figure 14 - The onboard portable fan and ventilation tubing. *Source:* The Company

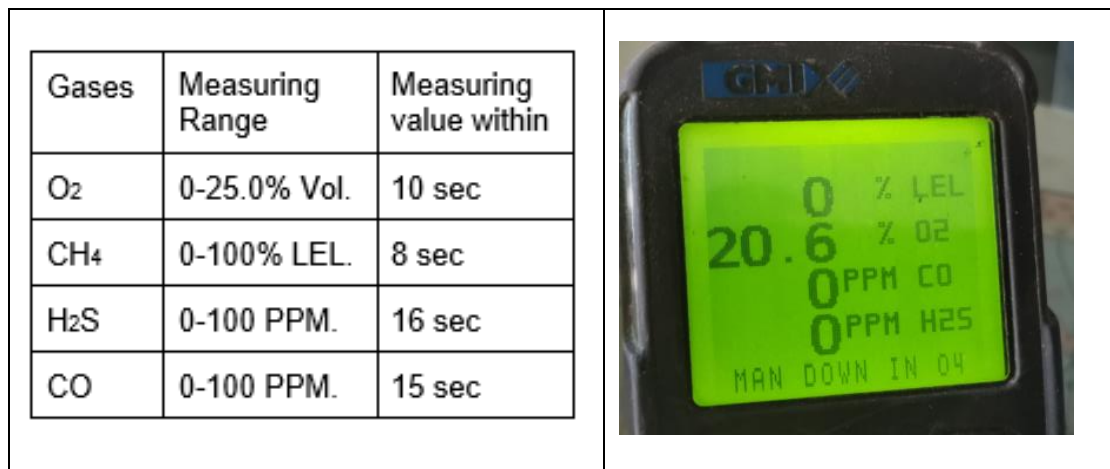
1.12.1 AT has onboard two sets of portable gas detector of type GMI, see **figure 15**. Both the units were last calibrated on 18 May 2022 and their annual calibration was due in May 2023. The investigation team was notified by the Company that the gas detector was not utilised to assess the O₂ content or presence of toxic gases within the cargo hold at the time of incident by any of the involved parties. In addition, there was no verification conducted for cargo samples, prior to rescue efforts, or following the rescue for recording purposes.

Figure 15 – Gas detector. *Source: The Company*

- 4.7 Completed the procurement of eight more portable O₂ content and gas detectors per ship in July 2023 and requires crew members to wear them when entering enclosed spaces.
