Final Report

COLLISION

**CRYSTAL SUNRISE
AND
ASTRO SATURN**

**SINGAPORE TERRITORIAL WATERS
17 APRIL 2018**

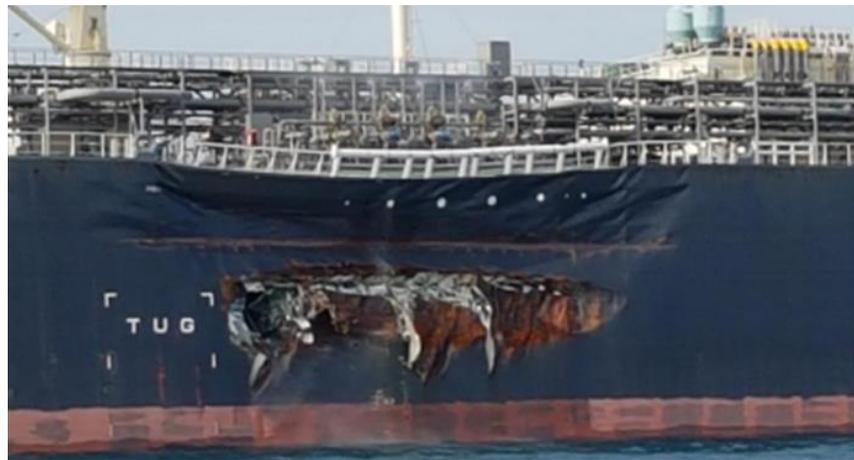
1.1.30 The collision did not result in any injuries on board CS. In the opinion of the Master the collision rendered the vessel unfit to continue its passage due to following damages (see **figures 11, 12 and 13**):

- No.3 port side water ballast tank and IBS⁵⁷ tank; and
- No.3 port side cargo tank that caused cargo leakages⁵⁸ into the atmosphere.

Figure 11 - External view of the vessel's damages in the midship section

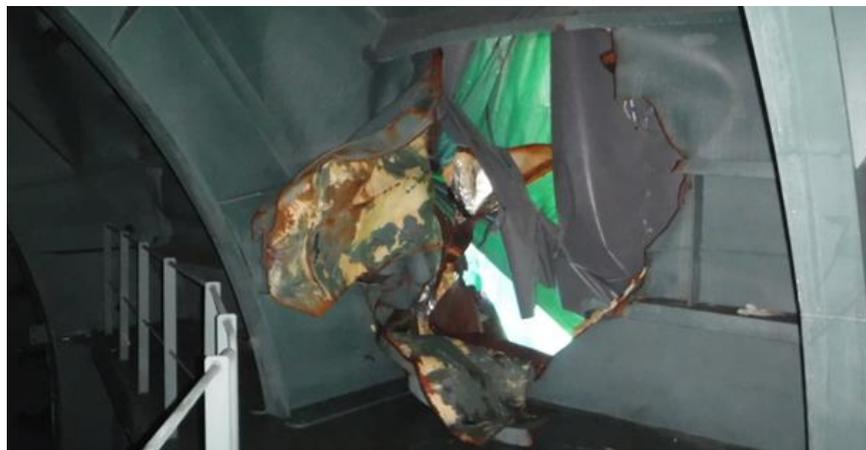
Figure 12 – Internal view of the vessel's damage (view from inside the tank)

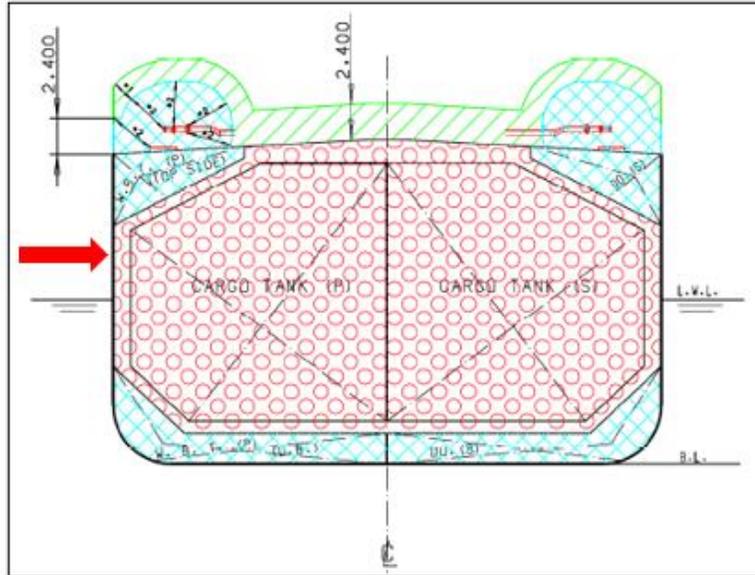
Figure 13 - Cross-section view of no.3 cargo tank indicating the approximate location of the damage (annotated by TSIB with a red arrow on CS port side)

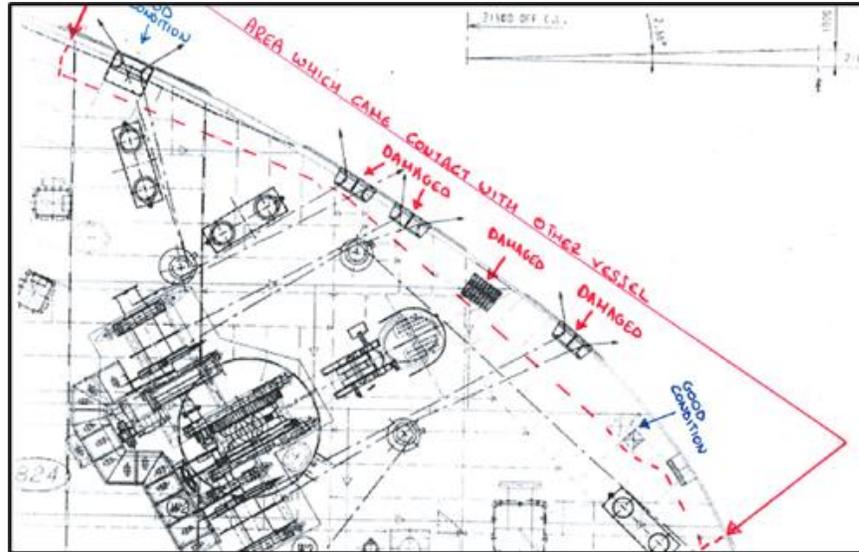
- 1.1.51 AS sustained damages at the forward port side bulwark, forecandle, adjacent structure⁷⁴ and to its port side anchor. (see **figures 19 and 20**). At about 0248H, the Master of AS informed VTIS (W) of the intention to continue AS' passage and to drift off to Tanjung Pelepas, Malaysia, for further advice from the Company.

⁷⁴ Damages and deformed from Fr. 100 to Fr. 115 (port bow).

Figure 19 – Plan view of the damaged section (Source: Company of AS)

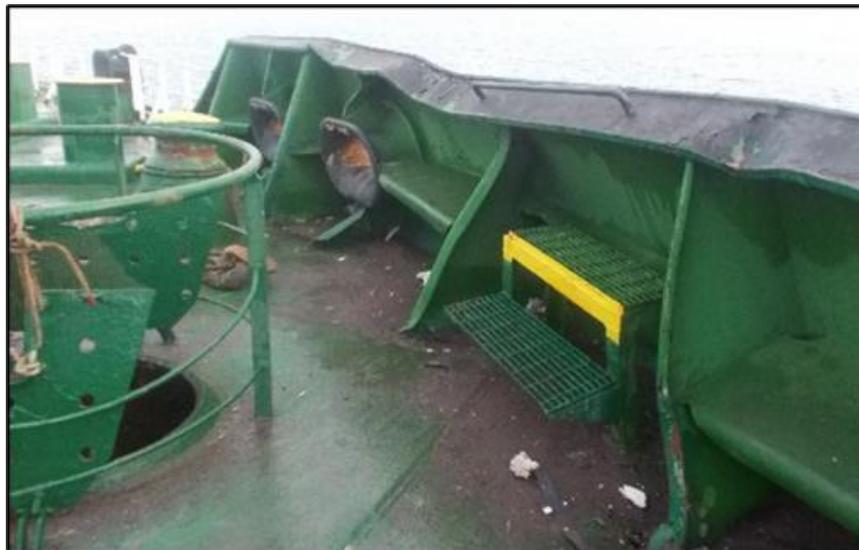
Figure 20 – Damaged section of the port side as viewed from the bow (Source: Company of AS)

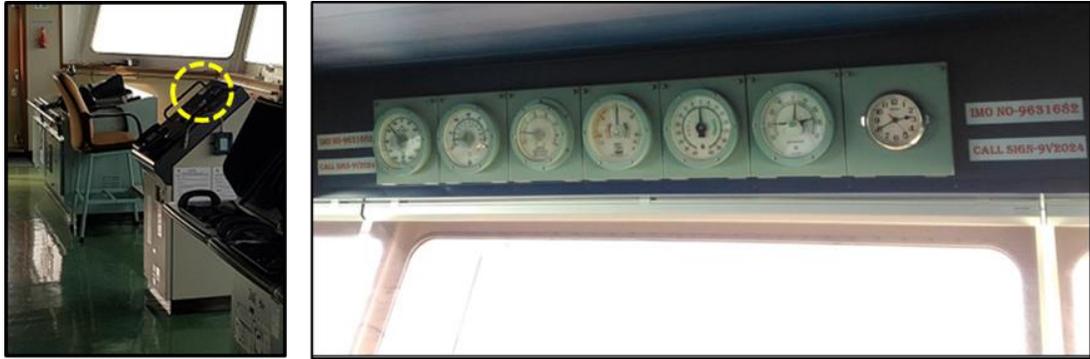
1.4.2 The Master of CS stated that the only RoT indicator on the bridge was at the helmsman's position (circled yellow in left hand side, see **figure 29** below) and opined that had it been provided⁸⁹ on the panel above the conning position (right hand side of **figure 29** below), it would have allowed the Master to have a better estimation of the vessel's RoT. When asked, the Master of CS confirmed that the vessel's RoT in the process of embarking the Pilot, had not been recognised by the Master, and that the 2M had not informed the Master of the effect of the current on CS' movement.

⁸⁹ As per SOLAS/V Reg.19.2.9.1 – All ships of 50,000 gross tonnage and upwards shall have a RoT indicator, or other means to determine and display the rate of turn. CS, because of its size, was not required to be fitted to display such an indicator. Notwithstanding, the steering column was provided with such an indicator and the helmsman was heard on the audio mic informing the Master of the RoT at regular intervals.

Figure 29 - Panel above the conning position showing, among others, wind speed and direction, engine rpm, rudder angle, etc.

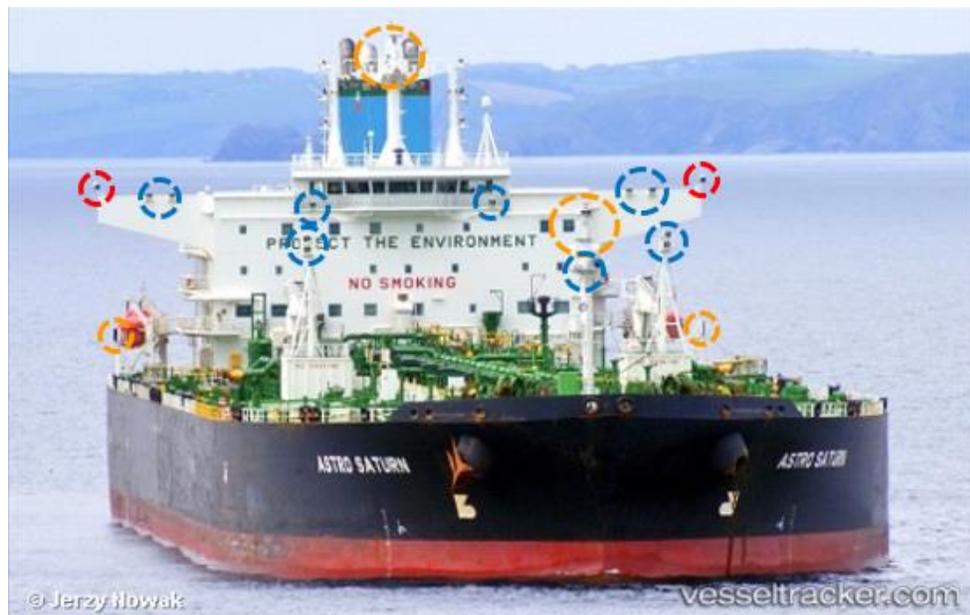
1.5.1 AS, like most vessels of its size, in addition to navigation lights (see **figure 30**, indicated by the dotted orange circle), had deck lights (dotted blue circle) fitted on the bridge front, midship mast and the foremast. Additionally, a searchlight (dotted red circle), for pilot embarkation was fitted at the extremities of the bridge wings. The deck lights would normally be used for operations in the port and were required to be kept switched off for the safety of navigation.

Figure 30 – Lights configuration of AS⁹⁰ – annotated by TSIB
