# **Final Report**

**MAN OVERBOARD  
MANDARIN GRACE  
AT STRAIT OF ÇANAKKALE, OFF AEGEAN SEA,  
TURKEY  
ON 23 August 2019**

MIB/MAI/CAS.068

Transport Safety Investigation Bureau  
Ministry of Transport  
Singapore

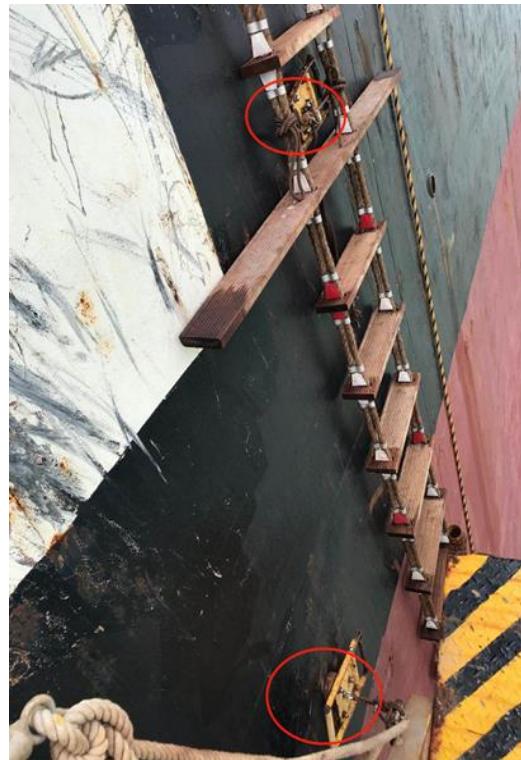
- 1.1.3 Between 0830H and 0920H, the BSN was on deck with two Ordinary Seamen (OS-1 and OS-2) to prepare the combination ladder. According to the OS-1, the BSN went down to the accommodation ladder with the remote control for controlling the movement of the accommodation ladder and instructed the OS-1 to lower the pilot ladder. The OS-1 recalled that when the accommodation ladder and pilot ladder were in position (aligned), the BSN instructed the OS-1 to secure the pilot ladder on deck and to prepare the magnets<sup>6</sup> (see **figure 1**) to be lowered down. According to the Company the lower platform at the time of occurrence was reportedly about 2-3m above the water level.

Figure 1 – Magnets arrangement demonstrated after the occurrence as intended to be used on MG – Annotated by TSIB – (Source: *The Company*)

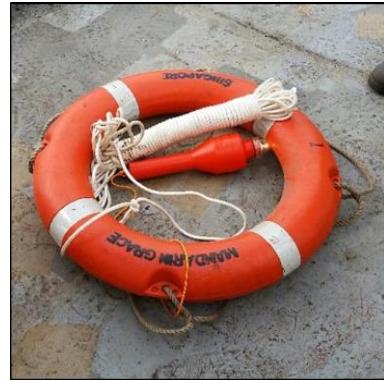
Figure 2 – Lifebuoy with self-igniting light and buoyant lifeline – (Source: UEİM<sup>8</sup>)

- 1.7.2 The lifebuoy deployed by the OS-1 was provided with a self-igniting light, buoyant lifeline (see **figure 2**) and was fitted on the port side aft shipside railing. This lifebuoy was lost and subsequently replaced by another on board.
- 1.7.3 MG had a fibre reinforced plastic (FRP) rescue boat which was located on "A" deck at the starboard side and had a capacity of six persons. The rescue boat was prepared for launching after the MOB but was not launched.
- 1.7.4 LSA items such as lifebuoys and rescue boat were inspected on a weekly and monthly basis, as required by SOLAS<sup>27</sup> and records maintained on board using a checklist, as part of the SMS. There were no known defects of any of the items recorded in the checklist.

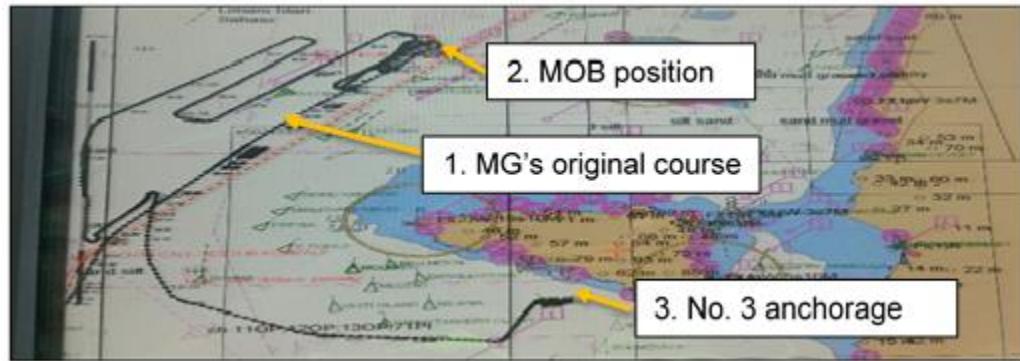
Figure 3 – Course and track of MG – Annotated by TSIB – (Source: *The Company*)

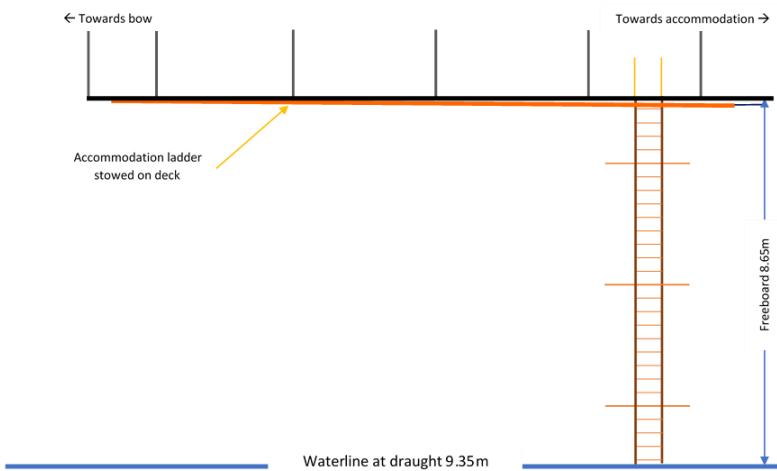
- 1.5.5 The investigation team also sought a similar clarification from CCS which confirmed that MG is not required to undergo modifications to achieve compliance with IMO Resolution A.1045(27).
- 1.5.6 Notwithstanding the above, the investigation team documented and illustrated MG's approved combination ladder arrangement plan (see **figures 5a – 5b**) with respect to her freeboard.

Figure 5a – Scaled illustration of accommodation ladder in stowed position at the prevailing draft

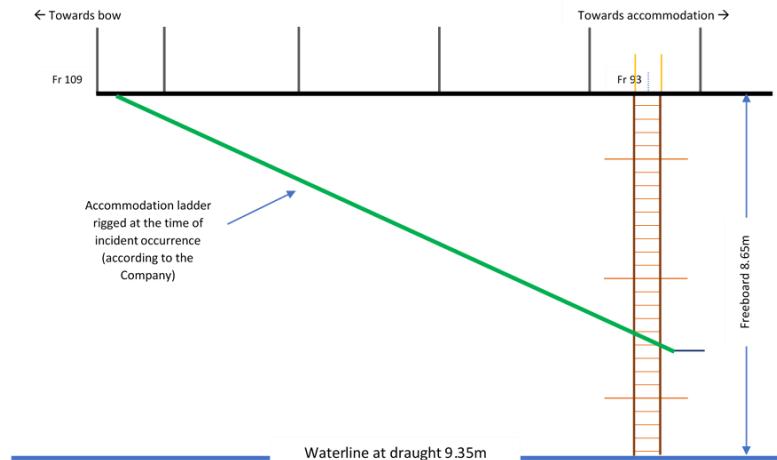
Figure 5b – Scaled illustration of combination ladder rigged with a freeboard of 8.65m. The accommodation ladder overlaps the rigged pilot ladder, at a height of 2.5m above the waterline

- 2.1.2 As can be seen in **figure 5b**, the lower platform of the accommodation ladder would be overlapping the pilot ladder with a freeboard of about 9m and to maintain 2.5m above the waterline (according to the Company stated in paragraph 1.1.3), which is unsafe for a Pilot to embark. For the accommodation ladder not to overlap the pilot ladder, it would have to be lowered further to a position where the lower platform is very close to the waterline as illustrated in **figure 12**. Hence, to facilitate embarkation of the Pilot, it is highly probable that the BSN had lowered the accommodation ladder causing the lower platform to be very close the waterline.

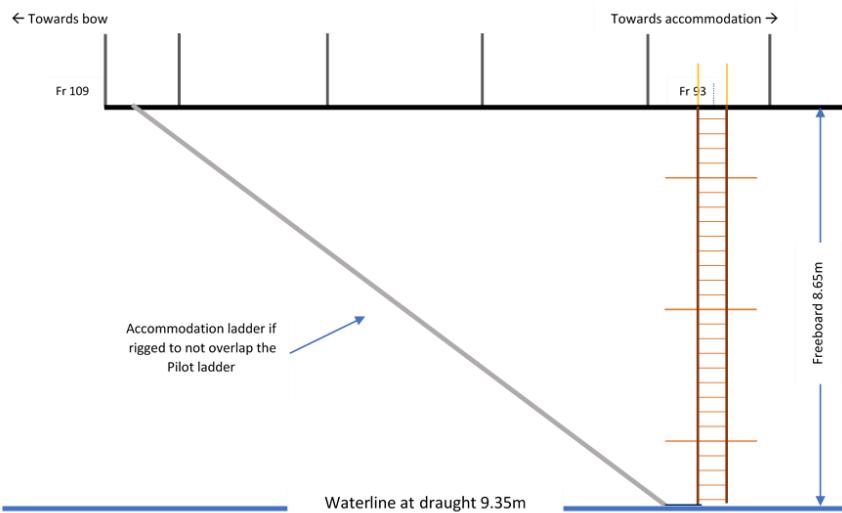
- 1.5.7 It was also determined by the investigation team that in order for the Pilot to embark MG using the combination ladder with the freeboard of about 8.65m, the accommodation ladder would have to be lowered until the lower platform does not overlap the pilot ladder, bringing the lower platform very close to the waterline (see **figure 6**).

Figure 6 – Scaled illustration of accommodation ladder not overlapping the rigged pilot ladder, and the lower platform very close to waterline

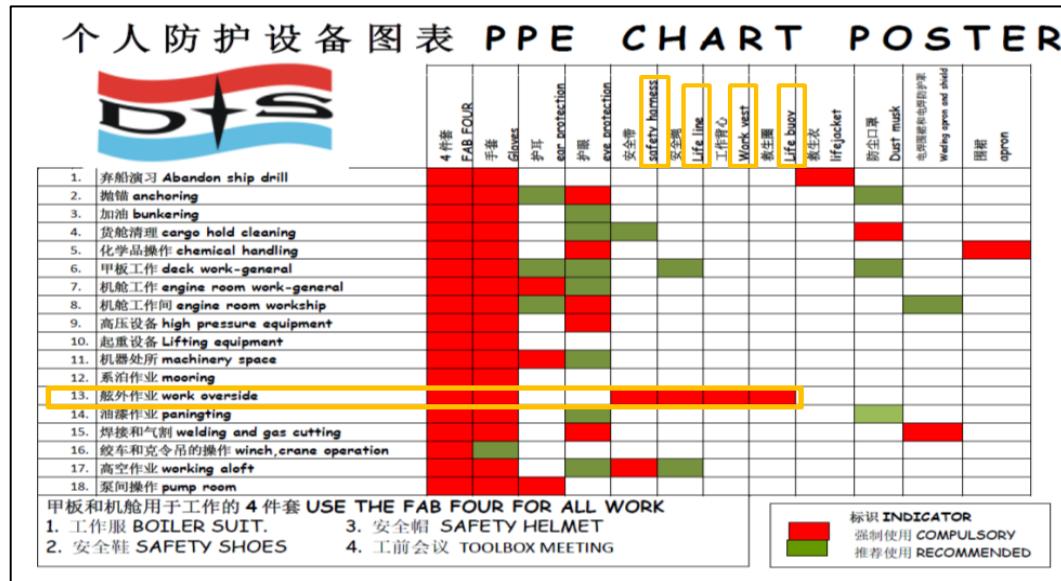
Figure 7 – PPE matrix – Annotated by TSIB – (Source: *The Company*)

- 1.6.5 As per the PPE matrix, a toolbox meeting was also required to be done for any work listed. According to the interviews obtained by UEIM, the crew were unable to recall whether a toolbox meeting was carried out on the day or for the previous times the accommodation ladder or the pilot ladder was rigged.
- 1.6.6 The ship was provided with work vests which were kept in the vicinity but had not been used by any of the crew on the day of the occurrence (see **figure 8**). It could not be established whether this non-usage of work vest was a practice on the ship in the past.

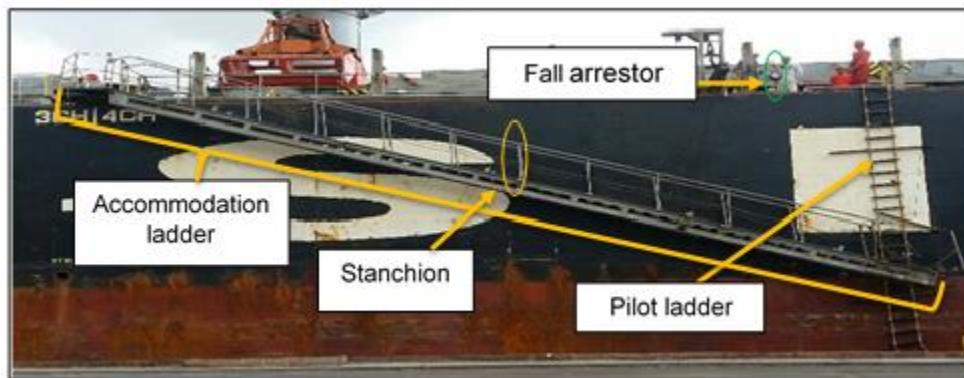
- 1.8.1 UEIM requested the crew of MG to simulate the rigging of the combination ladder and took a video footage<sup>28</sup> of the process (see video screen grabs in **figure 10a**). Typically, the accommodation ladder was first rigged, thereafter the pilot ladder lowered from the main deck and secured to the main deck using shackles after estimating the height of the pilot ladder above the water level. (see **figure 10b**).

Figure 10a – Simulated rigging of the combination ladder with fall arrestor – Annotated by TSIB – (Source: UEIM after the occurrence)

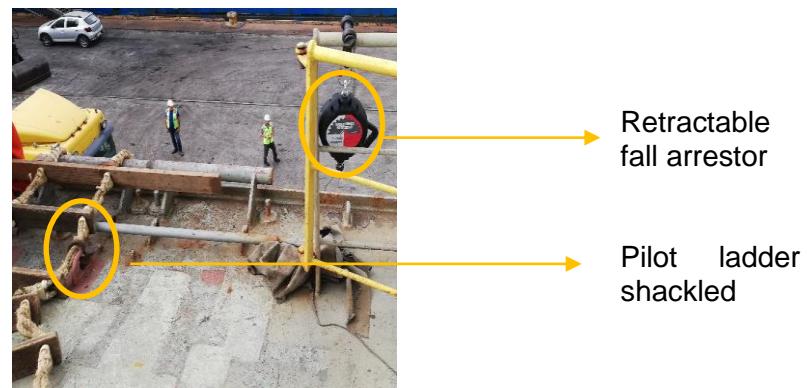
Figure 10b – Pilot ladder shackled on the main deck and retractable fall arrestor on main deck railing – Annotated by TSIB – (Source: UEIM after the occurrence)

lower end of the accommodation ladder (towards the pilot ladder) as per **figure 10b**, while the other (Crew B) remained near the top of the accommodation ladder. Crew A then raised the collapsible stanchions, railings and ropes running the length of the accommodation ladder.

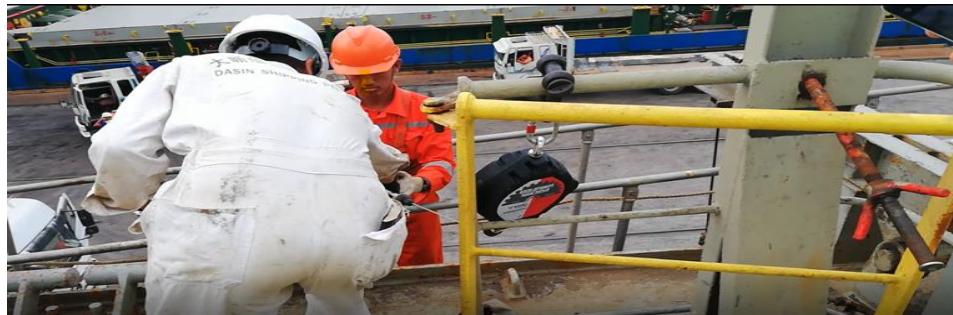
- 1.8.3 During the process, Crew A was seen removing the lifeline from the fall arrestor as it restricted the movements and the ship's officer reminded Crew A to re-attach the lifeline to the fall arrestor (see **figure 10c**).

Figure 10c – Ship's officers reminding Crew A to connect the lifeline to the fall arrestor – (Source: UEIM video screen grab)

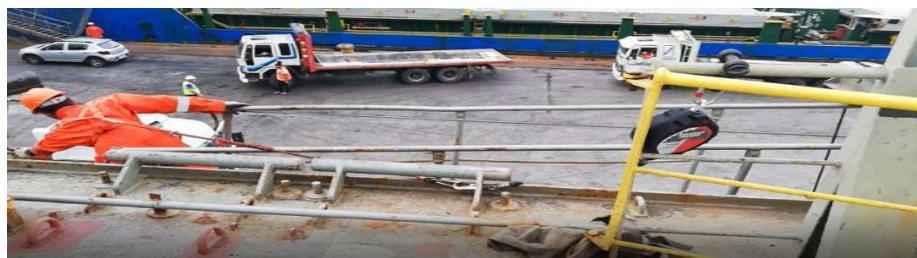
- 1.8.4 The investigation team observed from the video footage that the fall arrestor was fitted to the end of the railing on deck which did not stretch along the length of the accommodation ladder. With the fall arrestor fitted to this railing, the cable of the fall arrestor attached to the crew's lifeline would be slanting when the crew moved along the accommodation ladder (see **figure 10d**). To reduce the slant of the fall arrestor cable when the crew moved along the accommodation ladder, another crew would have to reattach the fall arrestor to another suitable point on deck. It was further observed that Crew B's lifeline was not connected to any strong point.

Figure 10d – Crew standing on the lower platform with the lifeline connected to the fall arrestor – (Source: UEIM video screen grab)

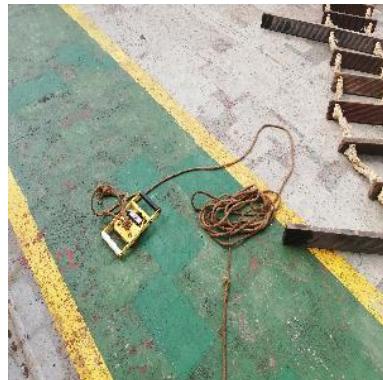
- 1.8.5 MG was provided with two magnets<sup>29</sup>, each tied to a piece of rope. The magnets were for securing the pilot ladder and the accommodation ladder to the hull to prevent lateral movement.
- 1.8.6 In practice, according to the Company, once the pilot ladder is rigged, the magnets would be lowered to the BSN (see **figure 11**) who would stand on the lower platform of the accommodation ladder and ‘affix’ one magnet to the accommodation ladder and the other to the pilot ladder. At the time of the occurrence, the magnets were still on deck as the two OSes were still in the process of securing the pilot ladder on deck with shackles.

Figure 11 – Magnet with lowering rope – (Source: UEIM)

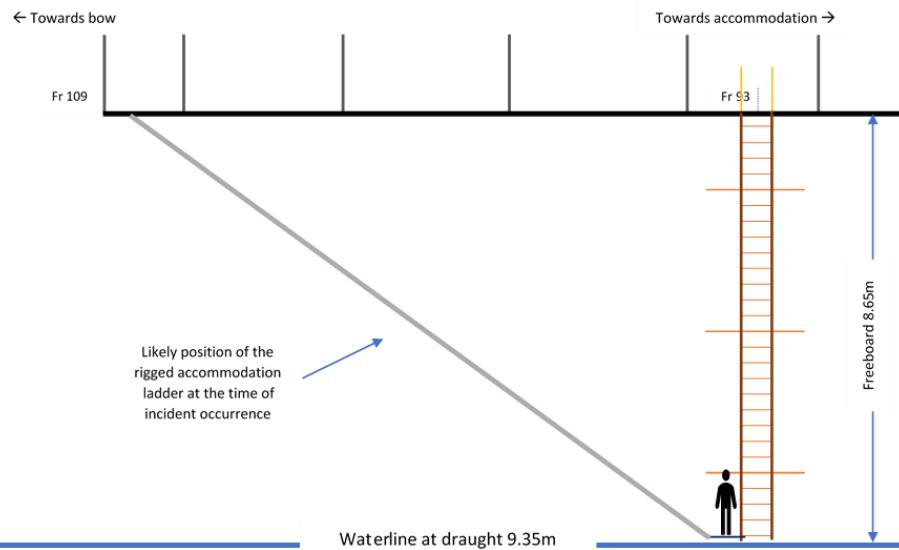
Figure 12 – Scaled illustration of the position of accommodation ladder likely rigged at the time of occurrence, with the lower platform very close to the waterline – (Note: Person not to scale)

- 2.1.3 The swell at that time was about 2m and recalling that the OS-1 heard a sound and rattling of the accommodation ladder, it is plausible that while the BSN was on the lower platform in the process of rigging the accommodation ladder, the swell may have come into contact with the lower platform which was very close to the waterline, and caught the BSN unaware, causing him to lose balance and fall into the water.

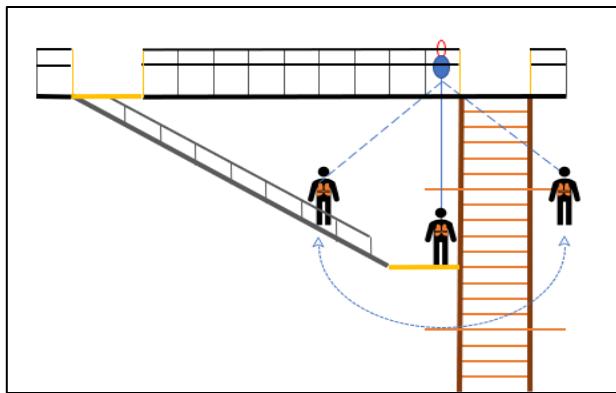
- 2.5.1 The investigation team noted that MG was provided with a retractable type fall arrestor, which was connected to the end of the deck railing (see **figures 9a-9d and 13a**). The Company's SMS did not contain any specific procedures on how and where this fall arrestor was to be attached. Reviewing the video footage provided by UEİM during the simulated rigging of the combination ladder, it is also noted that the sections of the railing did not permit the fall arrestor to extend or move freely with the crew as the crew moved on the accommodation ladder.
- 2.5.2 In the absence of a continuous railing / fixed wire on deck, the crew would have to shift the fall arrestor at every section of the deck railing, thus defeating the purpose of having a fall arrestor for the safety of the crew.
- 2.5.3 The investigation team further noted that attaching the retractable fall arrestor

at a single shackled anchor point on the railing could subject the crew to a swing fall<sup>30</sup> should the crew lose their footing (see **figure 13a**). In addition, the swing fall distance<sup>31</sup> is affected by the crew's position from the anchor point.

- 2.5.4 The further the crew moves away from the anchor point, the greater arc swing and the greater clearance required for the crew to be safe from any obstructions. The swinging motion could result in injuries. To minimise swing fall, the fall arrestor should be placed as directly above the crew as possible.

Figure 13a – Possible swing positions of a crew if the safety harness is attached to the retractable fall arrestor at a single fixed point as on the case of MG – Illustration by TSIB (*Not to scale*)

- 5.1.3 To include provisions in the Company's SMS for ensuring the fall arrestor is rigged appropriately and used for tasks where there is a risk of falling overboard or from a height. **[TSIB Recommendation RM-2021-024]**

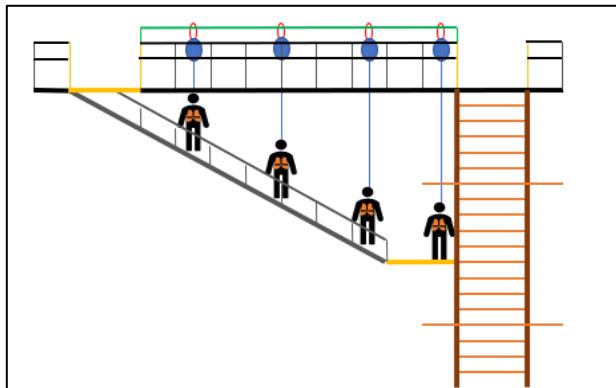
- 2.5.5 It is thus desirable to have a continuous rigging arrangement which allows the fall arrestor to move on the deck railing along the length of the accommodation ladder. As the crew descends/ascends the accommodation ladder, the fall arrestor moves along the deck railing. Such a continuous rigging arrangement of the fall arrestor would ensure that the crew is always connected to a strong point and is below the fall arrestor (see **figure 13b**) minimising the risk of swing fall.

Figure 13b – Rigging arrangement where the retractable fall arrestor moves<sup>32</sup> along the deck railing when the crew moves along the accommodation ladder  
– Illustration by TSIB (*Not to scale*)

- 5.1.4 To consider having a continuous rigging arrangement for the fall arrestor to ensure that the crew stay connected to the ship and are directly underneath the fall arrestor when working along the length of the accommodation ladder. **[TSIB Recommendation RM-2021-025]**
