Final Report

CREW MISSING AT SEA FROM THE CONTAINER SHIP KOTA LAZIM ON 12 SEPTEMBER 2020

TIB/MAI/CAS.091

Transport Safety Investigation Bureau
Ministry of Transport
Singapore

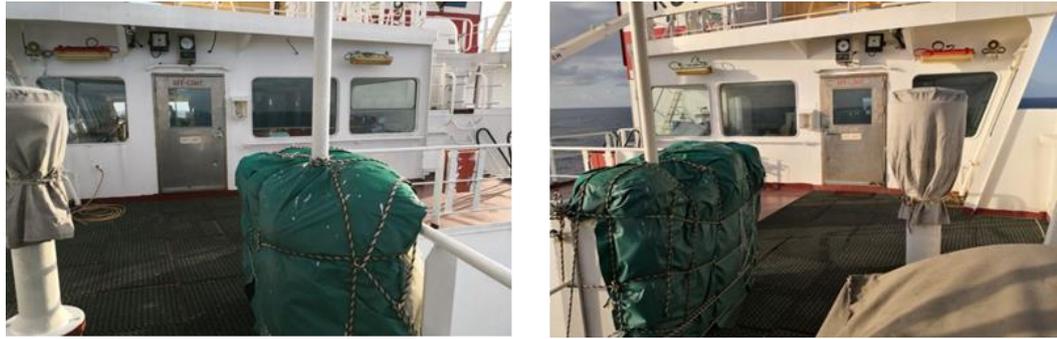
- 1.2.4 The bridge is connected to the bridge wings by two doors, one on each side, capable of being opened using a lever from inside and outside. Both the doors were found closed when the Bosun came to the bridge. The bridge wings extended to the ship's side and had rubber mats throughout (see **figure 3**).

Figure 3 – View of the port bridge wing (left image) and starboard bridge wing – both looking towards the bridge – *Source: The Company*

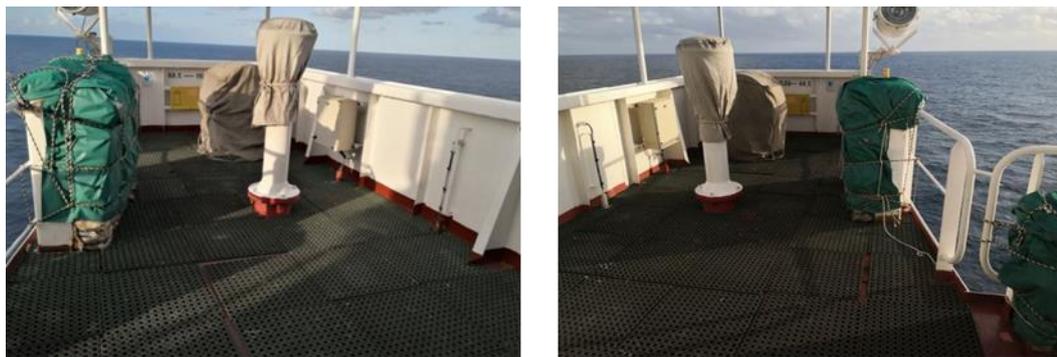
- 1.2.5 The forward and side parts of the bridge wings are of continuous wind breaker¹⁰ (protection from wind) while the aft part has railings, which are directly above the lower decks, again a standard design on ships of this size. According to the Company, there were no marks (of leaning over or footmarks on railings) that could indicate an accidental fall over any part of the wing.

Figure 4 – The port bridge wing (left image) and starboard bridge wing – both viewed from the bridge – *Source: The Company*
