# **FINAL REPORT**

## **FALL INTO CARGO HOLD (LOSS OF LIFE) ON-BOARD SRS WAN HAI 212 AT TAICHUNG, TAIWAN ON 5 NOVEMBER 2017**

MIB/MAI/CAS.028

Transport Safety Investigation Bureau  
Ministry of Transport  
Singapore

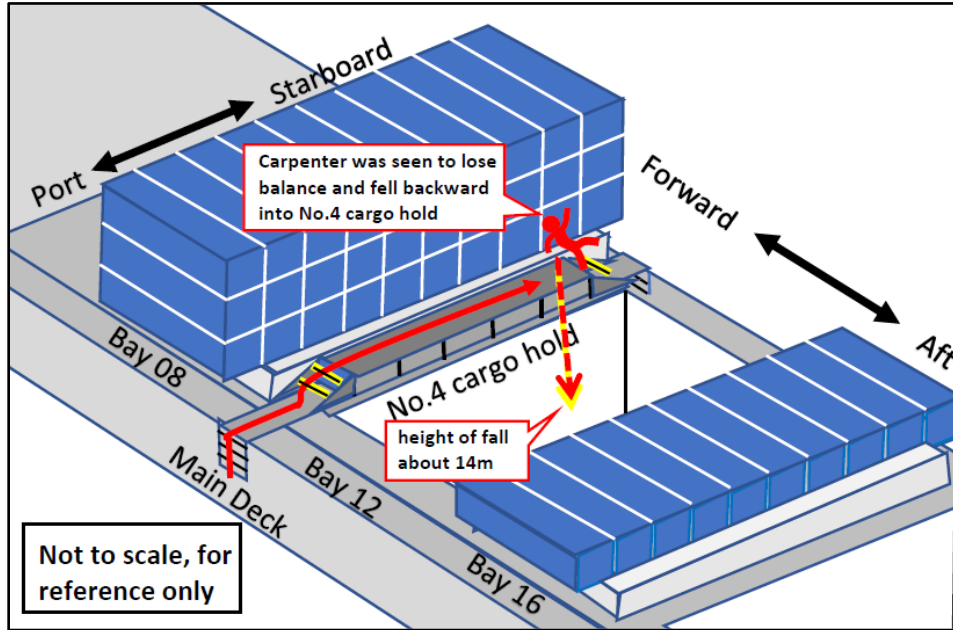
- 1.2.1 There were two witnesses to the occurrence, the shore Tallyman who was onboard the vessel and the crane Operator (shore crane cabin).
- 1.2.2 According to the two witnesses, the Carpenter was initially seen walking on the port side of the main deck, then seen climbing a short fixed vertical ladder and eventually walking across the raised catwalk between bay 8 and bay 12, from the portside to the starboard side.
- 1.2.3 Towards the end of this raised catwalk, he was seen to lose his balance and fall backward into No.4 cargo hold. The hold had been open since the last discharging operation. (see **Fig 3a and 3b**).
- 1.2.4 The Carpenter was observed to have been wearing safety shoes and safety helmet.

Fig 3a – Carpenter’s route on the catwalk before falling into No.4 cargo hold

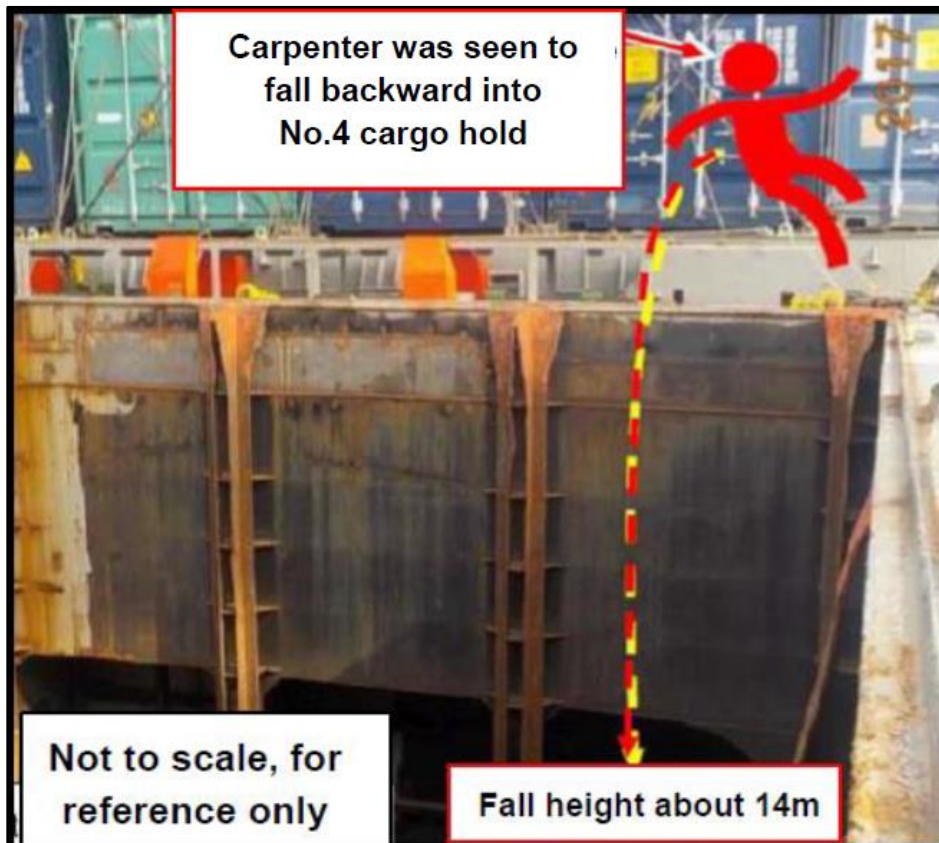
Fig 3b – Witness account of how the Carpenter fell into the cargo hold – viewed from aft

- 2.1.4 These unsafe conditions, coupled with an adjacent unguarded opening (cargo hold) had intensified the probability of falling from height.
- 2.1.5 It would be reasonable to conclude that when the Carpenter was walking on this catwalk, there could have been a slip or trip as a result of the wet and cluttered walkway, that caused him to lose balance and fall into the unguarded open cargo hold.

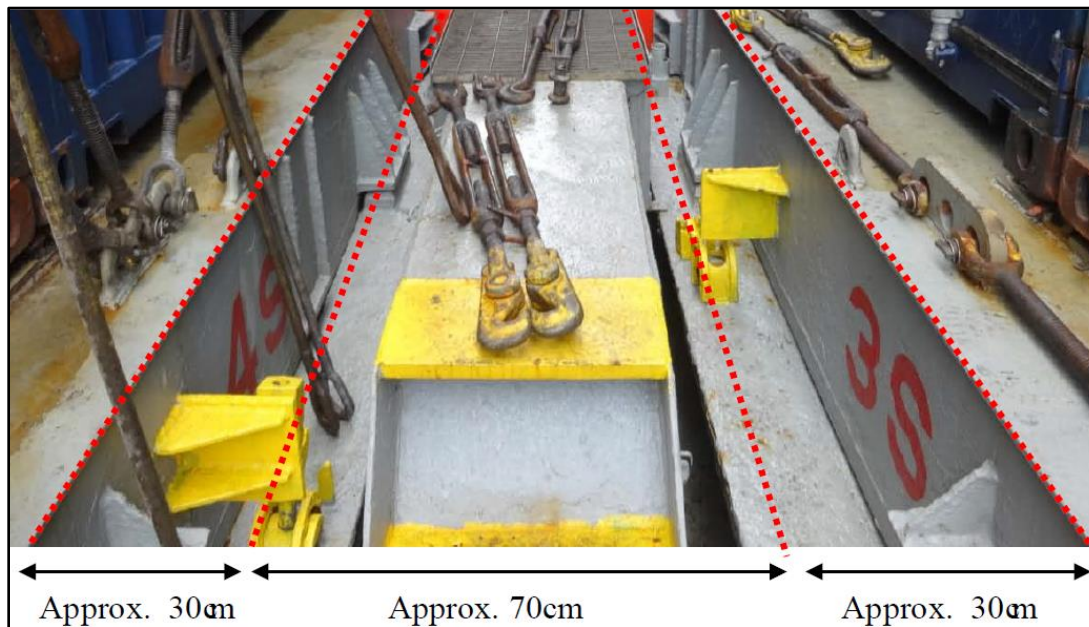
1.3.2 The width of the raised catwalk was about 70cm. At the time of the occurrence the catwalk was cluttered with loose lashing bars and turnbuckles (see **Fig 4**).

Fig 4 – Illustrating an example of loose lashing gears on raised catwalk

- 2.1.1 Before the occurrence, at about 0730H, the adjacent bay 8 had just completed loading of containers on deck. It is not uncommon for a catwalk between bays to be cluttered with loose lashing gears (lashing bars, turnbuckles, twist-locks, etc.) especially after discharging of deck containers, as stevedores would reuse the same lashing gears after loading, to secure the containers for sea passage. However, as the catwalk is only 70cm in width, these obstructions could pose a hazard to the crew.

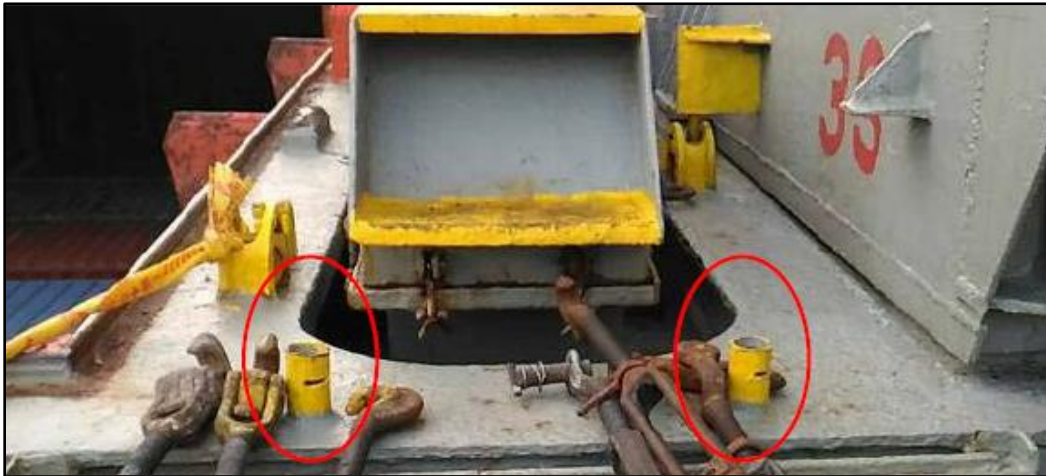
1.3.3 There were no signs of damage to the deck, catwalk and coaming near the location of the occurrence. There were no stanchions/ railings or fencing<sup>9</sup> to guard against accidental fall when the hatch cover was not in place.

1.3.4 There were four sockets<sup>10</sup>, two on each side of the ship, meant for installing portable stanchion near the steps. The portable stanchion provided support when walking up and down the steps. At the time of the occurrence, there were no portable stanchions fitted at the sockets. (see **Fig 5** – stanchion sockets circled in red).

Fig 5 – Stanchion sockets marked red circle

- 4.1 Sharing of information and highlighting the circumstances of the accident with all crew members of its fleet of vessels;
- 4.2 The Supervisor responsible for the safety of all crew and shore personnel onboard the vessel shall ensure that all possible risks identified are controlled before commencing work. Work should not commence until personnel involved are made aware of the risks involved;
- 4.3 No work or operation shall be performed by any personnel near an unguarded open cargo hold. "No Entry" signs procured and placed at specific locations to alert any personnel of the hazards;
- 4.4 Conducted training to enhance safety awareness of the crew, on matters relating to good seamanship; and
- 4.5 The company installed safeguards comprising portable stanchions and safety lines along the catwalk for all the cargo holds when in open condition.

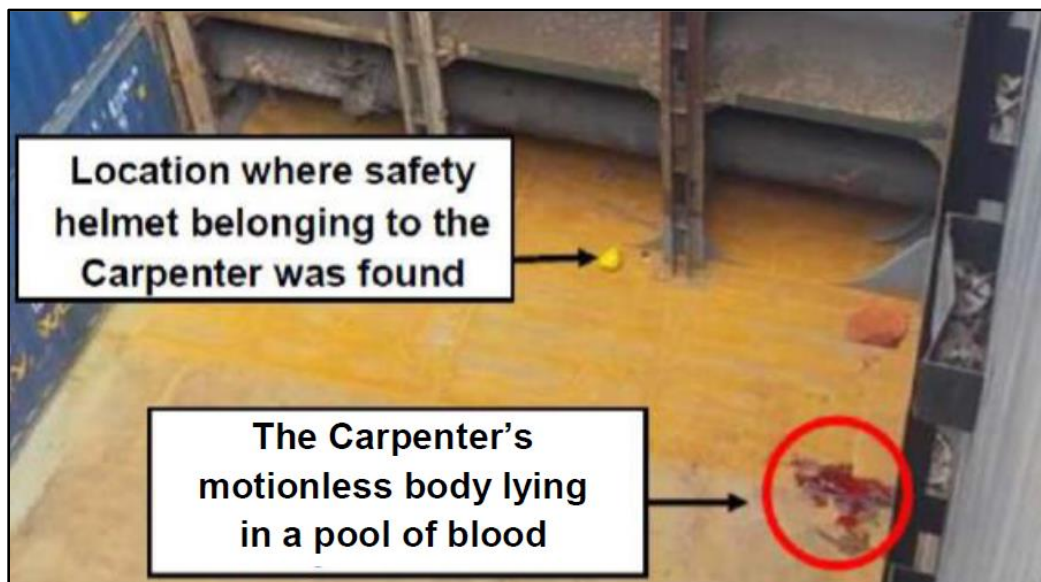
- 1.3.5 The body of the Carpenter was lying motionless in a pool of blood at the bottom of No.4 cargo hold (see **Fig 6**)

Figure 6 – showing location of the Carpenter's body
