# **FINAL REPORT**

## **COLLISION BETWEEN BULK CARRIER EIRINI P AND OIL TANKER VIKTOR BAKAEV IN SINGAPORE STRAIT ON 24 JANUARY 2017**

**MIB/MAI/CAS.011**

**Transport Safety Investigation Bureau  
Ministry of Transport  
Singapore**

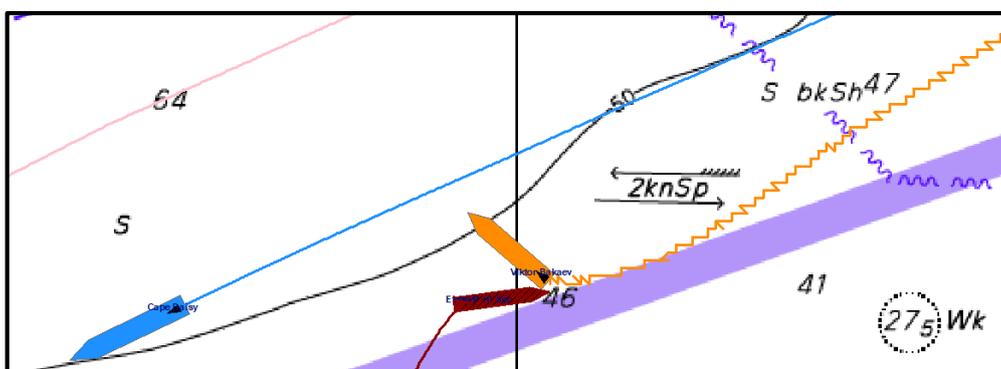
- 1.1.11 At about 0036H, EP’s port bow collided with VB’s port quarter in position Lat: 01° 14.27’N Long: 103° 57.0’E in the westbound lane of the TSS, 1.1nm south of PEBGB in Singapore territorial waters.

Figure 2: Data plotted using VDR data – at about 0036H – For illustration only

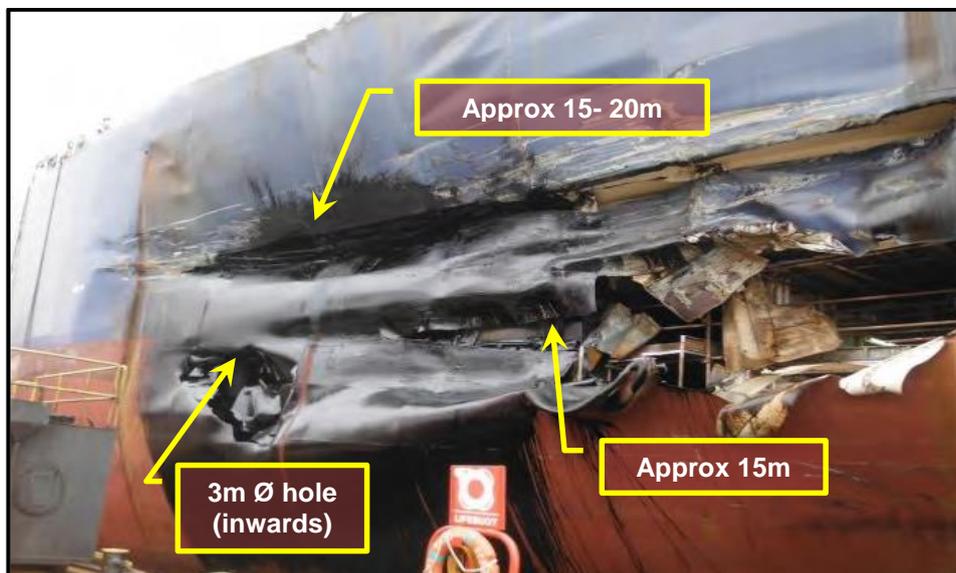
1.2.2 VB later reported to have a loss about 150 metric tonnes of heavy fuel oil into the sea<sup>10</sup> as a result of ruptured heavy fuel oil tank. VB also reported that some of this fuel oil had leaked into the engine room.

- A horizontal tear of approximately 15-20m in length, on the port quarter shell-plating adjacent to the No.2 fuel oil tank and adjacent to the engine room.
- A hole of approximately 3m in diameter on the shell-plating below the tear, into the No.2 fuel oil tank.

Figure 3: Damages on MT Viktor Bakaev's port quarter.  
Source: Liberian International Shipping & Corporate Registry (LISCR)

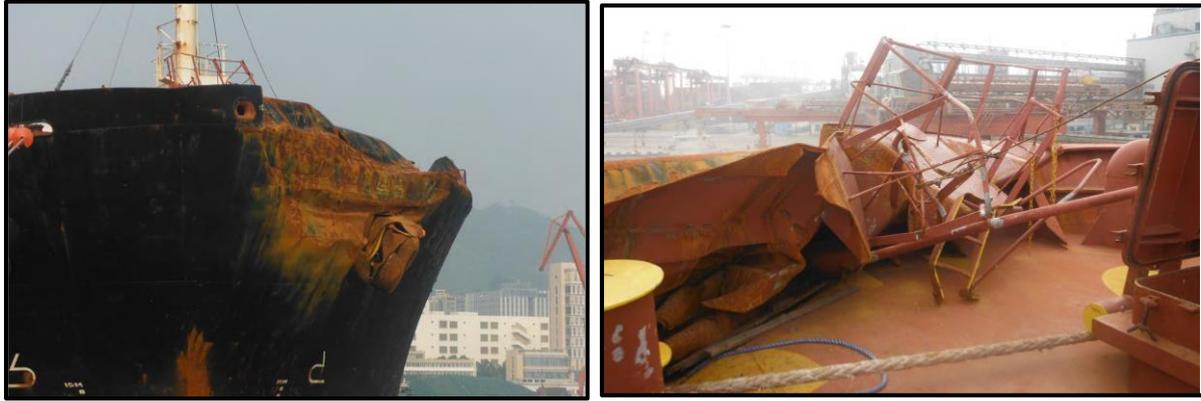
1.2.3 EP suffered damages as follows -

- Deformed bulwark at the port bow with damaged air vent
- Loss of port anchor

Figure 4: Damages on MV Eirini P's port bow.  
Source: LISCR

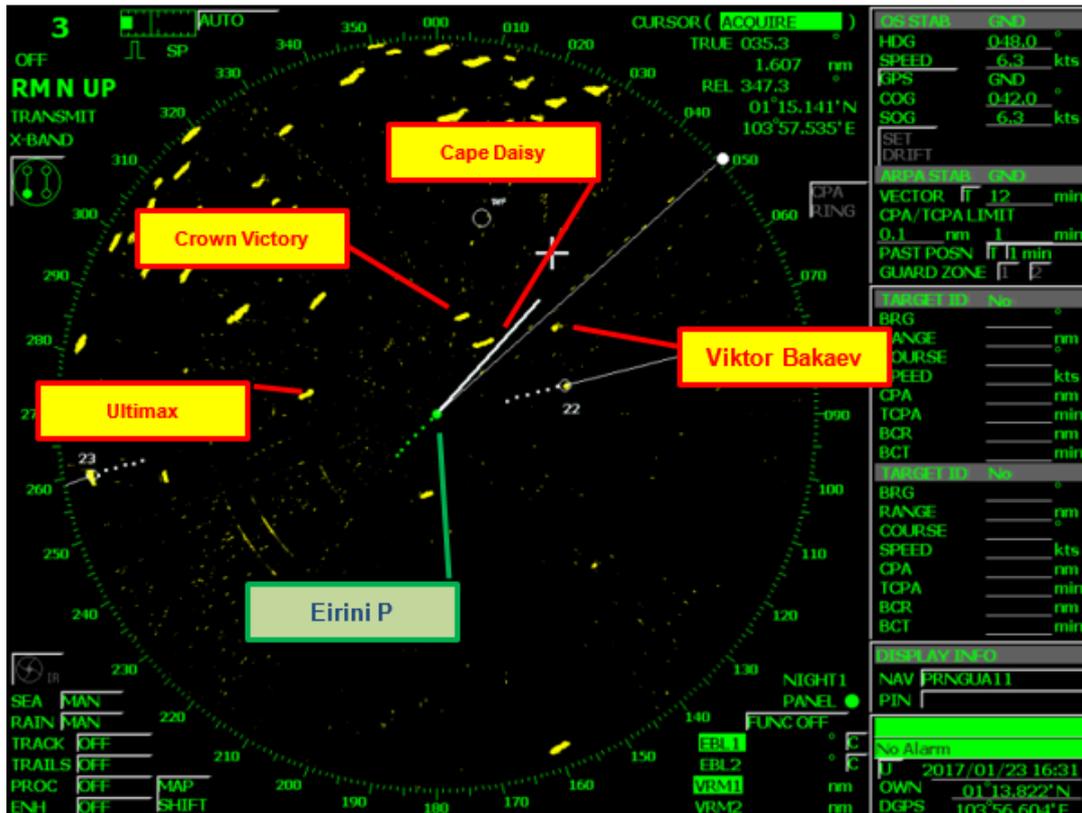
Figure 5: EP's X-band radar (targets not acquired) at about 0031H (annotated by TSIB)

- 2.1.1 EP's Master stated to have been monitoring the traffic from the front of the bridge and using the S-band radar. However, since only the X-Band radar was connected to the VDR it would be difficult to establish whether the targets were indeed acquired by the bridge team, as claimed by the Master. If the targets of interest had been acquired on the S-band radar, then the Bridge team had not correlated to VTIS' advice (see Para 1.5.6) to wait until VB had passed, before attempting to cross the TSS to PEBGB (see **Figures 5, 6 and 7**).

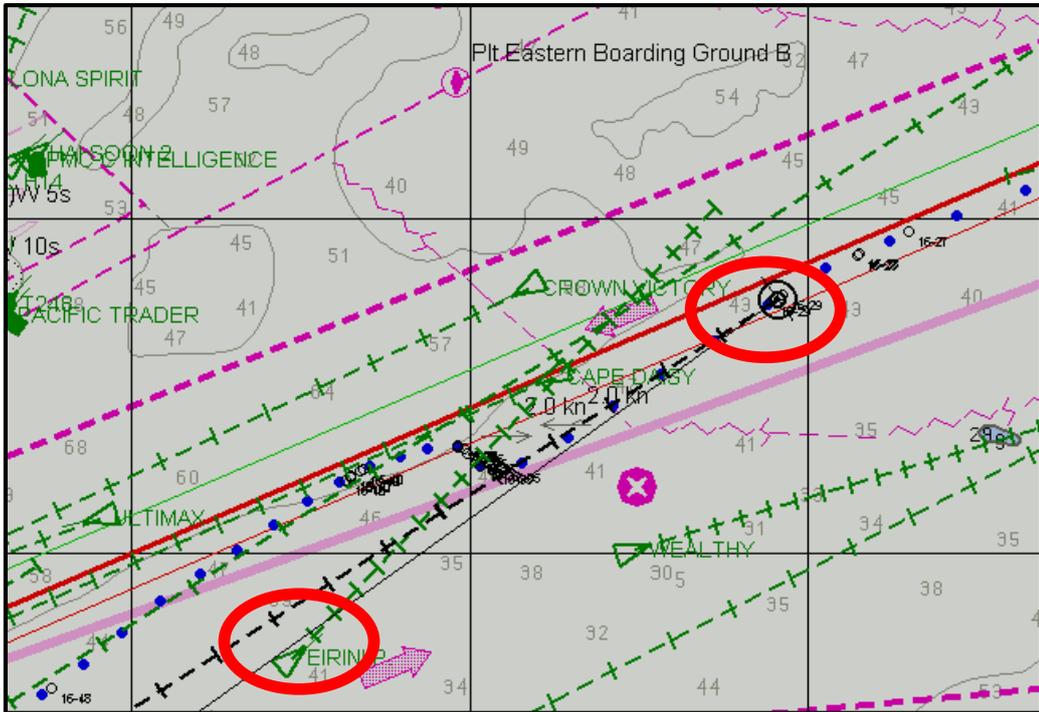
staying within the westbound lane. By about 0031H, EP (in the opposite lane) was showing both sidelights (see **Figure 6**)

Figure 6: VB's ECDIS displaying EP in a nearly head-on situation, with both vessels in their respective traffic lanes (circles annotated by TSIB)  
Source: LISCR

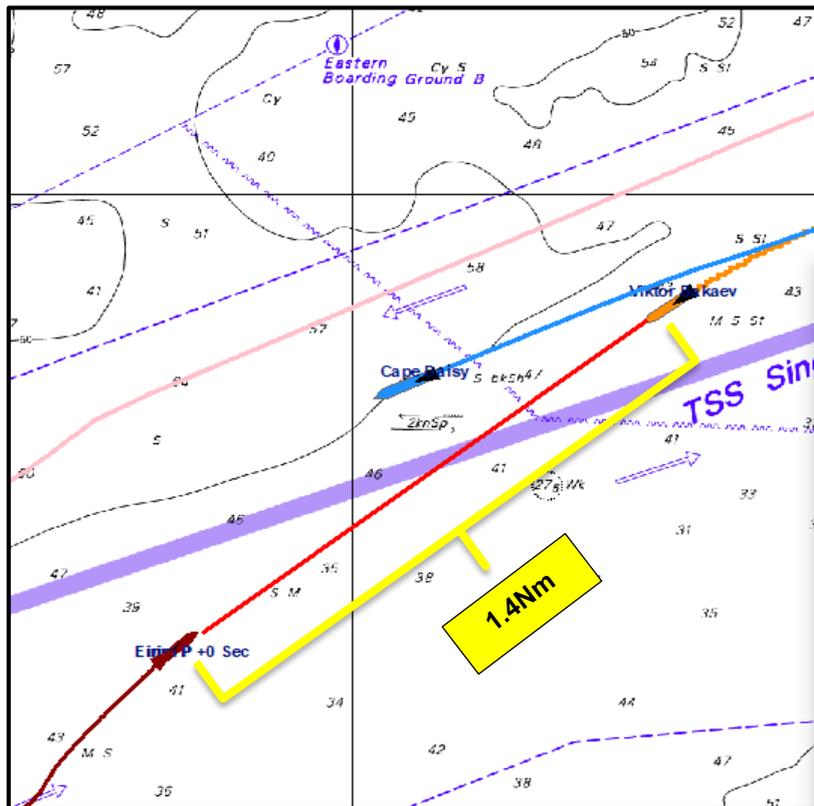
Figure 7: Positions of MV Cape Daisy (blue), MT Viktor Bakaev (amber) and MV Eirini P (maroon) at 0031H based on data from VTIS and voyage data recorder

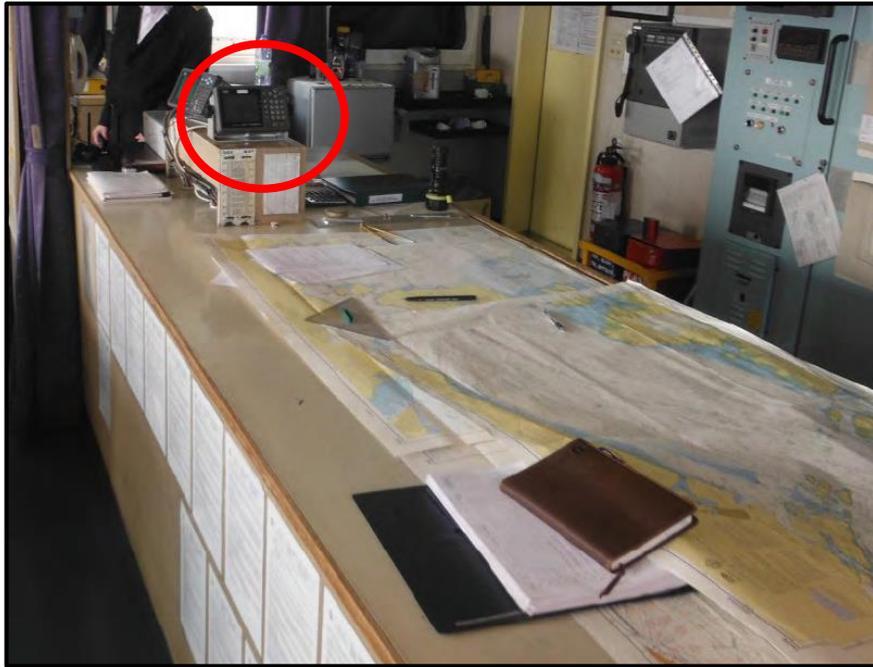
1.6.1.6 EP's primary means of navigation was paper charts<sup>16</sup> with the chart table at aft part of the wheelhouse behind the navigation console and radars with automatic radar plotting capabilities. The Automatic Identification System (AIS) display screen was located in the chart room separated by a curtain which was closed for night navigation (see **Figures 8 and 9**).

Figure 8: Chart table (separated by curtain in hours of darkness) on EP's bridge with AIS (circled red by TSIB) display equipment  
Source: LISCR

- 2.1.3 The AIS display was located in the chart room and not integrated with the radars thus making it difficult for the bridge team to positively identify the vessels by name or call sign which was one of the means used by VTIS to provide information to EP.

- 3.2 EP's layout of navigational equipment on the bridge with the AIS display placed near the chart table at a distance away from the radars as well as lack of maintaining a proper lookout, resulted in the situational awareness on the bridge to be reduced, as they were unable to corroborate important navigational information.

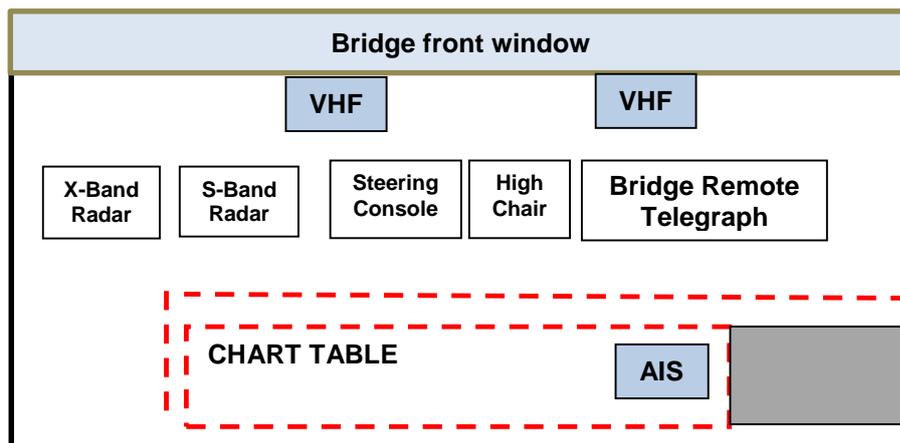
1.6.1.7 Both the X-band and S-band radar consoles were on the port side of the bridge, while the VHF radio(s) were in front, with the steering console in the middle. The Master stated that he was navigating from the bridge front and moving around to check the radars, having acquired targets of interest on the S-band radar. The OOW also stated that he was moving around the bridge, checking the radars and navigation charts on the chart table.

Figure 9: Illustration of MV Eirini P's bridge layout. Red dashed line indicate approximate chart space separated by curtains.

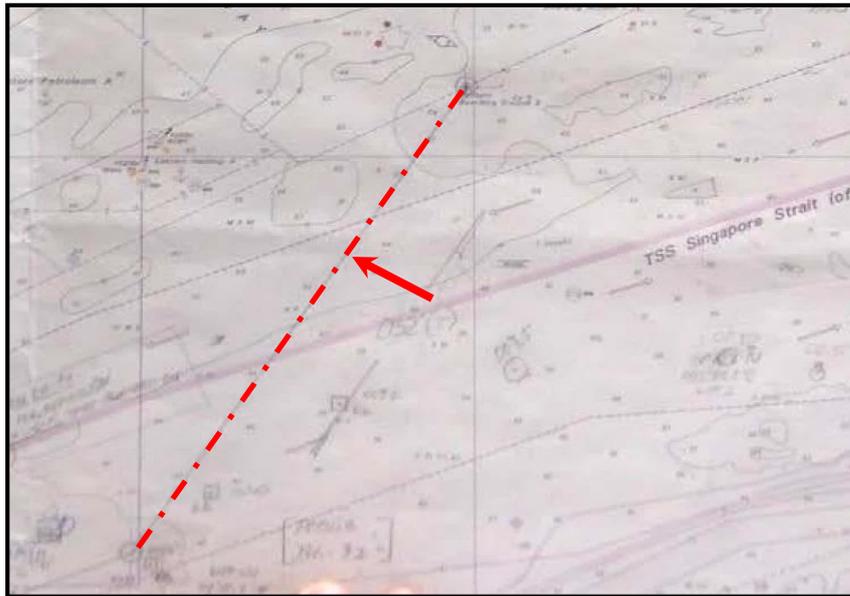
1.6.1.8 EP's passage plan indicated that the intended course marked in the nautical chart (no. 4041) towards PEBGB was 032° (T) starting from the middle of the eastbound lane (see **Figure 10**).

Figure 10: EP's Planned passage on chart no. 4041 (red dotted line annotated by TSIB) showing the planned course from the eastbound TSS lane to PEBGB  
Source: LISCR

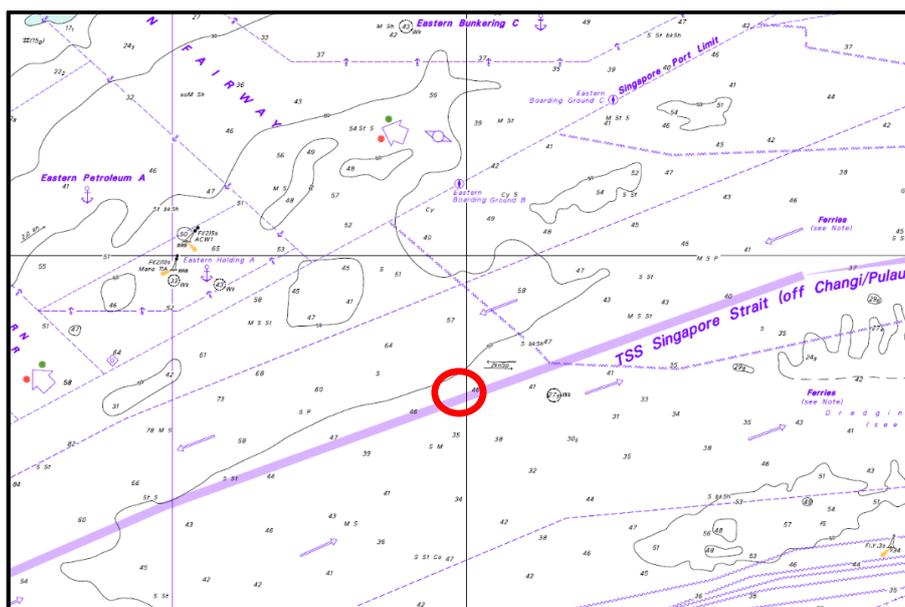
1.7.1 The collision took place in the southern limits of the westbound lane, with both the eastbound (0.9nm) and westbound (0.6nm) lanes measuring about 1.5nm of available water in width, with respect to the draught of both vessels. The northern limits include PEBGB which is about 1.4nm from the incident location; as well as the Pilot disembarkation ground (commonly known as DG3). The general directions of the lanes are 068° and 248° for eastbound and westbound traffic respectively.

Figure 12: Red-coloured circle denotes location of incident
