COLLISION

EXPLORER

A WOODEN COASTER

MIB/MAI/CAS.039

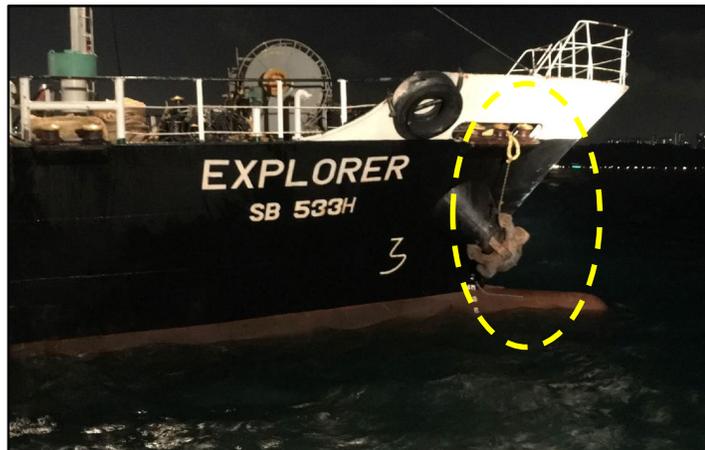
Figure 1 – The EXP's starboard bow with minor scratches – annotated by TSIB

- 1.2.5 The collision did not result in any injuries onboard the EXP. In the opinion of the Master the collision did not result in any damages to the EXP (other than a few scratches) and the Master decided to continue the passage. The Master did not establish¹⁴ whether the other boat needed assistance.

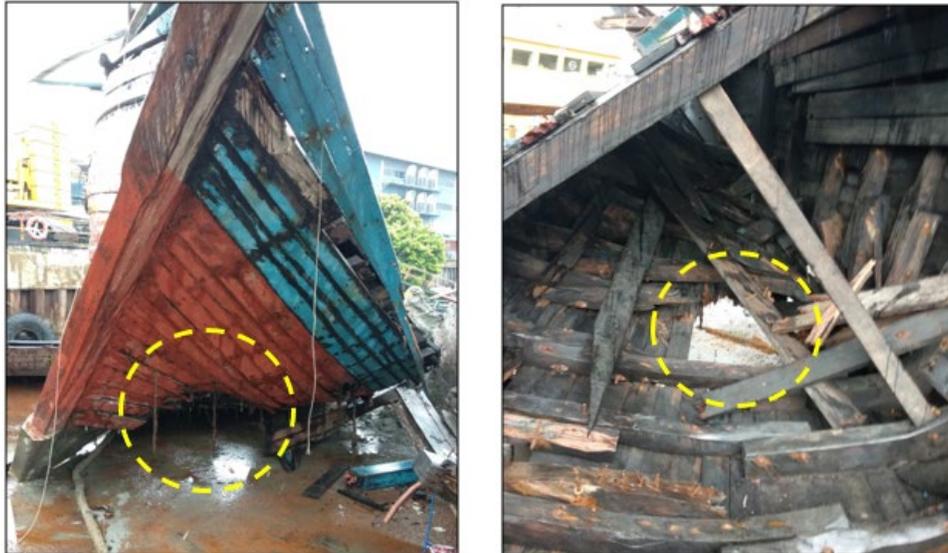
1.6.1 After the WC was salvaged, the investigation team examined the wreck and noted signs of a hole²⁵ on the port side (see **figure 2**, below the waterline – circled in yellow).

Figure 2 – WC's view from the outside and inside showing a hole on the port side

²⁵ Deemed as the location of impact by EXP's bulbous bow.

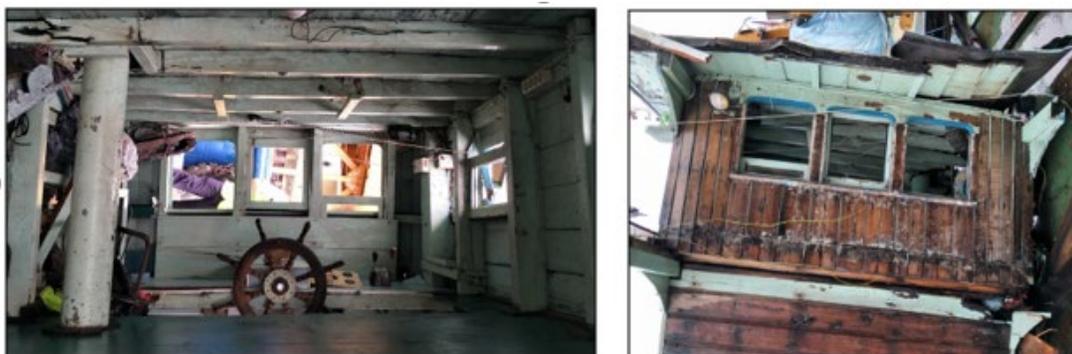
1.6.2 The Skipper's position was on a chair (height of about 0.8m) behind the steering wheel looking out from the three windows in front. A slightly smaller set of windows were found on the starboard and port side of the steering structure. The side windows had sliding panels to open/close them. At the time of the inspection of the wreck, it was observed that these panels were partially open on the port side.

Figure 3 - The steering position (located at the aft end of the WC) and the three windows (viewed from front) facing forward for visual navigation

2.2.2 In all probability, the Skipper of the WC had likely not been navigating with caution when approaching the Seraya buoy, until the WC was close to the EXP, especially considering the panels on the port side of the steering structure which had likely

limited or blocked the view of the Skipper on the port side.

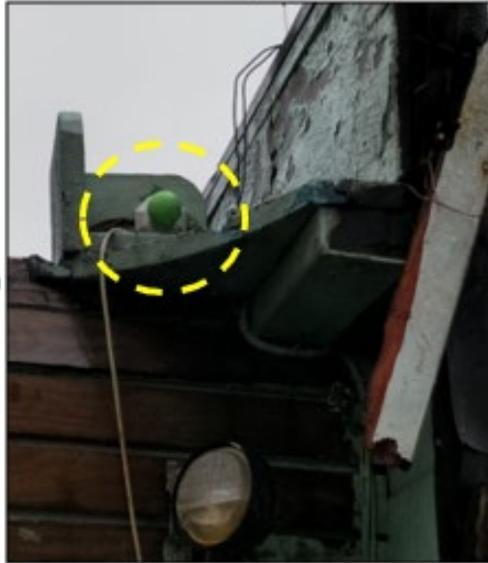
1.6.3 The starboard side 'green' light fitted to the steering structure, was found connected to a DC 24V source. A similar light (red) was fitted on the port side. The bulbs fitted were confirmed to be of 'Zero watt' type, and not normally found in marine usage. The masthead light could not be found during the inspection of the wreckage²⁶.

Figure 4 – Zero-watt green bulb on the starboard side - annotated by TSIB

2.1.3 The WC was a vessel of primitive build and wooden material. Such a material is likely to have a lower radar signature and may be difficult to detect by radar unless fitted with a radar reflector. There was no evidence to suggest that the WC had a radar reflector fitted. When analysing the wreck of the WC, the investigation team determined that the navigation lights of the WC were not compliant with the light specifications³¹ that would be required to be on vessels of this size.

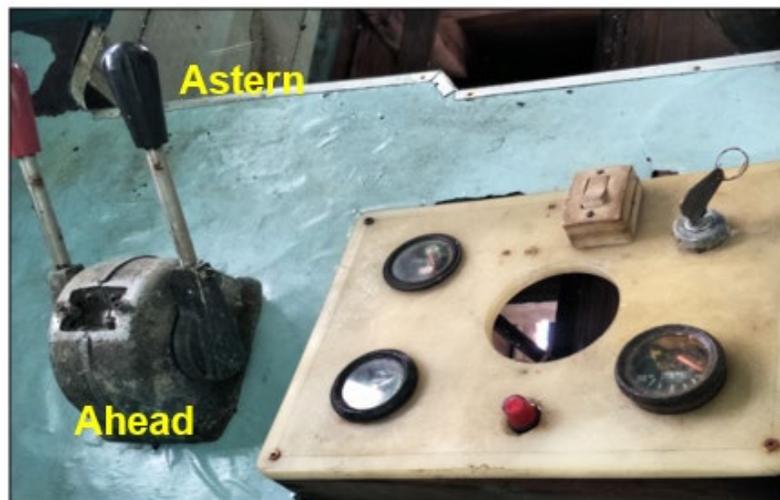
1.6.4 The engine throttle was found in the “astern” position.

Figure 5 – Engine throttle position (annotated by TSIB)

2.2.1 The position of the engine throttle for the WC that was found in the "astern" position could be indicative of the Skipper of the WC was either attempting to slow the WC prior to the collision or using the engines to clear away from the EXP after the collision.

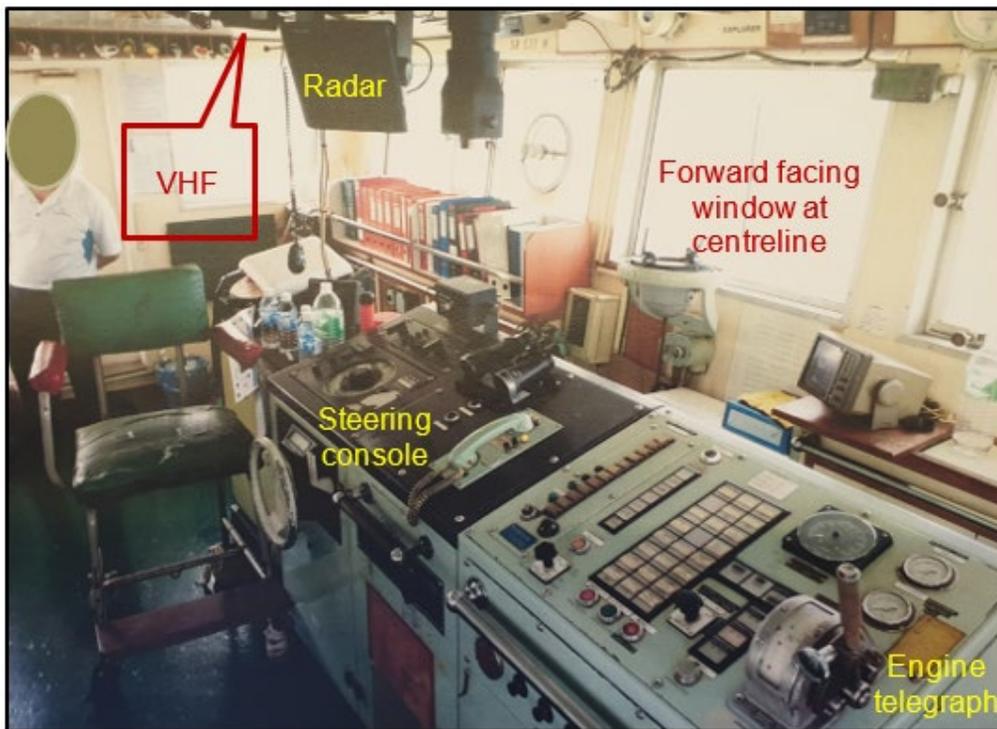
1.7.2 The telegraph column had a press button and tooth-gear mechanism which needed to be pressed in order to move the telegraph to other positions (ahead or astern). Two hands were required to operate the telegraph. (see **figure 6**)

Figure 6 – Steering console and engine telegraph

- 2.3.2 This conversation was acknowledged while the EXP was being steered manually by the Master. To reduce the EXP's speed, the Master would have had to stretch across and use both hands to move the engine telegraph to slow ahead, and then return to the steering console to continue steering the EXP.

5.1.1 Ensure non-navigation related tasks are not carried out when the vessel is underway so that members of the bridge team could work closely together to maintain safety of navigation. **[TSIB-RM-2020-20]**
