# **Final Report**

## **AIRBUS A320, REGISTRATION 9V-JSM TAKE-OFF INCIDENT AT CHANGI AIRPORT**

**27 July 2021**

TIB/AAI/CAS.199

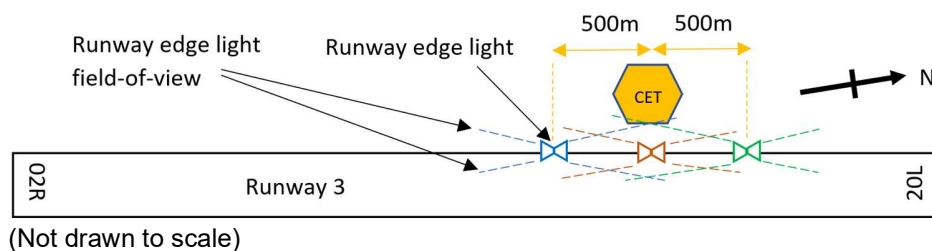
Figure 5: Viewing of runway edge lights from CET

1.7.3.1 Given the directional nature of the runway edge lights and runway centreline lights, as well as the location of CET relative to Runway 3, it is quite impossible for air traffic controllers (hereinafter referred to as 'controllers') at CET to see the runway edge lights and runway centreline lights within about 500m along the runway on either side of CET. However, controllers may see those lights that are further away from this section (see sketch in **Figure 5**).

- (c) Runway 3's edge lights and centreline lights are bi-directional. When switched ON, it is doubtful if controllers can see the runway edge lights

and runway centreline lights within about 500m along the runway on either side of CET (see **Figure 5**). While the edge lights beyond this section of the runway might be seen by controllers at CET, they are not easily discernible. When switched OFF, none of these lights could of course be seen. However, RWC3 did not detect anything unusual when she looked out of the tower windows to check the runway edge lights and runway centreline lights<sup>13</sup>. RWC3 probably had expected the runway lights to be ON and the quick glance at the A-SMGCS could not clearly indicate the status of these lights. Given the bi-directional nature of Runway 3's edge lights and runway centreline lights, the view of the centre portion of Runway 3 is similar at night whether the runway lights are ON or not. As CET had just been in operation for a few months, controllers might not have realised this similarity. It is desirable that the ANSP highlights such similarity to controllers and develops methods to enable controllers to positively identify the status of the runway lights.

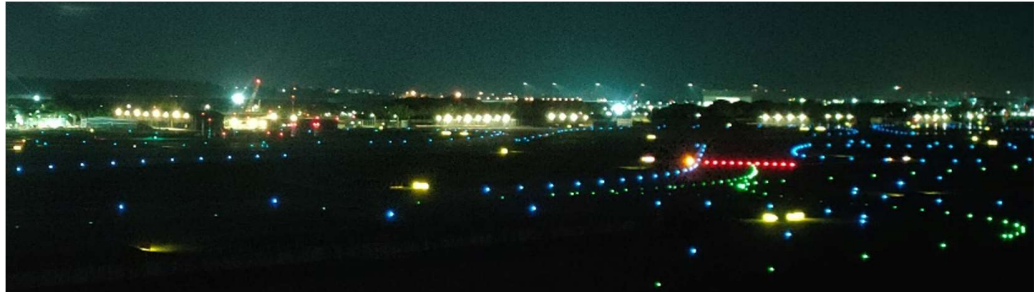
Figure 6: View from CET with Runway 3's edge lights OFF

1.7.4 Furthermore, Runway 3's edge lights, owing to their directional nature, may not be easily discernible even when they are switched ON. **Figure 6** and **Figure 7**

below illustrate the views from CET of a section of Runway 3 when the edge lights were switched OFF and ON respectively.

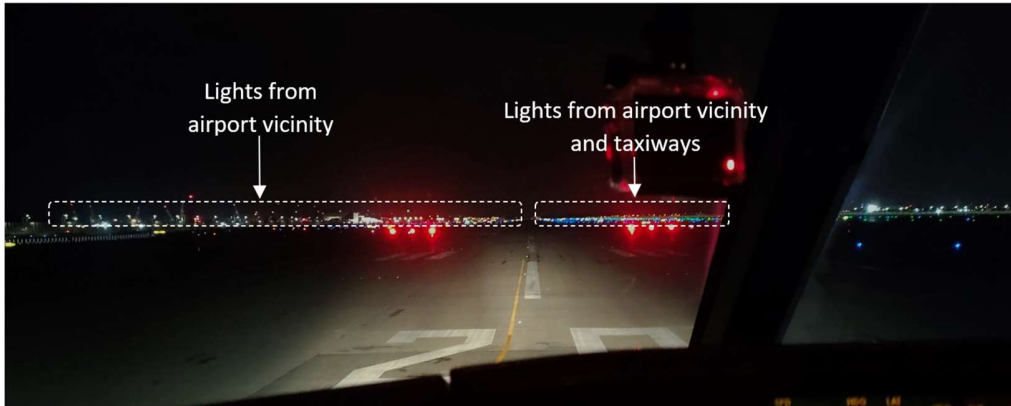
Figure 8: Runway edge lights and runway centreline lights both OFF

Scenario	Runway centreline lights	Runway edge lights	Observations/Remarks
1	OFF	OFF	<ul style="list-style-type: none"><li>- See <b>Figure 8</b>.</li><li>- Actual runway lights configuration at the time of the incident.</li><li>- Lights from the airport vicinity can be seen at the background of the runway.</li><li>- The runway edge lights, runway centreline lights and runway end lights were clearly OFF.</li></ul>
2	OFF	ON	<ul style="list-style-type: none"><li>- See <b>Figure 9</b>.</li><li>- The runway edge lights and runway end lights were visible.</li><li>- The runway centreline lights were clearly OFF.</li></ul>

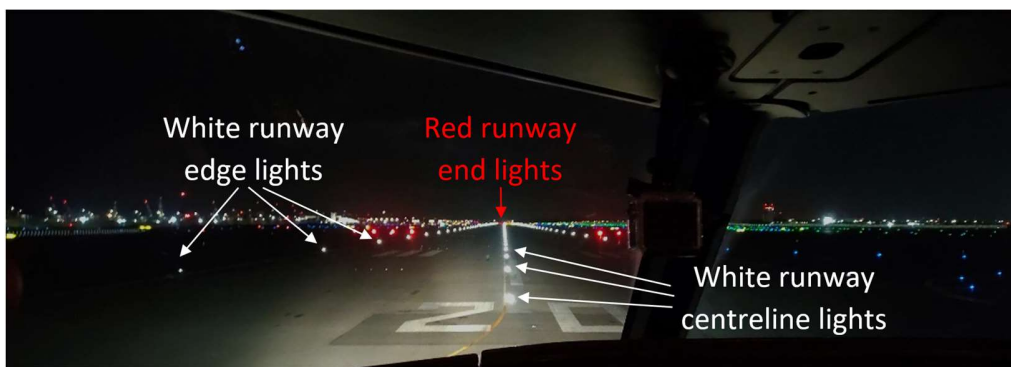
Figure 10: Runway edge lights and runway centreline lights both ON

Scenario	Runway centreline lights	Runway edge lights	Observations/Remarks
3	ON	ON	<ul style="list-style-type: none"> <li>- See <b>Figure 10</b>.</li> <li>- This is the normal runway lights configuration for night operations.</li> <li>- The runway centreline, runway edge lights and runway end lights were visible.</li> </ul>

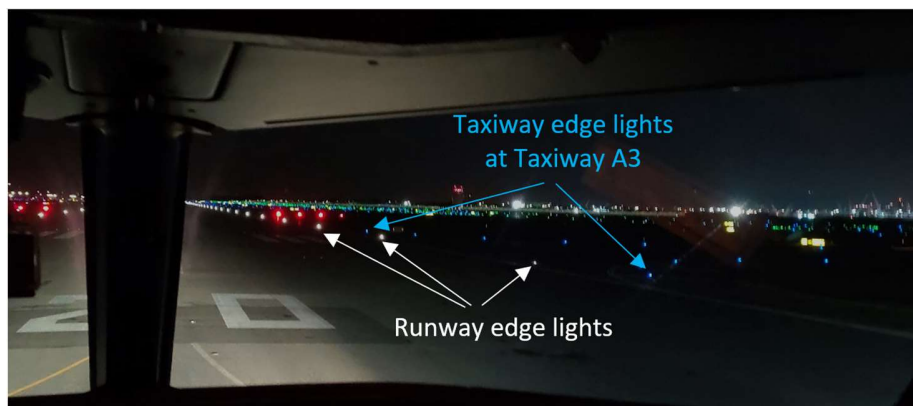
Figure 11: Taxiway edge lights, near the runway threshold, ON with runway edge lights ON

Scenario	Runway edge lights	Taxiway A2/A3 edge lights	Observations/remarks
4	ON	ON	<ul style="list-style-type: none"> <li>- See <b>Figure 11</b>.</li> <li>- Runway edge lights visible.</li> <li>- White runway edge lights were distinct from the blue taxiway edge lights at Taxiway A3.</li> </ul>
5	OFF	ON	<ul style="list-style-type: none"> <li>- See <b>Figure 12</b>.</li> <li>- Actual lights configuration at the time of the incident.</li> <li>- Taxiway edge lights at Taxiway A2 and A3 were blue and not white.</li> <li>- White runway edge lights were clearly OFF.</li> </ul>

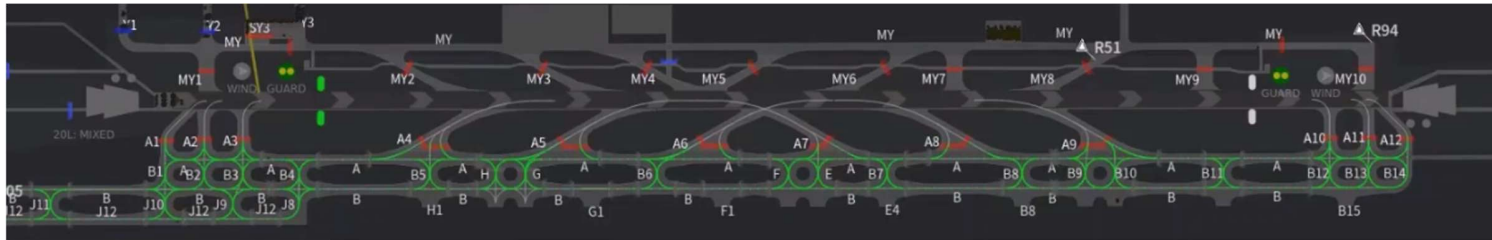
Figure 13: Section of A-SMGCS display indicating Runway 3's lights OFF

- 1.11.2.2 The A-SMGCS displays the ON/OFF status of runway lights to the controllers. **Figure 13** and **Figure 14** below illustrate a section of the A-SMGCS display indicating Runway 3's lights switched OFF and ON respectively. It seems that controllers would not be able to discern just by a quick glance at the display whether the runway lights are ON or OFF and would need to look closely at the display.

- 2.3.2 A-SMGCS display of ON/OFF status of runway lights
  - 2.3.2.1 According to the ANSP, the A-SMGCS provides controllers with an accurate representation of the ON/OFF status of runway lights. However, the investigation team found that the graphical presentation of the A-SMGCS appeared quite cluttered and that it was not easy to discern whether the runway lights are ON or OFF just by a quick glance at the A-SMGCS display. It seems desirable for the graphical presentation of the ON/OFF status of the runway lights to be enhanced.
