FINAL REPORT

LOSS OF LIFE ON BOARD SOUTHERNPEC 12 IN SINGAPORE ANCHORAGE ON 11 DECEMBER 2018

MIB/MAI/CAS.055

**Transport Safety Investigation Bureau
Ministry of Transport
Singapore**

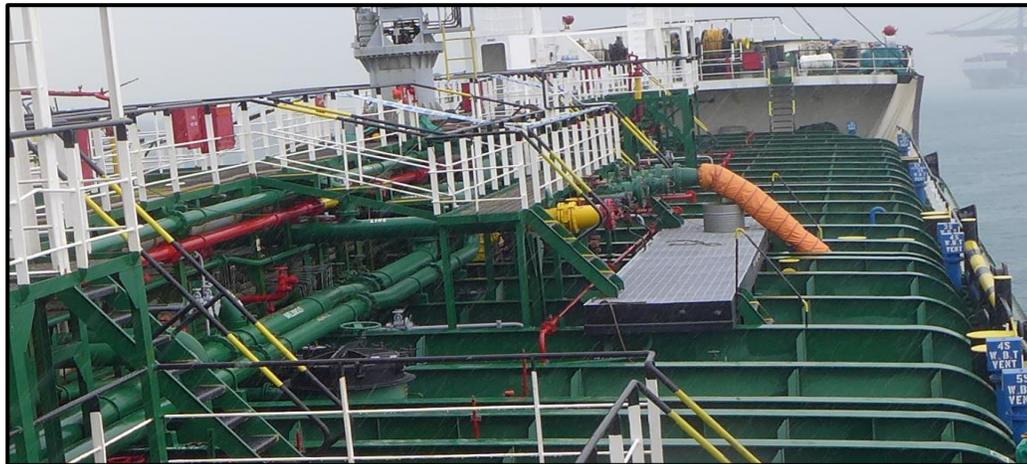
1.1.4 The CO instructed the same deck team to connect the chutes to the two manifolds¹³ on the starboard side and one manifold on the port side (see example in **Figure 1a & 1b**). All deck crossover valves were opened, as were the droplines, and the ventilation commenced at about 2300H, circulating fresh air from blowers, via the chutes, through crossover lines¹⁴ into the COTs and out of the tank dome.

Figure 1a: One remaining chute connected to starboard manifold when investigation team was on board

- 2.1.6 In addition, instead of introducing fresh air through the manifold via the deck crossover valves and the droplines into the COTs for ventilation, the investigation team held the view that portable blowers should have been placed at the openings of the COTs, as the distance between the tank domes and the forward most openings was sufficient to provide an effective exchange of air (see **Figure 6**). Such a method would prevent the introduction of remnants, residing in the pipelines (if any), into the COTs.

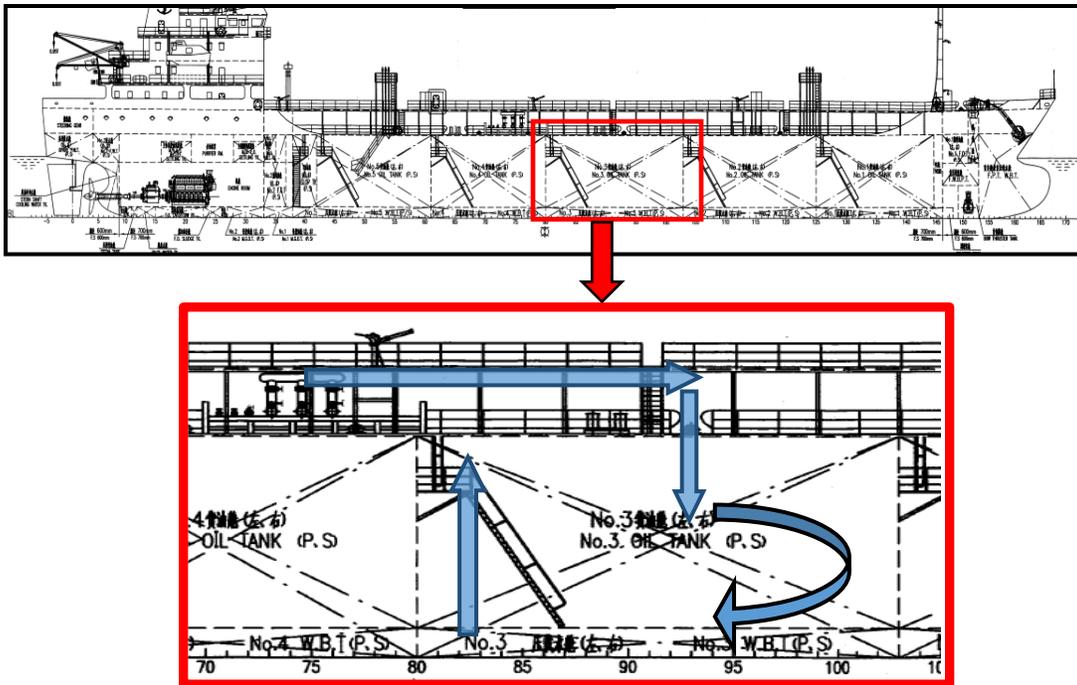
Figure 1b: For Illustration only and not to scale. The blue arrows show the direction of the air circulation from the blower (chute) via the manifold to COT (via cargo line and dropline) and out from the tank dome. Annotated by TSIB.

- 3.2 Prior to commencement of gas freeing of the COTs, the pipelines through which fresh air was being supplied by blowers had not been flushed to remove remnants of the previous cargo. As a result, it is likely that hydrocarbon vapors made way into the COT, making it unsafe for entry.

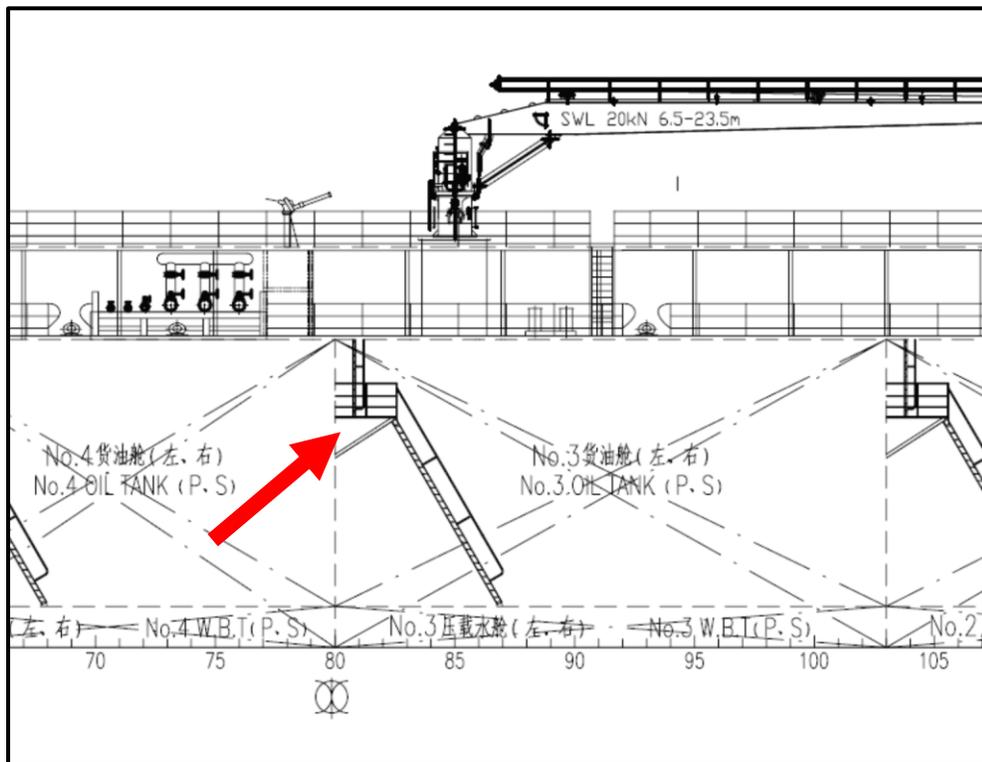
- 1.1.18 By about 1430H, the rain had stopped and the deck crew (now comprising the ASD1, ASD2, BSN and the Deck Cadet) went to 3-Starboard COT with the intention to continue pumping out the water using the wilden pump which had been lowered earlier. At about 1500H the ASD1 was seen by the others as wearing the face mask with a new canister cartridge and entering the first platform of the COT (see **Figure 2**). The ASD2 who was standing on deck could smell a strong odour of gas and told the ASD1 not to proceed down. The ASD1 was seen to continue descending the COT with a walkie-talkie. At about 1515H, on reaching the bottom of the tank, the ASD1 was seen by the deck crew walking erratically and appeared disoriented. The ASD1 was heard on the walkie-talkie by the deck crew to have said (twice) that ASD1 could not see anything and could not breathe.

Figure 2: 3-Starboard COT on Southernpec 12. The intermediate platform was the COT's ladder access as shown by the red arrow

- 2.2.4 During the re-entry after the extended break of 4-5 hours, the atmospheric condition of the 3-Wing COTs would have changed significantly. A reassessment of the risk was absolutely necessary, as stated in the PTW.

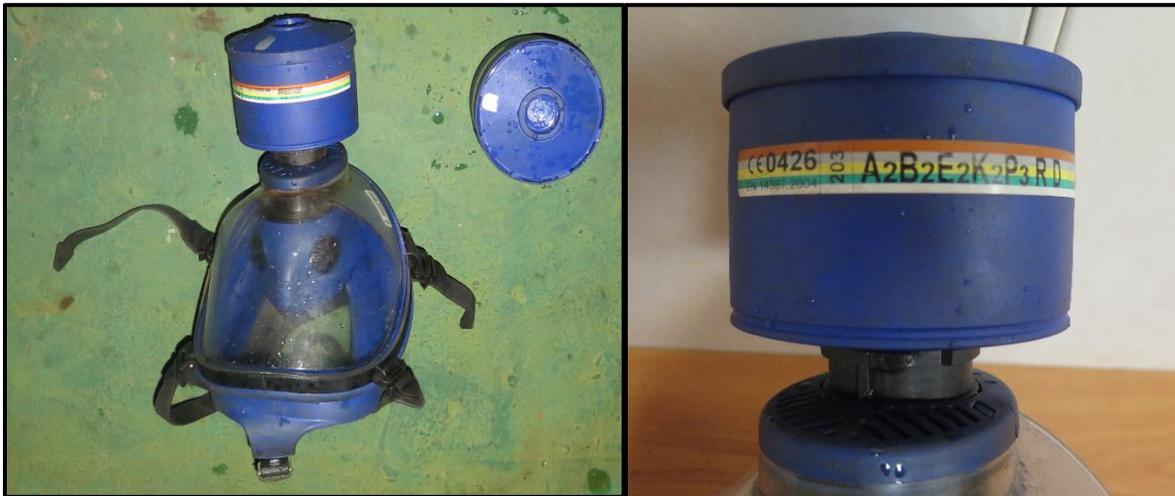
The face masks with canister used by the deck crew, including the ASD1 prior to the occurrence is shown in **Figure 4**. Canister masks with cartridges had been used on prior occasions on board, and the vessel’s store had a supply of spare cartridges. A check with the Company’s purchasing department indicated that the Company had not supplied the masks or their cartridges on board⁴¹.

Figure 4: Canister (gas) masks reportedly worn by the deceased ASD1. The cartridge filter found with the mask bore the year of manufacture as 2004.

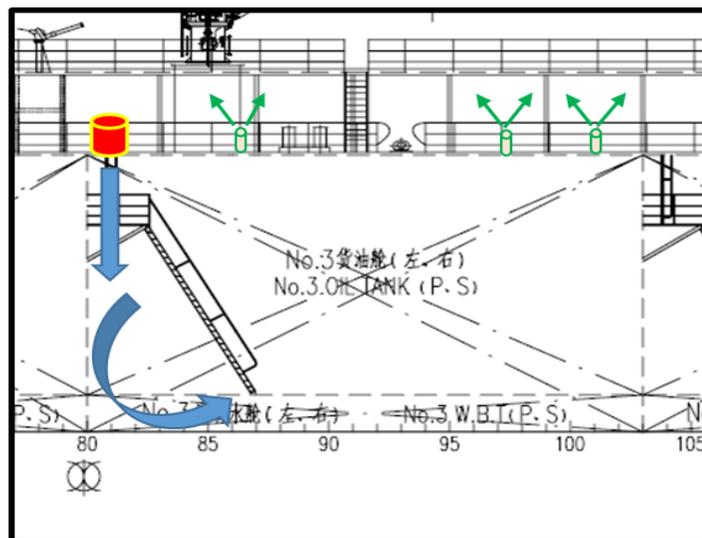
Figure 6: For Illustration only (not to scale). The red cylindrical shape shows the approximate location of the tank dome, while the green cylindrical shapes and arrows show the approximate location of the other openings (sampling points) on the tank. The forward most opening was

about 13m from the tank dome (entry of fresh air) if the chute were to be connected directly to the tank dome.
