FINAL REPORT

**MAN OVERBOARD (LOSS OF LIFE)
FROM OCEAN SUCCESS
WITHIN SINGAPORE TERRITORIAL WATERS
ON 4 MARCH 2018**

MIB/MAI/CAS.034

**Transport Safety Investigation Bureau
Ministry of Transport
Singapore**

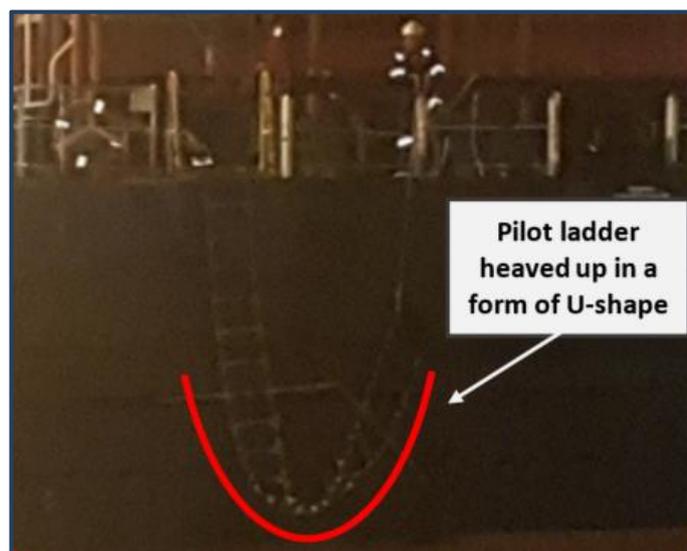
1.1.2 At about 0405H on 4 March 2018, bunkering operations were completed. After the bunker surveyor disembarked using the starboard side pilot ladder, the ladder was heaved up, clear of the water, using a tripping line⁴ forming a U-shape (see **Figure 1**). A Mooring Master⁵ was expected to board at the anchorage about two hours later to assist in the ship's departure. The OS would then pick up a PSA Marine Pilot (harbor pilot) at Singapore western pilot boarding ground 'A' for the ship's entry into the port of Singapore.

Figure 1 – Starboard pilot ladder heaved up in a U-shape form (annotated)
(Source: The ISM Manager)

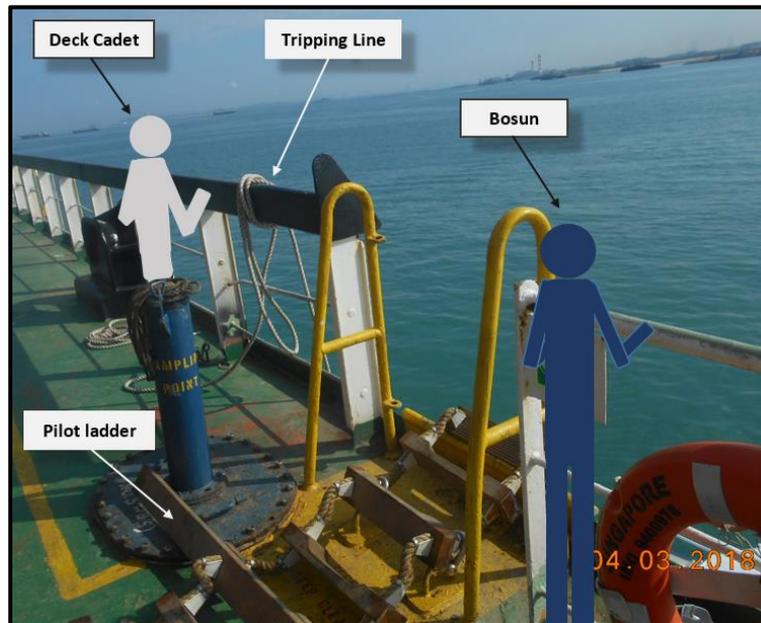
1.3.2 According to the DC, when he arrived at the pilot boarding station, he saw that the Bosun stood at the aft side of the ladder near to the lifebuoy storage location. He was wearing a safety helmet with the chin strap turned up above the helmet¹⁹. A hand torch was hung over his shoulder along with a walkie-talkie (see **Figure 3**).

Figure 3 – Crew’s positions at the time of occurrence
(Not to the scale, for illustration only)

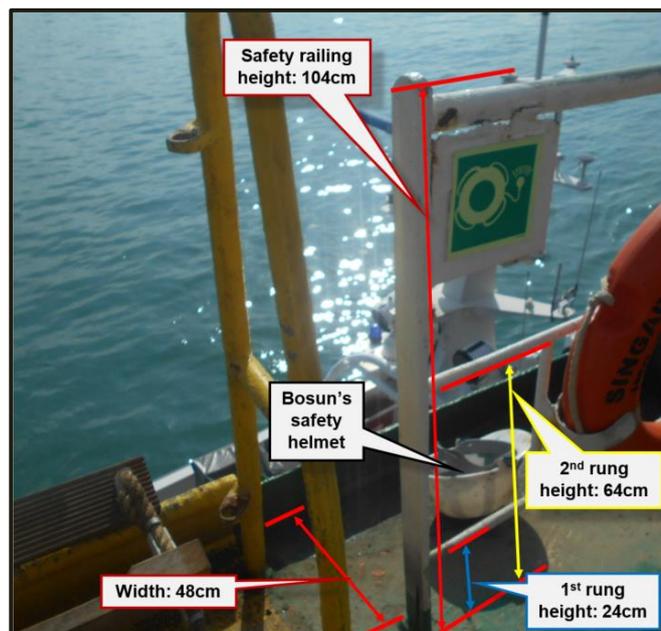
¹⁹ After the incident, the Bosun's safety helmet was found lying on deck near to ship side (see **Figure 4**). The company's Safety Management System requires person to wear safety helmet secured to the chin.

- 1.3.3 The Bosun and DC, were not wearing any floatation device. The walkie-talkie and the portable hand torch were not found on the Bosun’s body after the Sea Tetra recovered him from water.
- 1.3.4 The distance measured from the safety railing to the ship’s side was about 48cm. The height of the safety railing from the main deck was about 104cm. The height of the 1st rung and the 2nd rung of the railing above the main deck was about 24cm and 64cm respectively (see **Figure 4**).

Figure 4 – The location view of the occurrence

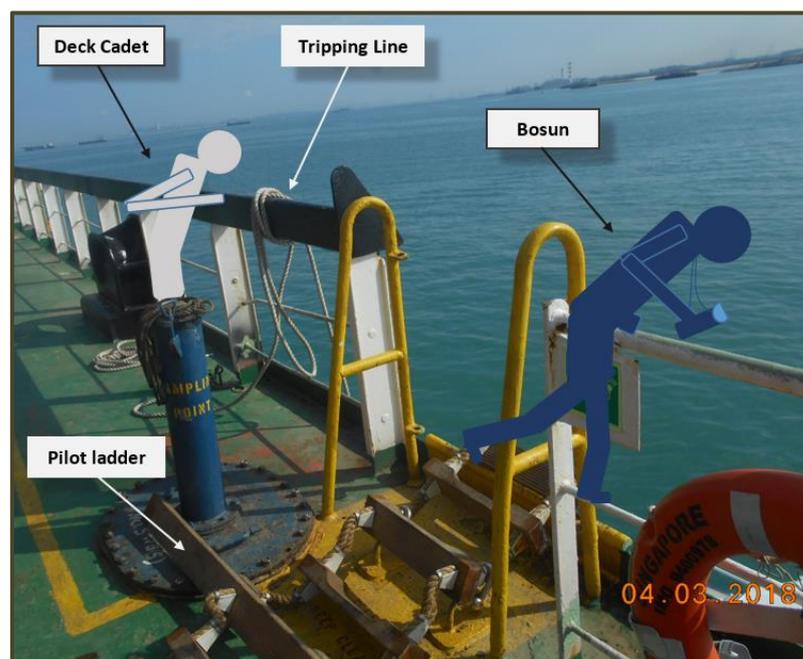
- 2.1.2 Given the Bosun's height of 165cm, it would not be possible for the Bosun to be able to sight and assess the ladder's height above the water line, if he stood on the main deck. This position was about half a metre inboard of the ship's side, and at a height of one metre above the deck (see **Figure 5**). A fall from this position was unlikely.

- 2.1.3 In order for him to fall from this position, he would have to increase his height above the safety railing. If his foot was on the first rung, his body would be raised by about 24cm. A step onto the second rung would have raised his body even more, causing his upper body to lean over the safety railing. If indeed he attempted to gain a better visual sight he may have lost his balance from this position.

Figure 5 – Possible position of Bosun prior to the accident
(Not to scale, for illustration only)

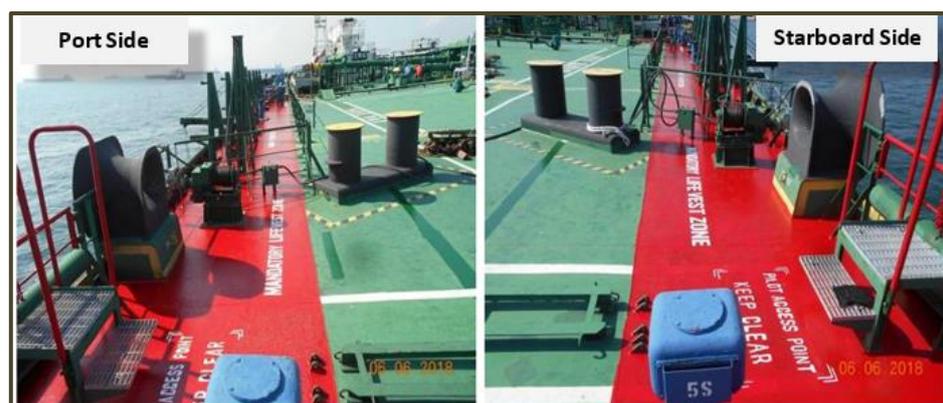
Figure 6 – Mandatory life vest zone
(Source: the ISM Manager)

4.3 Areas of mandatory donning of life vest were marked in red at pilot boarding station (see **Figure 6**).
