FINAL REPORT

**MAN OVERBOARD (LOSS OF LIFE)
FROM SUPPLY VESSEL
COASTLINK 8
IN THE SINGAPORE STRAIT
ON 26 AUGUST 2017**

MIB/MAI/CAS.023

**Transport Safety Investigation Bureau
Ministry of Transport
Singapore**

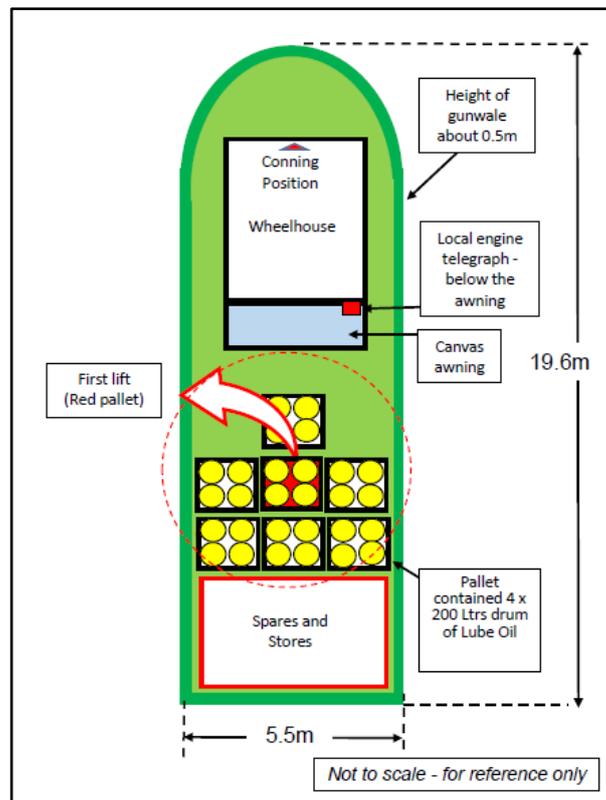
Fig.2 - Illustration of transfer plan

of about one metre and keeping in mind C8's cargo stowage, the Master and crew, based on their past experiences decided to commence the first lift¹¹ from the centreline of the C8 (see **Fig.2**).

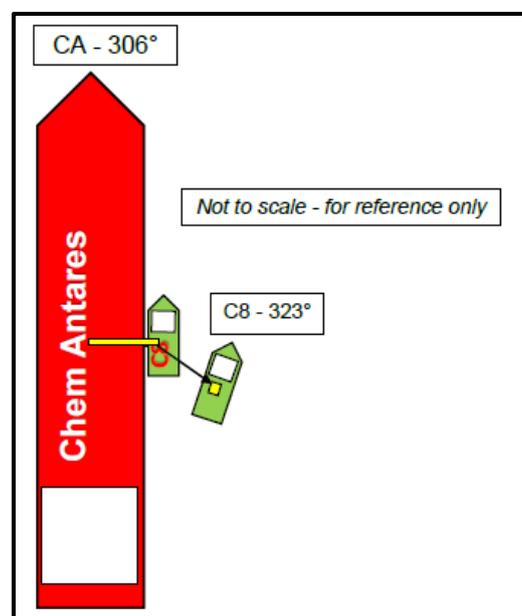
Fig.3 - Illustration on vessels' position at 2302H

- 1.1.12 At about this time, which was about 2302H, before the slack on the crane wire taken up, the bow of the C8 veered to starboard, and the supply vessel began moving away from CA shipside (see **Fig.3**).

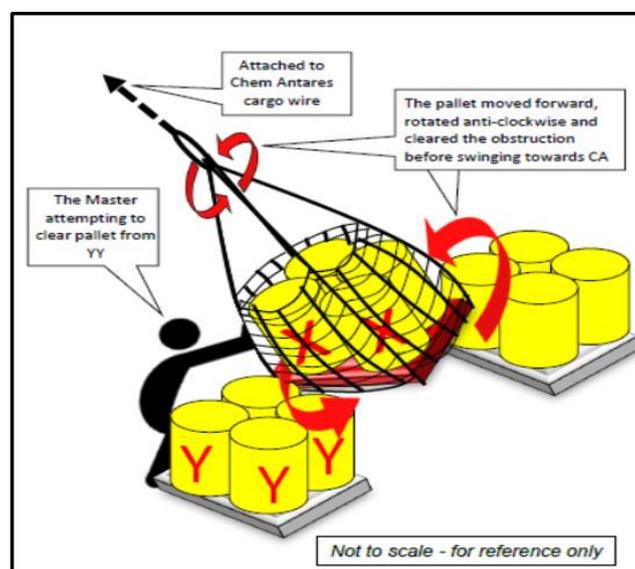
Fig.4 – Illustration of 'XX' obstructed by 'YY'

- 1.1.16 The Master and the ASD positioned themselves on the inboard¹⁶ and outboard sides of the C8 respectively. As the strain on the wire increased from C8's continuous movement away from CA's shipside, it caused the first lift (marked as XX) to be lifted off C8's main deck. The pallet 'XX' was getting obstructed by the inboard pallet (marked as 'YY') (see **Fig.4**).

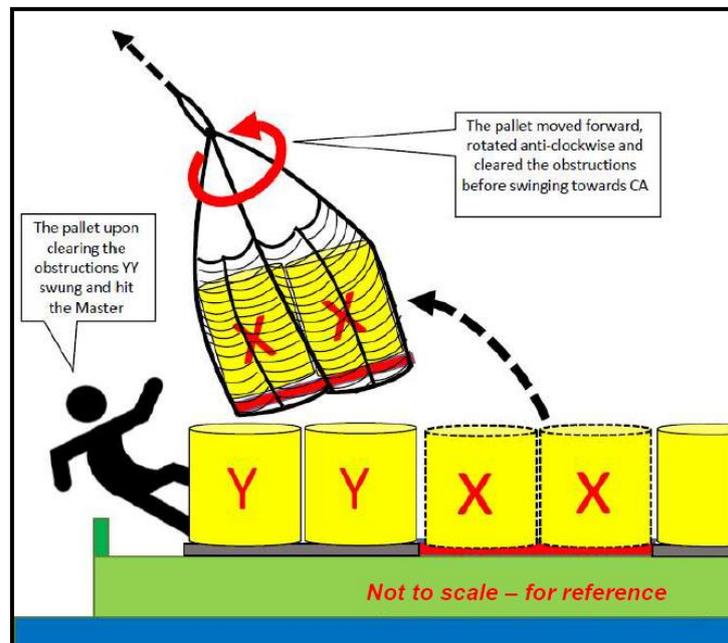
Fig.5 – Illustration of the 'XX' clearing the parcel 'YY'

- 1.1.18 Both the Master and ASD began pushing 'XX' from side to side while guiding it back to its original position. As the distance between the two vessels increased, it concurrently caused the strain on the crane wire to further increase.
- 1.1.19 At some point, the ASD saw 'XX' moved slightly upwards and warned the Master to stand clear. At a time reported as 2303H, 'XX' moved upward, cleared the adjacent obstruction 'YY' and swung towards CA's shipside. The swinging lift 'XX' hit the Master and threw him overboard into the sea (see **Fig.5**).

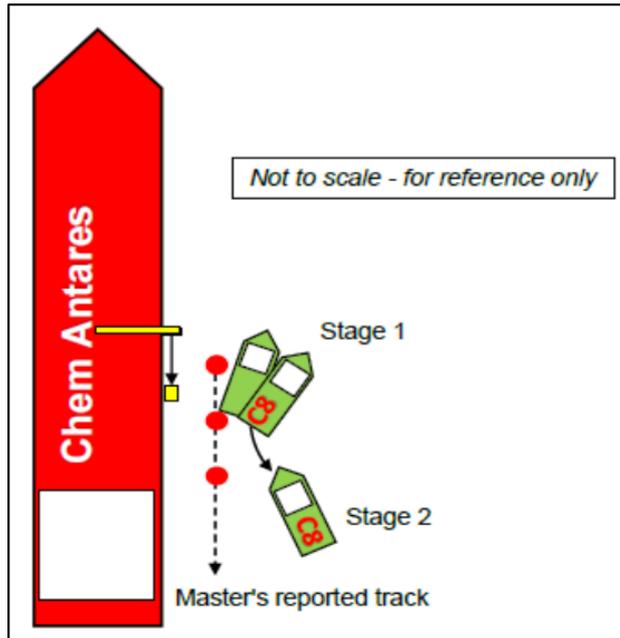
Fig.6 - Illustration on vessels' position after 2303H

- 1.1.20 The ASD was momentarily stunned before he shouted for help. The EO, on hearing ASD's call for help, looked over the wheelhouse's portside door and saw the Master struggling in the water. He instructed the ASD to throw a lifebuoy at the Master.
- 1.1.21 The EO stopped the engines and noted that C8 was by now slightly behind the crane's position at a horizontal distance of about 15m away from CA's crane outreach. The EO moved C8 further astern and performed series of maneuvers to clear C8's propeller away from the Master (see **Fig.6**¹⁷).

¹⁷Stage 1 – the position which the EO took the C8 away from the Master

Stage 2 – the position which the EO began maneuvers to recover the Master

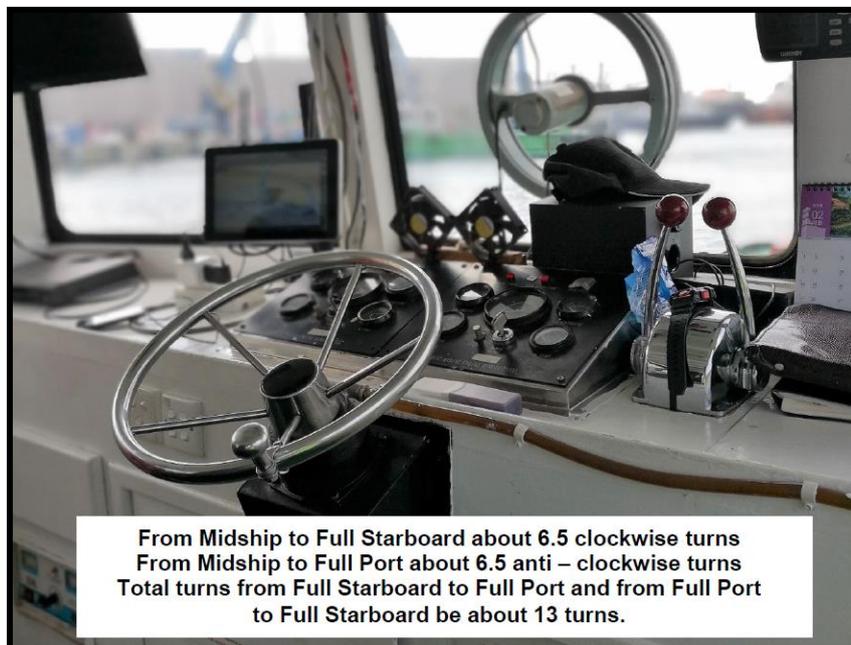
Fig.7 – Image of C8 steering wheel

⁶There is no rudder/helm indicator required by regulations. The Master/crew correspond the rudder angle to the number of steering wheel turns required to achieve the desired heading. The rudder swinging arc from 'Full' port rudder angle to 'Full' starboard rudder angle, or vice-versa, requires about 13 x 360 degrees turns on the steering wheel. Therefore, from mid-ship to 'Full' port or starboard rudder angle would require 6.5 x 360 degrees turns on the steering wheel. The number of turns were not marked or written at the steering position.

- 1.1.22 While the port engine was at 'Full Astern', the EO gave the starboard engine 'Full Ahead' and turned the steering wheel anti-clockwise or 'Hard' to port. In doing so, he noticed that the steering wheel, had to be turned for about 10 turns before it came to a stop, which was more than what he had expected from a mid-ship position, i.e. 6.5 turns (see Fig.7).

- 2.2.2 Considering the hours of darkness when the incident occurred, C8 being the smaller craft, would likely have been affected by the bow waves of the CA. With no helm/rudder indicator, the Master in trying to maintain C8's position alongside, while at the same time keeping the bow away from the shipside, may have lost his situational awareness. It is likely that the Master had unintentionally placed the steering wheel position more to starboard without realising it that had caused the vessel to move away from CA's shipside.
