Final Report

MAN OVER-BOARD (LOSS OF LIFE) FROM THE HARBOUR TUG, RESILIENT AT BANYAN BASIN, SINGAPORE ON 22 DECEMBER 2016

MIB/MAI/CAS.006

Transport Safety Investigation Bureau
Ministry of Transport
Singapore

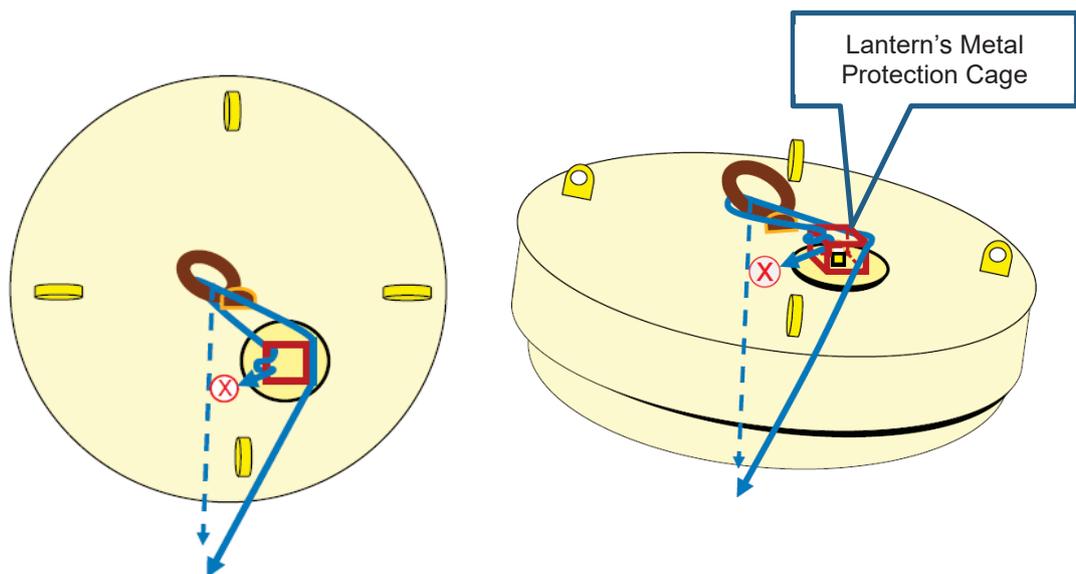
Figure 2: Illustration of CCTV footage

- 1.1.12 According to closed-circuit television (CCTV) footage of the tug, as the tug was approaching the buoy, and unknown to the TM, the EO used the bulwark door at the mid-ship to cross over to the buoy with the tug's rope in hand, while the tug was still moving. The tug's wake caused the buoy to rotate around its fixed anchors, sway and move in the sea.
- 1.1.13 CCTV footage showed the EO holding onto the rope making a few temporary turns on the lantern's metal protective cage. The rope had been passed through the shackle on the buoy. The tug's forward momentum and the buoy's rotation caused the rope to create a bight around the metal cage and tilting of the buoy forward (see **Figure 2**).

- 1.1.14 The footage also showed the EO squatting on the tilted buoy (marked by X in above figure within the bight of the rope, seemingly trying to keep himself in balance on the buoy. Then the taut rope slipped off the metal cage and sprang to hit the EO in his leg and caused the EO to fall into the water.
- 1.1.15 In the meantime, the TM, after confirming the tug's position and that the

2.2.2 The EO used an unsafe method of perform the mooring task. He crossed over to BBB-6 without wearing a life-vest. When he was crossing over to the buoy, the tug was still moving and the tug's wake caused the buoy to rotate around its fixed anchors, sway and move in the sea. It cannot be established whether the EO had been aware of the danger he could put himself in by trying to perform the mooring task on a buoy.

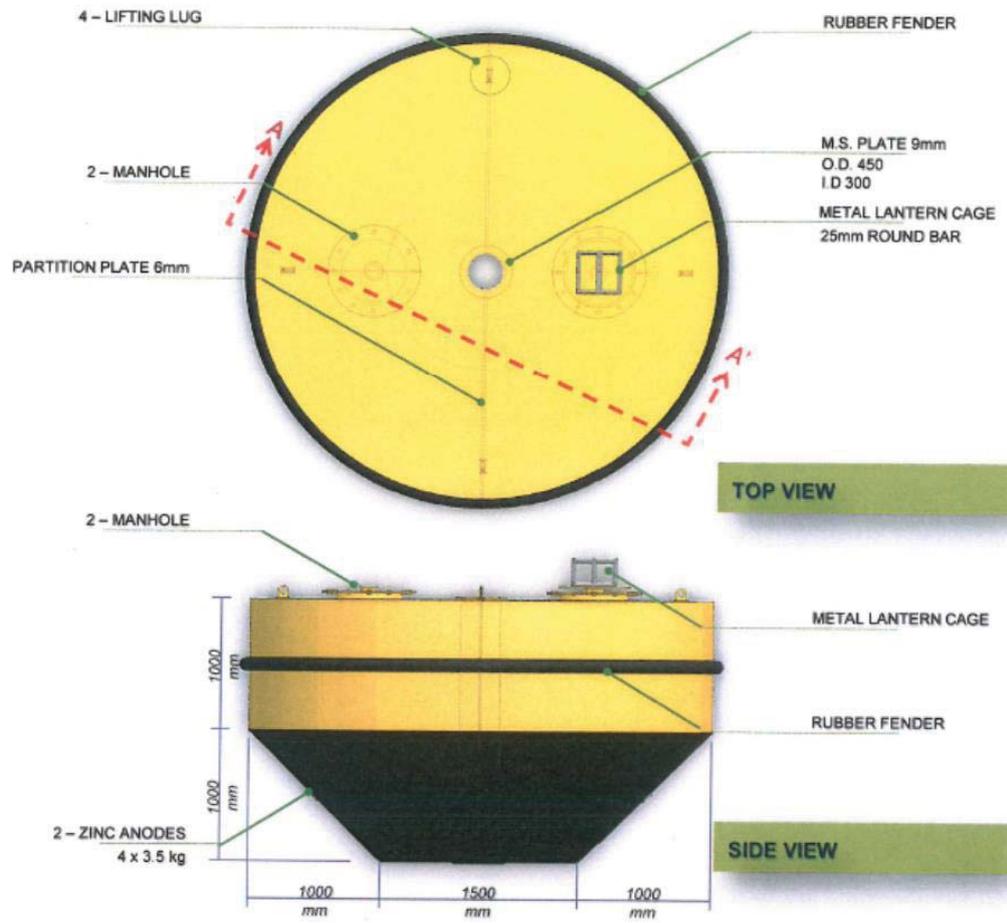
Figure 4: Specification details of BBB-6

1.3.1 **Figure 4** shows a typical buoy like the BBB-6. BBB-6 had a diameter of 3.5m and depth of 2m and had a flat top surface for the mooring personnel to stand on during mooring operation.

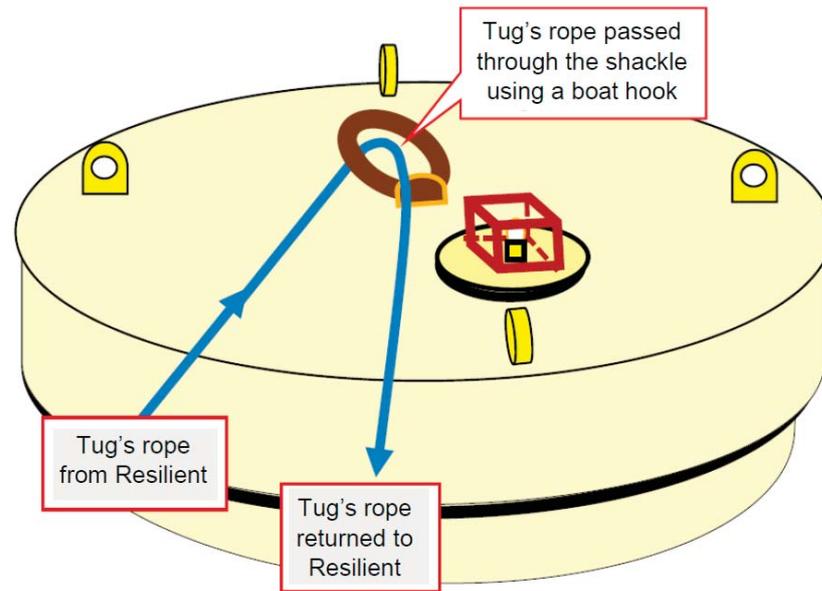
Figure 5: Mooring of buoy from the tug

1.3.2 For mooring the occurrence tug to the buoy (see **Figure 5**), a rope from the tug would have to be passed through the shackle on the buoy and returned back to the tug for securing. Considering the tug's size and personnel available, it is considered unsafe to try to do this mooring task while standing on the surface of the buoy. So it was not a recommended practice to cross over to the buoy to perform the mooring task. A proper way was for the mooring personnel, while remaining on the vessel, to throw the outboard eye end of the tug's rope to as close as possible the shackle on the buoy and then use a boat hook to guide the eye end through the shackle and pull the rope back on board the tug for securing. The TM was aware that this method was tedious, time consuming and required more skill on the part of the mooring personnel, but was considered safer.
