# **FINAL REPORT**

**FATALITY AND INJURY OF SHORE WORKERS  
DURING UNMOORING OPERATION INVOLVING  
BAHAMAS REGISTERED VESSEL  
PACIFIC ENLIGHTEN  
ON 17 APRIL 2017**

**MIB/MAI/CAS.017**

**Transport Safety Investigation Bureau  
Ministry of Transport  
Singapore**

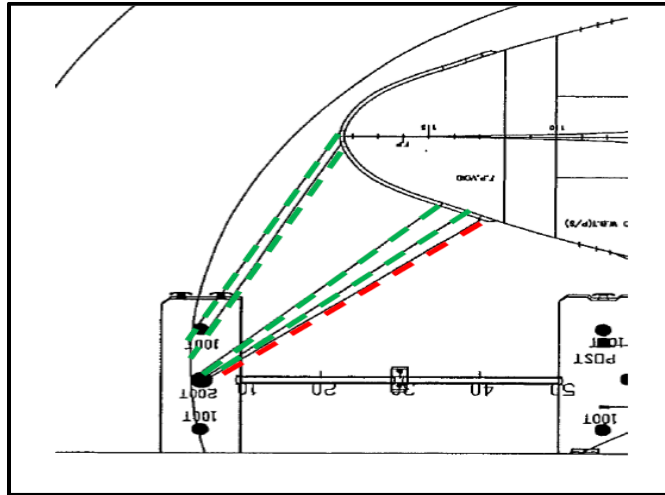
- 1.1.5 Soon, the Chief Officer heard a loud cracking sound (of a rope) and saw that the inner breast line which was under tension, jerked briefly. He noticed that the seizing twine (which held the bight of the rope tail together) of the inner breast line had parted, causing the bight of the tail to spring open wider. He also noted two shore workers lying beside the bollard. The three breast lines and their tails were still intact.

Figure 2 - The forward mooring arrangement with the affected inner breast line in red  
(Source: Keppel Shipyard)

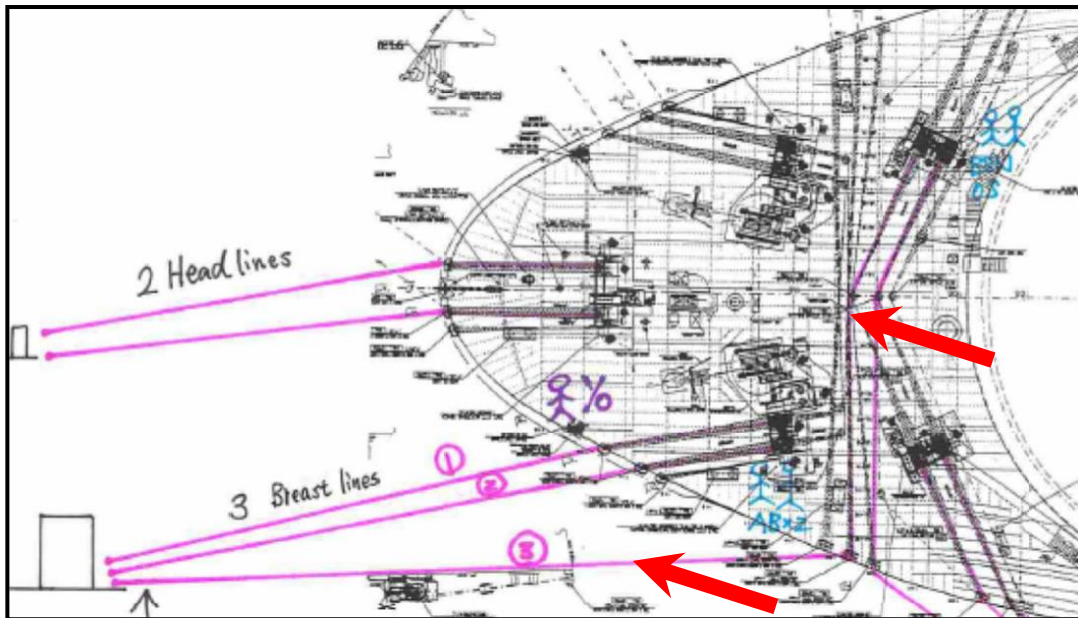
- 1.1.7 At the time of the occurrence, the Chief Officer was positioned at the port bow of the forecastle operating the winch using the remote controller. From this location, he was able to sight the quay and had walkie-talkie communication with the Bosun at the starboard winch. (see **Figure 3**). The Chief Officer had

Figure 3 - The forward mooring arrangement and the manning at the forward station relative to the winch and capstans at the forecastle. The red arrows point to the affected breast line  
(Source: Bahamas Maritime Authority)

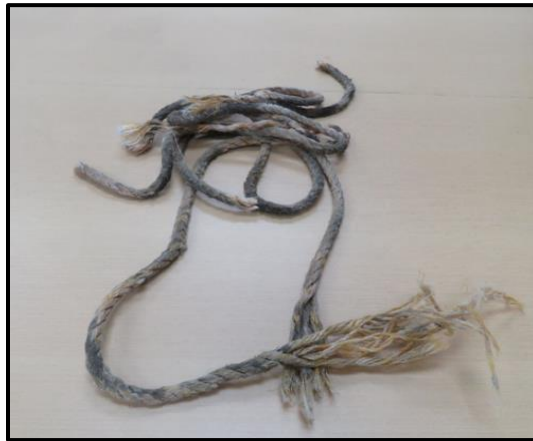
- 1.2.4 GW(B) moved closer to the bollard and bent down to throw the coil of messenger line under the breast lines for the supervisor to pick up. At about this time, the AM had also moved closer to the breast lines, when the seizing twine on the inner breast line (which was still taut) parted (see **Figure 5**).

Figure 5 - The fragments of the seizing twine  
(Source: Ministry of Manpower)

- 2.1.5 Seizing twines are subjected to the same environmental conditions<sup>24</sup> as the rope they bind. Being relatively smaller in size, they are also likely to be more susceptible<sup>25</sup> to breakage. In this case the mooring rope and the twines had been used over a period of 18 months during which time, they collectively would have been subjected to twisting, expansion and compression.

5.2.1 To consider taking the condition of the seizing twine into account when inspecting and appraising the condition of the tail rope and amend the Tail Rope Management guidelines accordingly. **[TSIB Recommendation-RM-2019-003]**

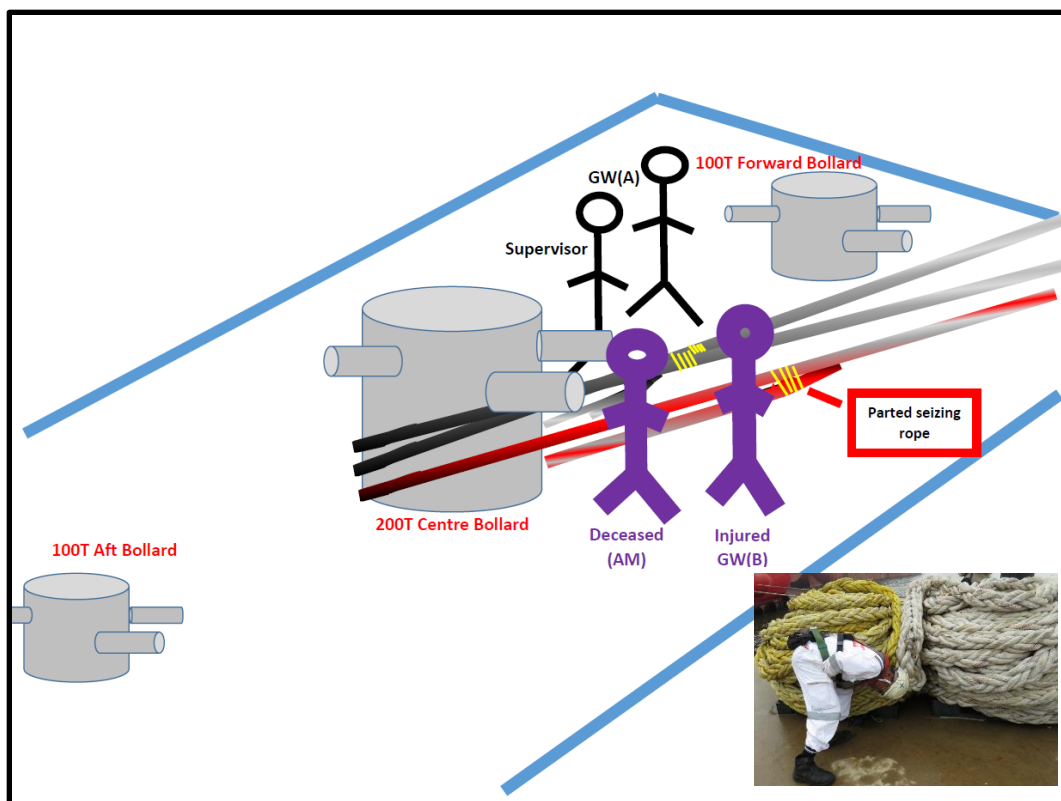
- 1.2.5 The bight of the inner breast line sprung open and hit the AM and GW(B). GW(B) fell onto the ground on his back and AM moved backward and leaned against a coiled mooring rope which was on the mooring dolphin (see inset in **Figure 6**). The supervisor informed the Pilot to suspend the operations and called for medical assistance from the shipyard's in-house medical services. At about 1550H the in-house ambulance conveyed the AM and GW(B) to the hospital.
- 1.2.6 The AM succumbed to his injuries at the hospital while the GW(B) was given three days of medical leave after receiving outpatient treatment.
- 1.2.7 The GWs had been working in their respective roles for between 2.5 to 4 years. The supervisor had been with the shipyard for about 40 years and the AM had been in his role for about four years.

Figure 6 - Approximate position of mooring crew nearest to the bollard with three breast lines. The red-coloured line shows the affected (inner) breast line – For illustration only

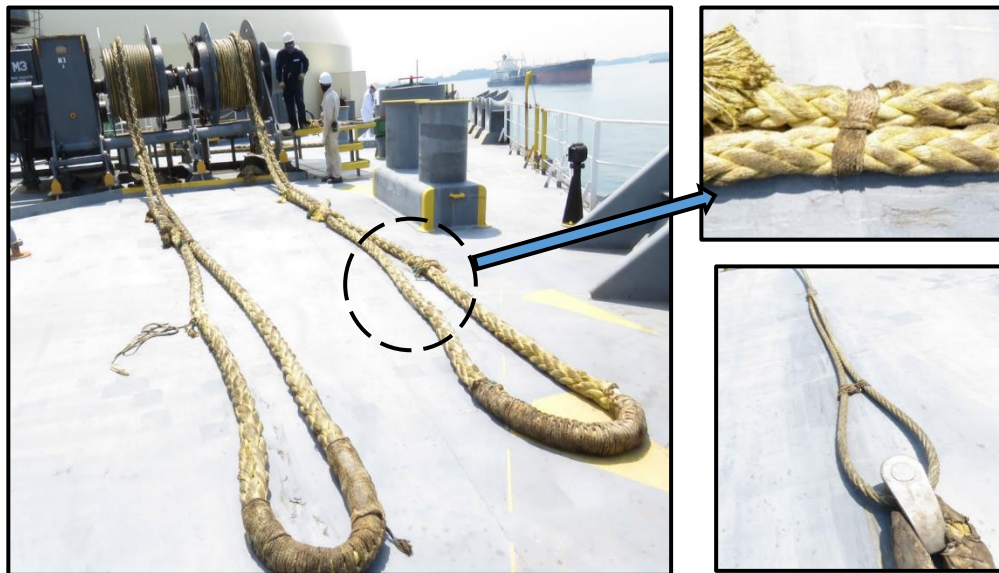
<sup>20</sup> "Seizing" is commonly used in place of a knot or a splice to bind ropes of the same material. In this case, the tail had been seized to make smaller hooks for use at LNG berths and ease of handling by reducing the size of the bight of the mooring rope so as to reduce accidental unloop from the bollard especially in ports where the bollard is small. The twine was wound around 13-14 turns. According to the company, this was the case for all the tails used on other mooring lines.

Figure 8 - An example of the original seizing on the tail end about 2.5m from the bight (top right) prior to it parting. Bottom right image shows tail's connection to the mooring wire via a tonsberg shackle  
(Source: Ministry of Manpower)

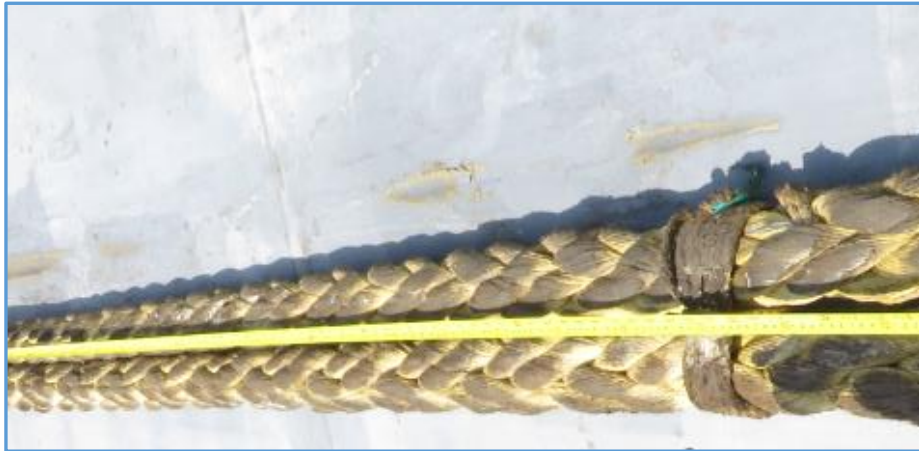
1.6.5 According to the company, the tail ropes (with the twine<sup>21</sup>) on-board PE were renewed on 5 Feb 2017, about a month prior to PE entering the dock for repairs. To prevent damage to the newly changed tail ropes during the stay at the berth, the company requested the shipyard to accept mooring wires without tail ropes for berthing at Quay 2- Extension. However, as no conclusion was reached, the company then instructed PE to restore the used mooring tail ropes for the duration of the berthing at Quay 2-Extension. The tail rope that was involved at the time of the accident is shown in **Figure 10**.

Figure 10 – Tail rope involved in at the time of the accident – Shown to indicate overall condition of the trope (*Source: Ministry of Manpower*)

- 3.2 In trying to preserve the new set of tail ropes which was only put to service one month prior to the occurrence, PE's crew used a previous set of tail ropes for this mooring. The used tail ropes although had been recorded to be in 'good' condition prior to being removed from service, they had been stored for two months which may have affected their previously known condition.

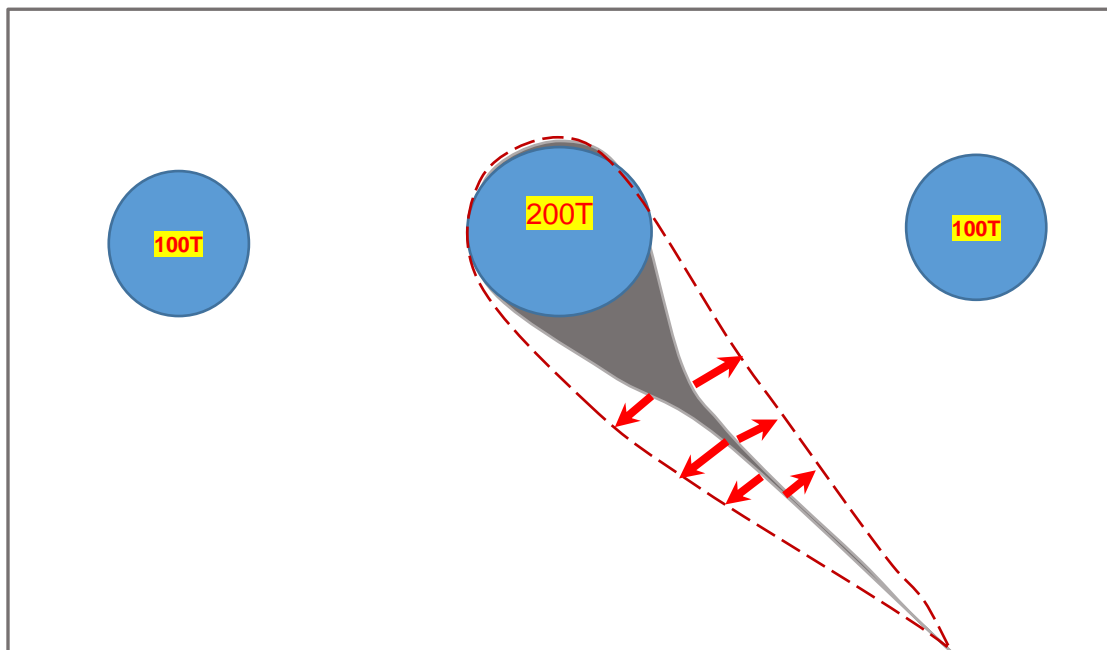
2.1.1 When the breast lines had been slackened (see Para 1.2.3), despite the tugs' push in keeping PE alongside, with one breast line (inner) still taut and three spring lines holding the vessel, there could be a possibility that the bow of PE may have, with the abatement of the initial fender compression, and an increase in the distance of the vessel's bow from the berth, caused further load on the inner breast line. It is likely that the seizing twine experienced additional strain from the load of the inner breast line and caused it to part, consequently opening the bight of the tail rope.

2.1.2 The first opening with the seizing twine was about 2.5m. When the seizing twine parted, a wider and longer 'new' bight would have formed (see **Figure 11**), causing a whiplash injury to both the AM and GW(B) who were standing close to the bollard

Figure 11 - Plan view of the dolphin showing the 200T bollard and the opening of bight at the tail-end when seizing twine parted (Not to scale)
