FINAL REPORT

**MAN-OVERBOARD (LOSS OF LIFE)
FROM MALAYSIA REGISTERED
OIL TANKER AQUABELLE
IN SINKI FAIRWAY, SINGAPORE
ON 6 JANUARY 2019**

MIB/MAI/CAS.058

**Transport Safety Investigation Bureau
Ministry of Transport
Singapore**

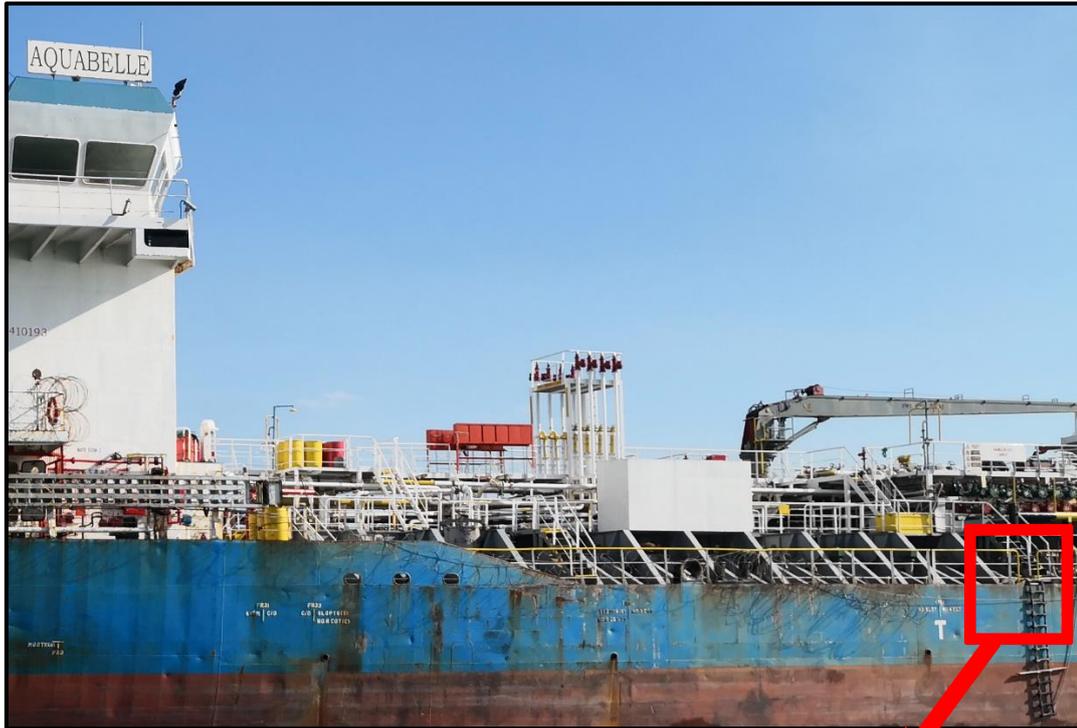
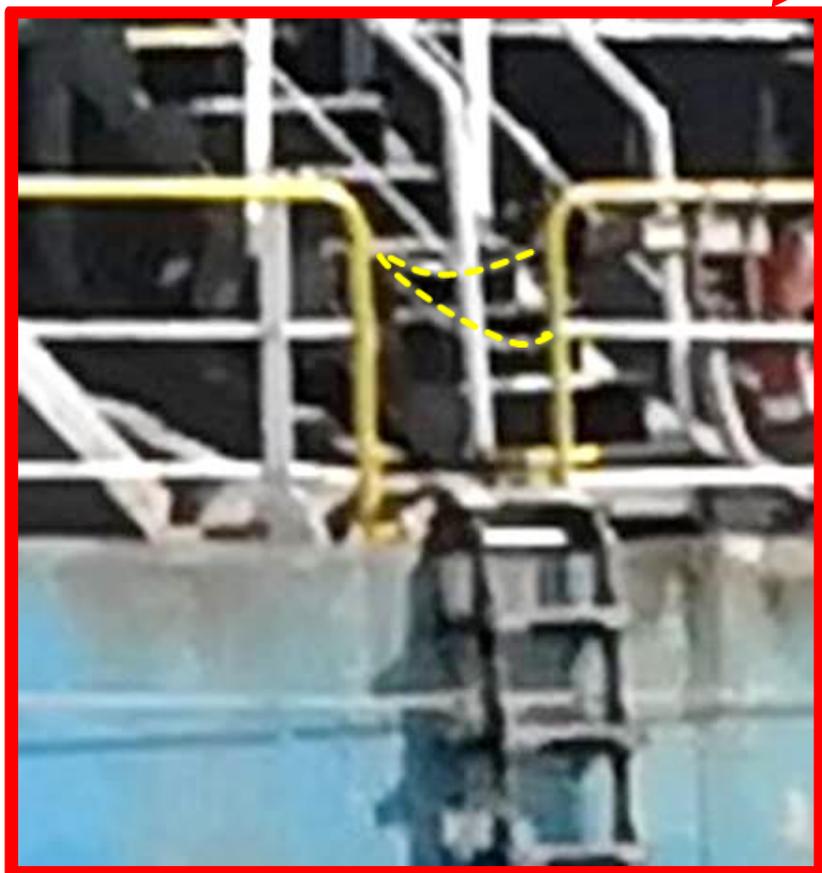
Figure 1: A single yellow-coloured chain in this figure (annotated by TSIB) was understood to have been fixed on the starboard-side pilot access area. This was different from the arrangement on the Port side which contained two separate chains

- 2.1.1 This coiled razor wire was laid from aft to forward of the ship. ASD-3 was holding the front of the razor wire and was lifting and stretching it to the front of the ship. From the ship's CCTV footage, it appeared that ASD-3 was leaning towards the railing each time he lifted the razor wire as he stretched them and pulled towards the bow while facing towards aft. In doing so, he had likely fell over board when he was at the pilot access area.

- 2.1.3 It was thus likely that the single safety chain was in place at this location prior to AQB unberthing and was not touched by any crew member or adjusted, prior proceeding for mooring operations once the Pilot boarded (see paragraphs 1.1.5 and 1.5.3). The single safety chain was likely not sufficiently secured to prevent a person from falling over, either owing to the slack in the chain or it being looped around the railings.

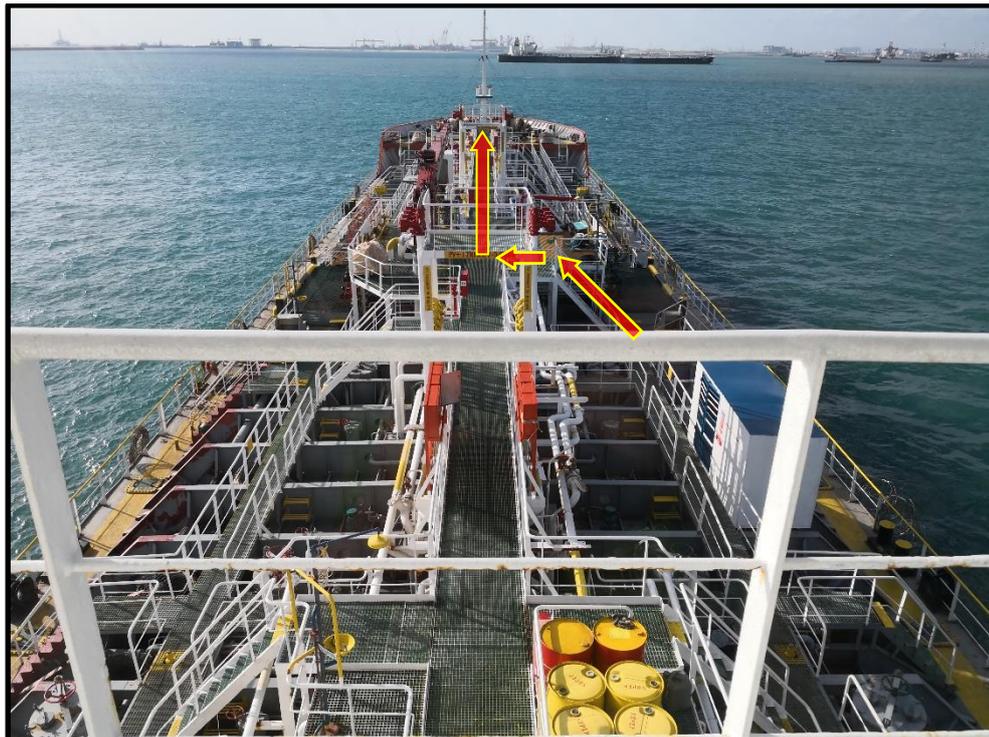
Figure 2: The upper-deck view from the bridge. Red-coloured arrows indicating the direction the gangway crew took via the catwalk to the forecandle on board AQB (annotated by TSIB)

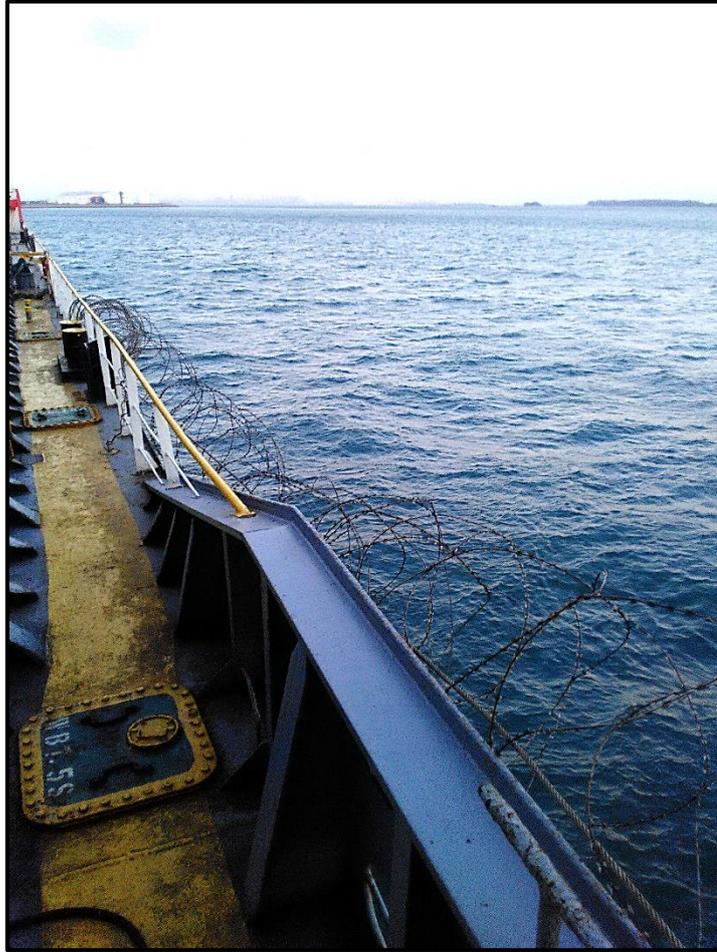
Figure 3: The starboard side of AQB showing the unfinished rigging of the razor wire.

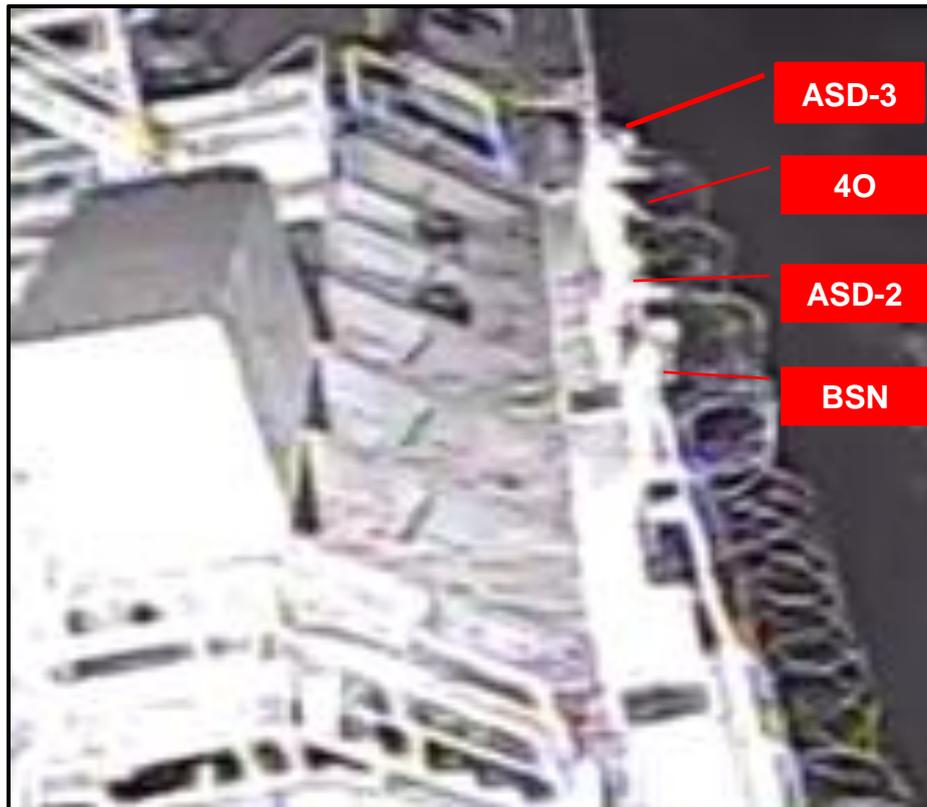
- 1.1.12 The BSN organised the deck crew and began freeing up the coiled razor wire nearest to the accommodation. The 4O and ASD-3 were tasked to secure (fasten) them to the ship's railings after ASD-2 had done with the opening of the coil. ASD-3 was the first person towards the bow (See **Figure 4**).

Figure 4: The sequence of the group rigging the razor wire over the railing on the starboard side. (Source: AQB's CCTV footage)

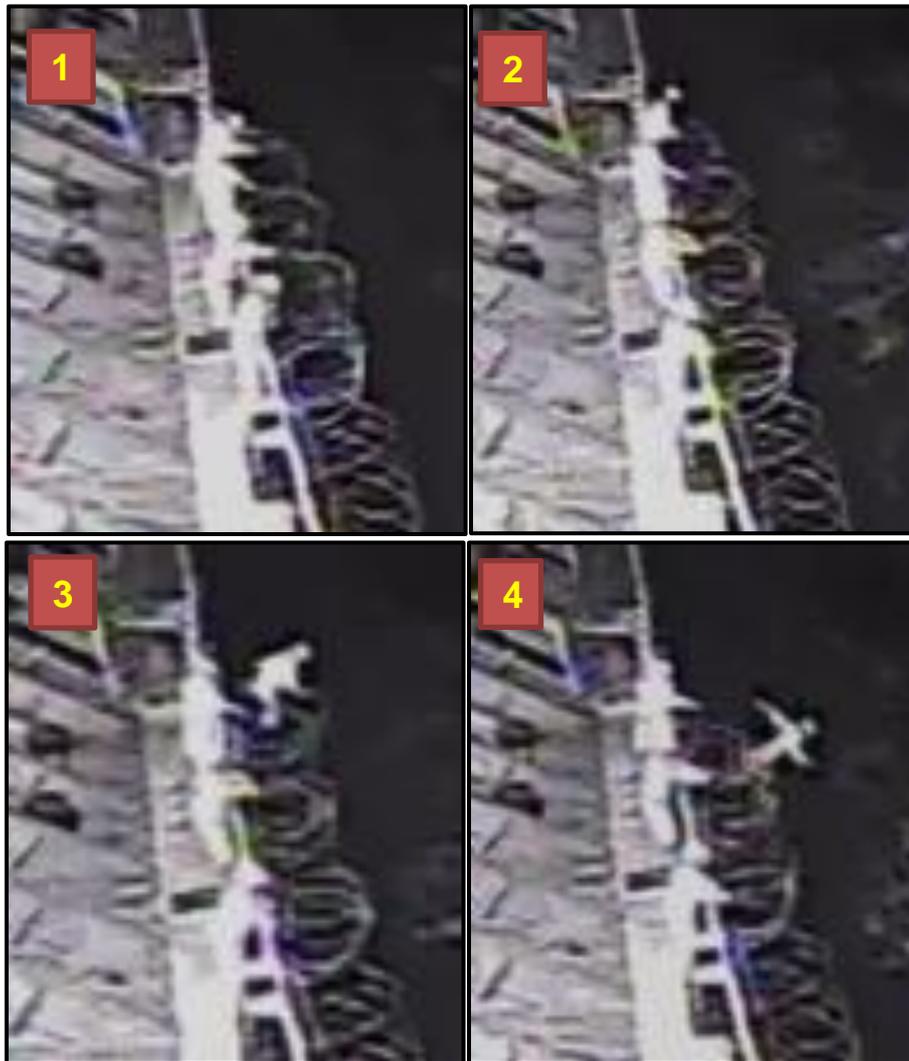
- 1.6.1 The investigation team reviewed the AQB's CCTV footage at the time of occurrence. From the recording, it was established that at about 2111H, ASD-3, fell laterally through the ship's railing. Prior to this fall, the CCTV footage also indicated that the action of heave and pull (associated with picking up and straightening the razor wires) would cause the body to lean towards the ship's railing. (See **Figure 7**).

Figure 7: Snapshots of CCTV footage showing ASD-3 falling into the water at about 2111H

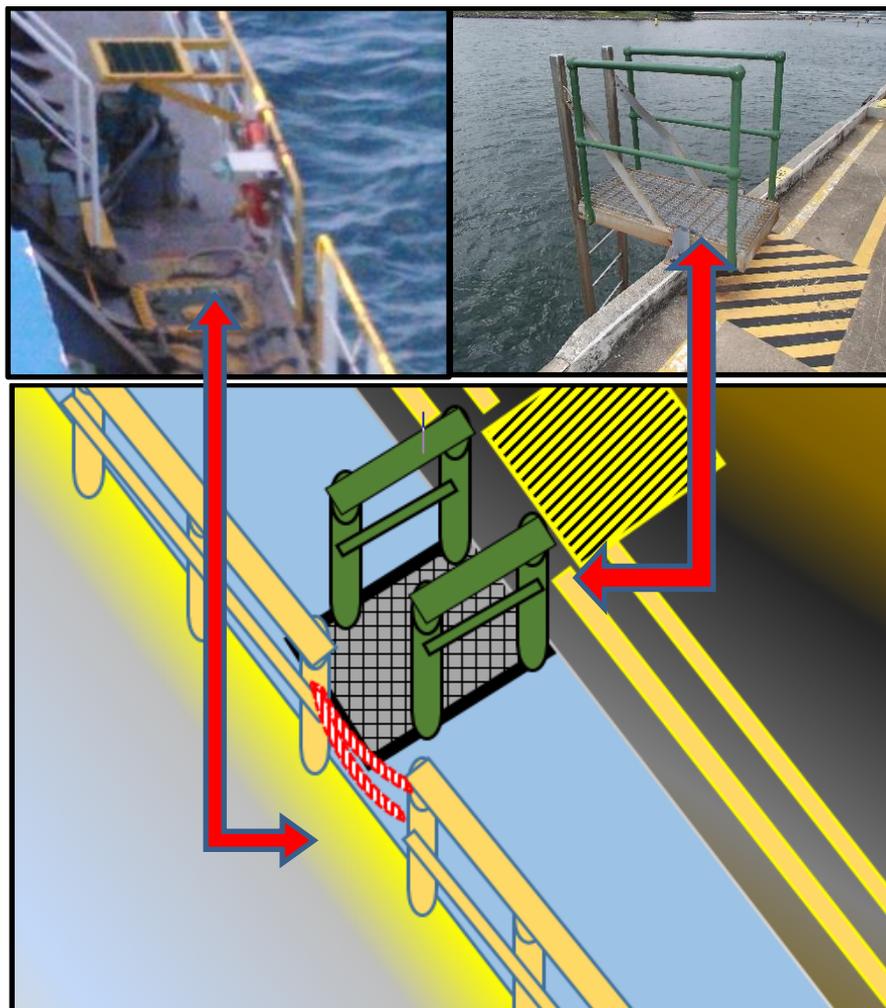
1.6.2 Additionally, the investigation team obtained the CCTV footage from the oil terminal where AQB was berthed, for the period prior to its departure. From the footage and speaking with terminal personnel, it was established that the means of access from the terminal to the ship's starboard side was by a fixed platform which was a part of the terminal jetty. The opening of this platform on that day was nearly in-line with the pilot access point located near the ship's manifold. It was further confirmed that there was a single chain on the starboard side at this pilot access point during the time AQB was berthed. Shore personnel recalled bending under this chain when leaving the AQB (see **Figure 8**).

Figure 8: Illustration of the means of access between AQB and the oil terminal with a single-chain between the openings of the railings

- 2.1.2 After analysing the CCTV footage from the oil terminal, the investigation team noted that the last shore person disembarking AQB before the vessel unberthed, was seen to bend under the height of the railings when moving to the fixed platform (ashore) at the location of the pilot access area.

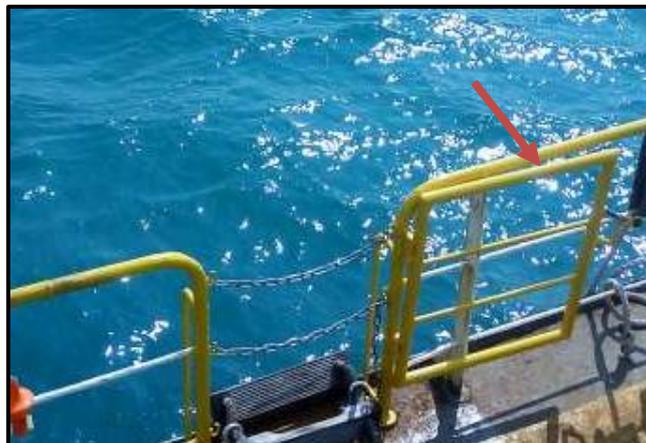
Figure 9: Red arrow showing hinged swing-gate installed on board AQB
(Source: MTM)

- 4.1.4 Installation of hinged swing gates (see **Figure 9**) with the strength equivalent to the railings at the earliest opportunity. Introduction of new checklist to be implemented for anti-piracy with reinforced steel doors and grilled gates at the accommodation, in lieu of reducing the need to surround the vessel perimeter with razor wire, less poop deck.
