# **FINAL REPORT**

## **CREW MISSING AT SEA FROM THE CONTAINER SHIP CEZANNE ON 15 JANUARY 2019**

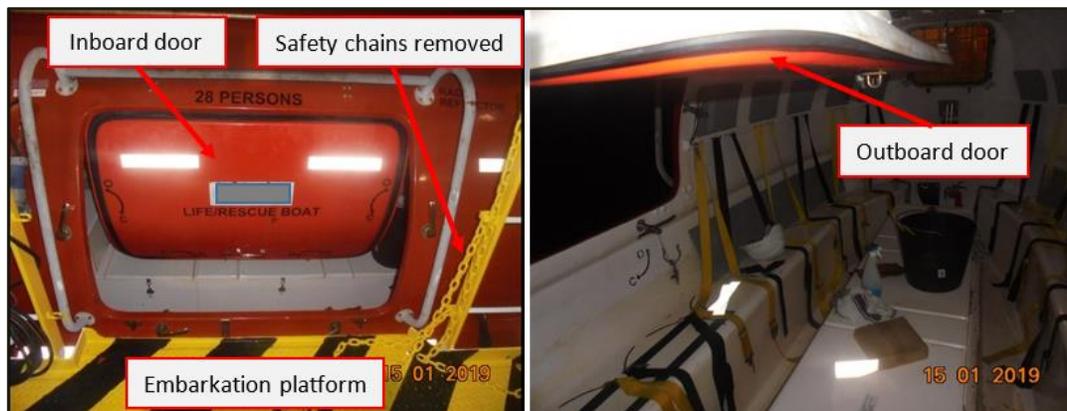
Figure 1 – View of both doors, photo taken by the search team  
(Photo source: the ISM Manager)

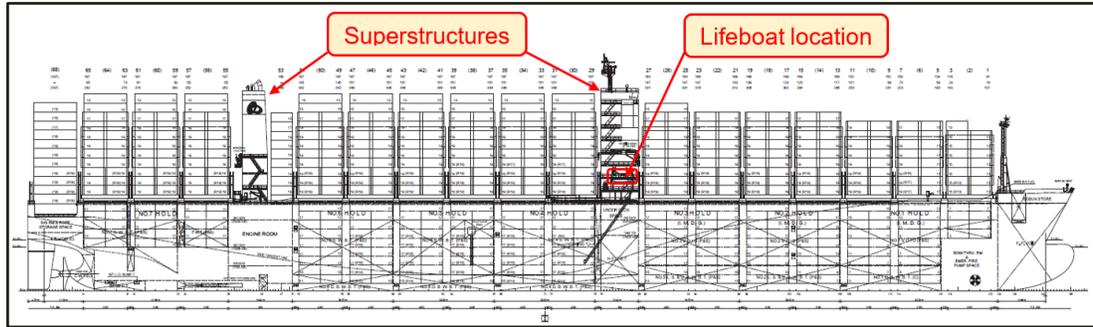
Figure 2 - General arrangement plan of Cezanne (annotated by TSIB)  
(Source: the ISM Manager)

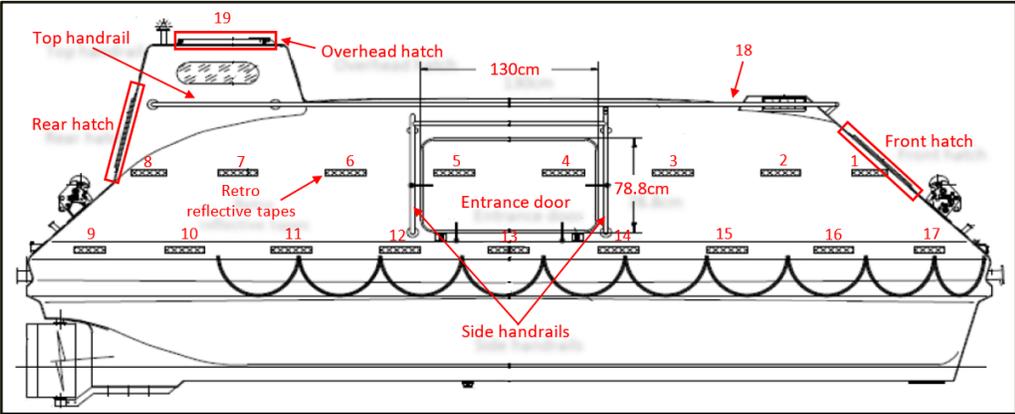
Figure 4 – Starboard side view of the port side lifeboat with annotations made by TSIB (Source: ISM Manager)

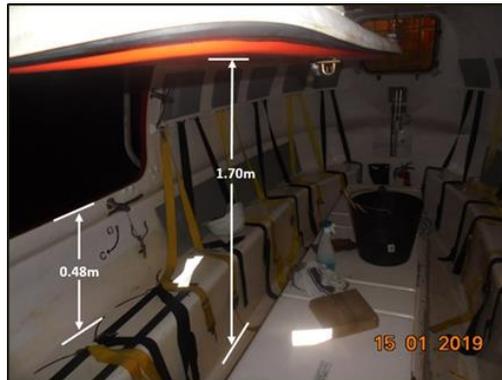
Figure 5 – Port side lifeboat internal height measurement  
(Photo source: the ISM Manager)

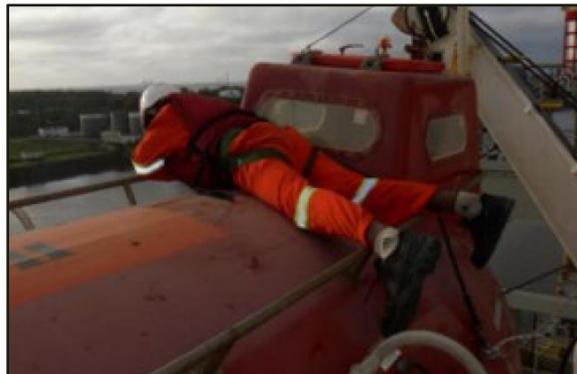
Figure 6 - Ship's crew replacing outboard retro-reflective strips in May 2018 in port  
(Photo source: the ISM Manager)

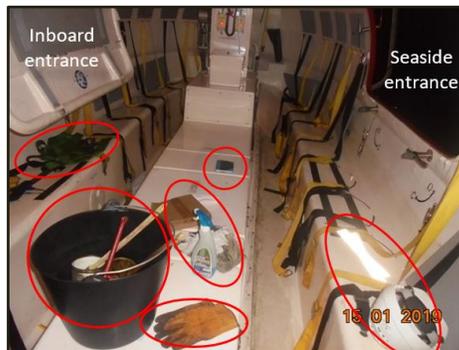
Figure 7 - Port side lifeboat internal view taken from the forward part of the lifeboat  
(Photo source: the ISM Manager)

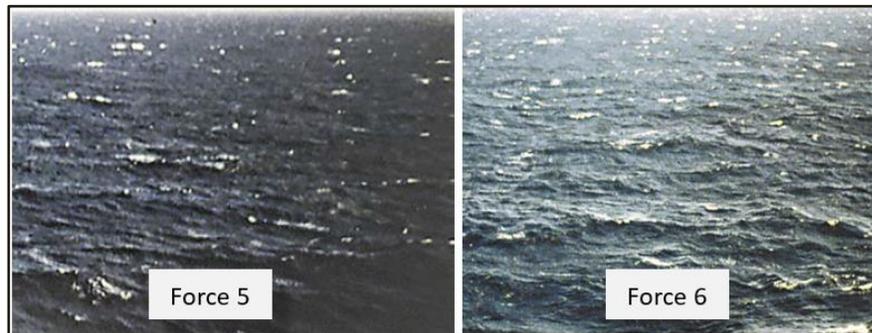
Figure 8 - Illustration of sea state at Beaufort scale of wind force  
(Source: The Mariner's Handbook, NP100)
