FINAL REPORT

**SINKING OF
SUPPLY VESSEL
OCEAN COOPER 2
IN THE SINGAPORE STRAIT
ON 14 FEBRUARY 2019**

MIB/MAI/CAS.061

**Transport Safety Investigation Bureau
Ministry of Transport
Singapore**

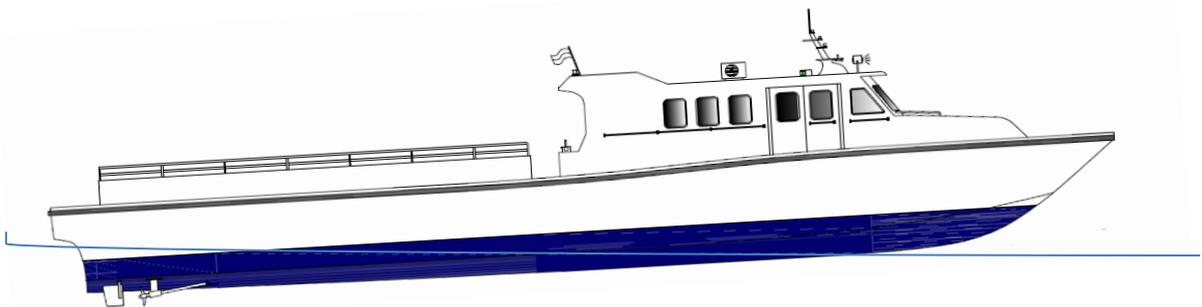
- 1.1.1 In the late hours of 13 February, 2019, OC2 departed Singapore⁸ with 16 pallets (evenly distributed over the cargo deck), to be delivered to the Polaris Melody (PM). With a tentative estimated time of arrival (ETA) of 0300H on 14 February 2019 to the rendezvous location⁹, OC2 navigated with an approximate speed of 7 knots¹⁰. At this speed, according to the skipper¹¹, the stern of OC2 would be between 0.5m to 0.7m above the waterline (illustrated in **Figure 1**).

Figure 1: An illustration of OC2's position relative to the waterline (blue) with 16 pallets at the speed of about 7 knots – *not to scale*

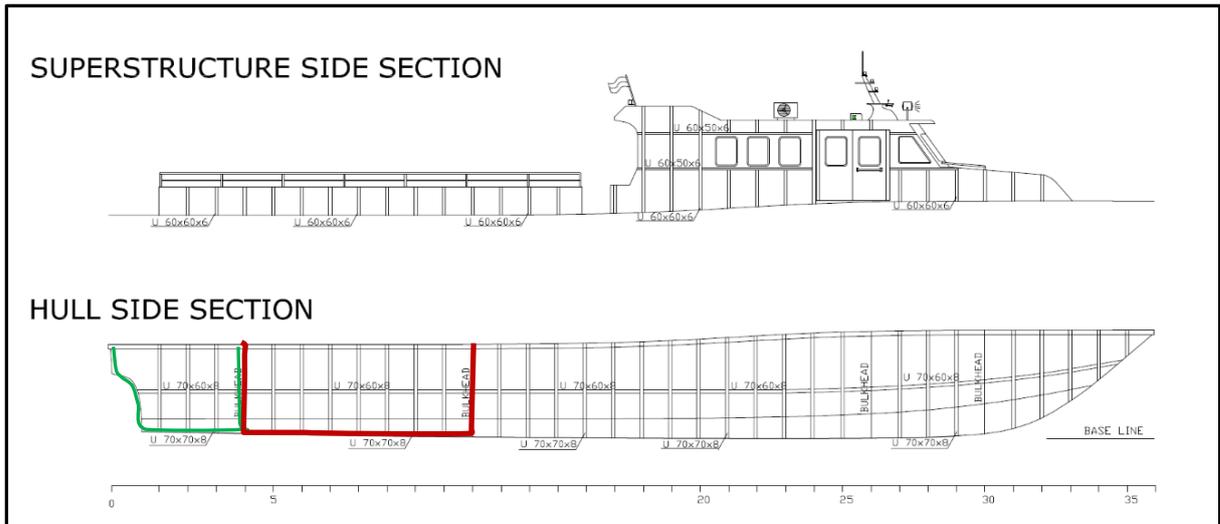
- 1.1.5 The skipper instructed the engineer to check and to also start the bilge pump¹⁴ for the engine room compartment¹⁵. The engineer first went out of the superstructure to open the manhole cover (flushed with the main deck) for the steering gear compartment (see **Figure 2** – annotated in green), and observed that steering gear compartment had a breach, and that sea water had completely filled up the space.

Figure 2: OC2's layout with Fr. numbers marked on the scale at the bottom

- 1.1.6 On inspecting the engine room compartment (annotated in red in **Figure 2**) which was separated by a watertight bulkhead from the steering gear compartment, the engineer observed that sea water was entering the space from the starboard corner through the exhaust fan¹⁶ (see **Figure 3**). OC2 had 36 frames (Fr.). The steering gear compartment¹⁷ was from Fr. 0 to Fr. 4 and the engine room compartment was from Fr. 4 to Fr. 12

5.1.1 To implement a process of checking the compartments below the waterline at a regular basis for early detection and intervention on vessels under its operation. **[TSIB-RM-2020-006]**

5.2.1 To implement a process of checking the compartments below the waterline at a regular basis for early detection and intervention. **[TSIB-RM-2020-009]**

5.3.1 To review the requirements of the Non-Convention regulations for the fitting of bilge high level alarms. **[TSIB-RM-2020-011]**

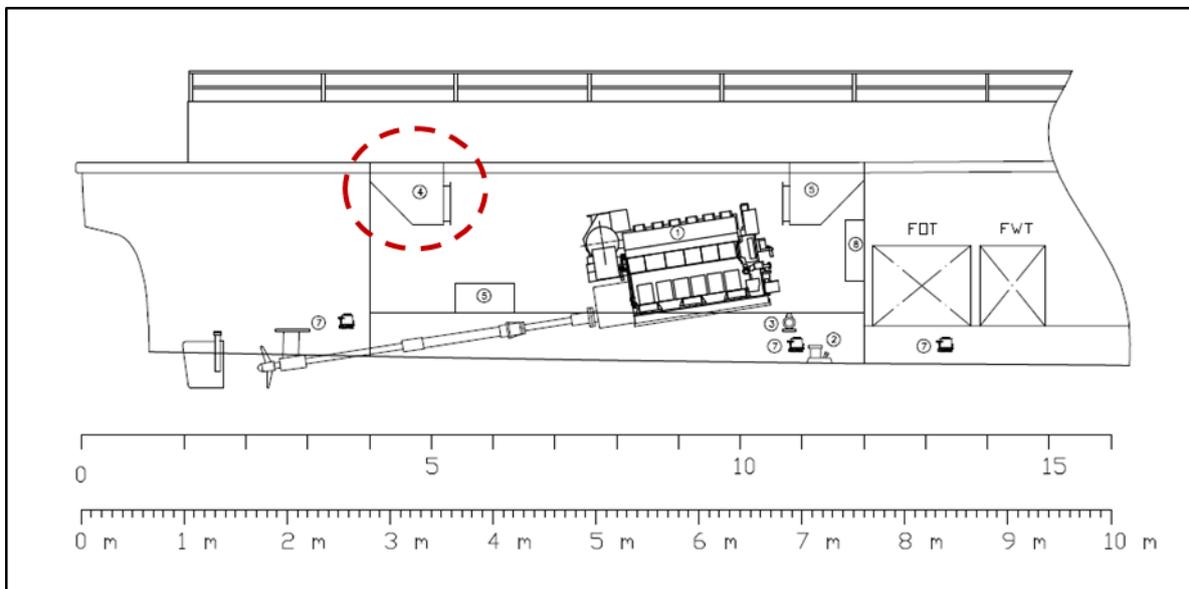
Figure 3: Starboard side view of engine room layout. Exhaust fan is circled in red.

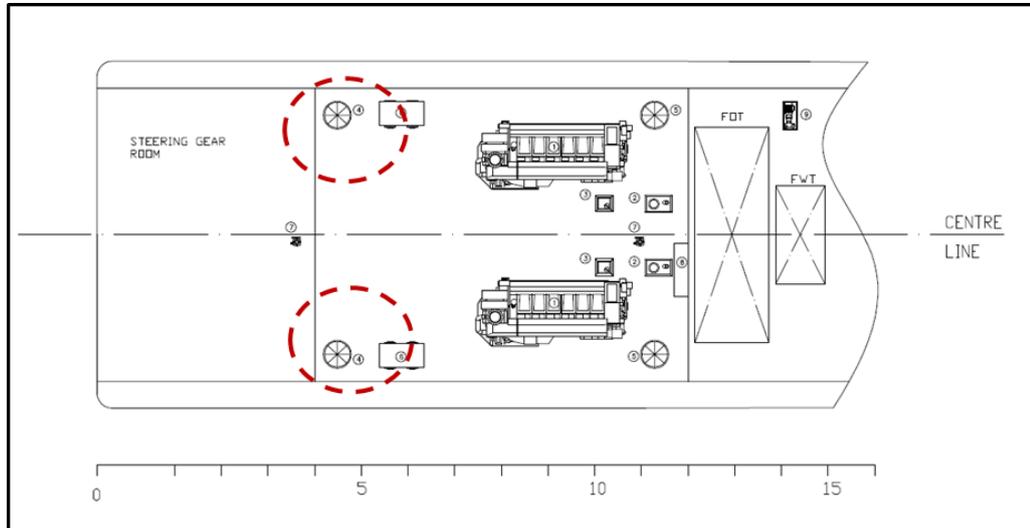
1.1.7 The exhaust fan outlet was flushed with the cargo deck as per the general arrangement plan. Photographs provided by the flag Administration indicated that the outlet(s) were covered by wooden dunnage (typically used to protect cargo). See **Figures 4a and 4b**.

Figure 4a: Plan view of engine room compartment layout. Exhaust fans are circled in red.

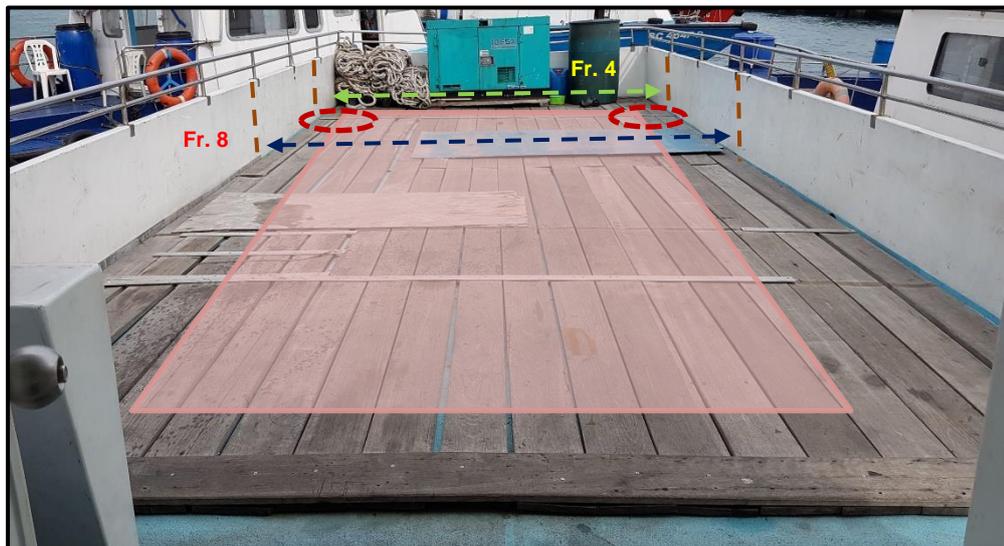
Figure 4b: Photograph taken looking aft towards the cargo deck (annotated by TSIB with approximate cargo which extended across the cargo deck till the aft– *not to scale*). Location of exhaust fans are circled in red. Cargo was evenly distributed till Fr. 4

1.1.8 Green dashed line in **Figure 4b** indicates the approximate location of the watertight bulkhead separating the steering gear compartment and engine room compartment (at Fr. 4) below the cargo deck.

2.3.3 Though the exhaust fans were flushed with the main deck and situated under the wooden dunnage to maximise cargo space, considering the possibility of a flooded compartment causing the stern to sink closer to the waterline, additional risk mitigating measures should be considered for such vessels, to prevent an ingress of water into the engine room compartment.

- 3.2 The consequent increase in OC2's aft draught caused sea water to enter the engine room compartment from the two exhaust fan openings which were flushed with the main deck. By the time the crew noticed the problem, the water ingress was much more than the bilge pumps could have handled, despite the crew of OC2 using a portable pump from Jolly Rachel, and eventually resulted in the crew abandoning the vessel.

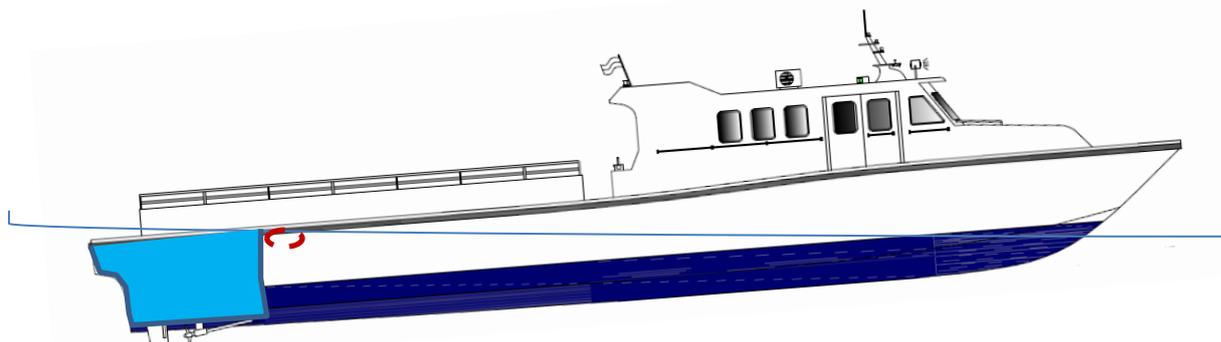
Figure 6 – Illustration of the stern's position according to the skipper – *not to scale*

- 2.1.4 The reasons for the breach of the steering gear compartment of OC2 (indicated by blue in the figure above) could not be established during the period of OC2's departure from Harbourfront Centre and its location while waiting for PM to arrive.
- 2.1.5 With an estimated volume of 17 cu.m, the steering gear compartment would possibly contain an added weight of at least 15T²⁷ which would have further reduced the freeboard²⁸. It is likely that by this time, sea water would have likely made its way nearer to the location where the exhaust fans were situated (under the dunnage) and entered the engine room compartment, eventually disabling the vessel and causing it to sink.
