FINAL REPORT

FATALITY OF STEVEDORE ON BOARD CAROLINE MAERSK IN PORT OF BUENAVENTURA, COLOMBIA ON 16 JULY 2019

MIB/MAI/CAS.069

**Transport Safety Investigation Bureau
Ministry of Transport
Singapore**

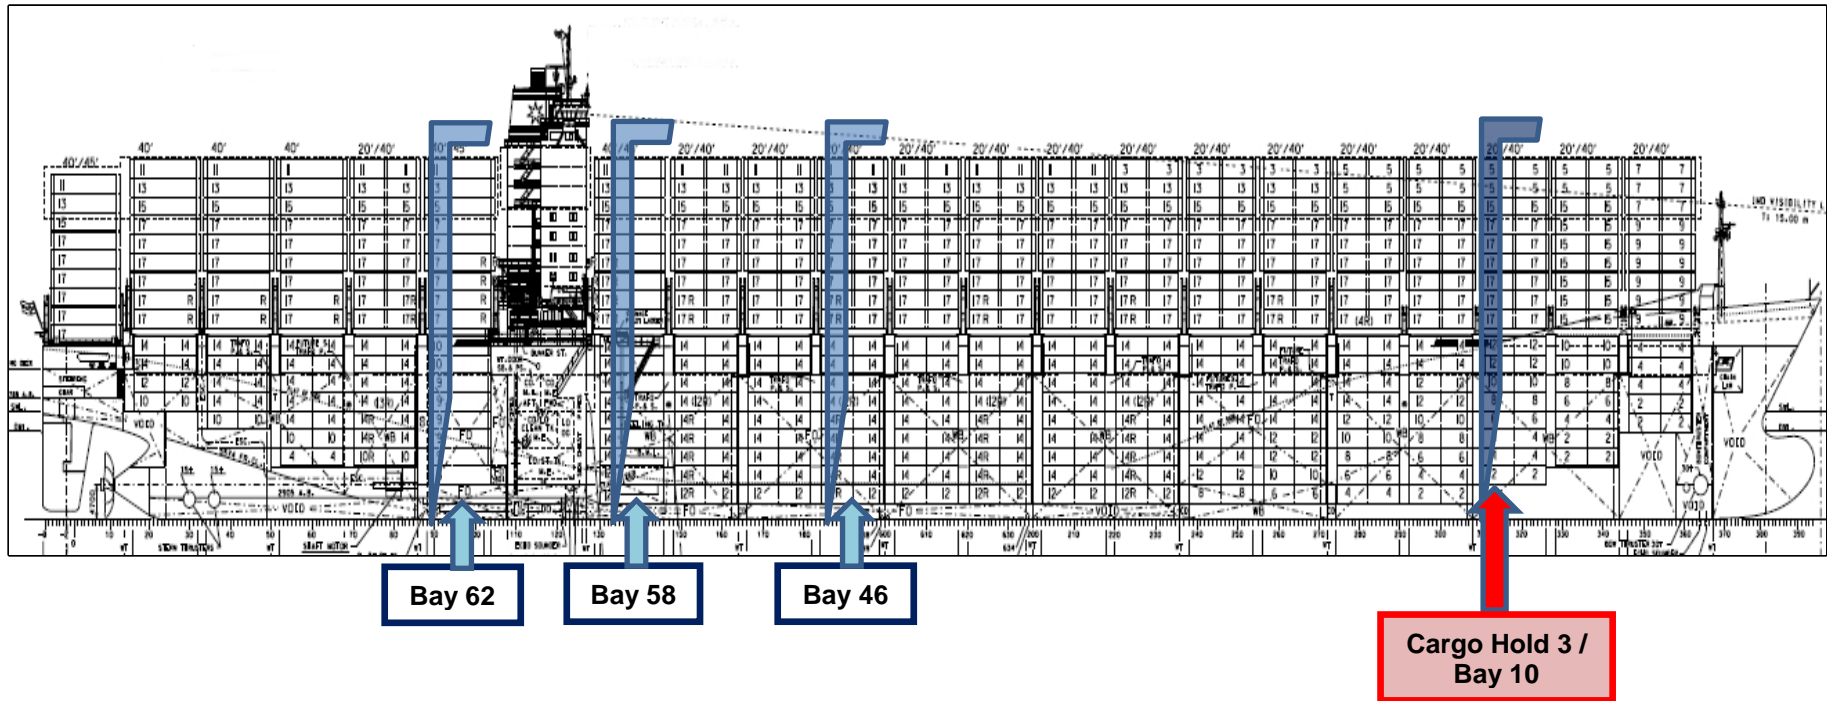
1.1.2 Between 1610H and 1915H, several shore personnel boarded the vessel for various purposes, i.e. immigration, quarantine matters, security checks, as well as operational matters, i.e. agents, cargo planners and stevedores³. Two stevedores embarked at about 1913H as cargo watchmen for the terminal crane operators and for assisting the terminal's cargo planner. One of them was at Bay 10 (cargo hold no. 3) to assist the crane operator for discharging the cargo. Four gantry cranes were in use for carrying out discharging and loading operations, at the respective bays (see **Figure 1**).

Figure 1: Starboard profile of CRM from the G.A. Plan. The positions of the gantry cranes (in blue) and the locations of the bay/ cargo holds where the incident occurred indicated in red (annotated by TSIB)

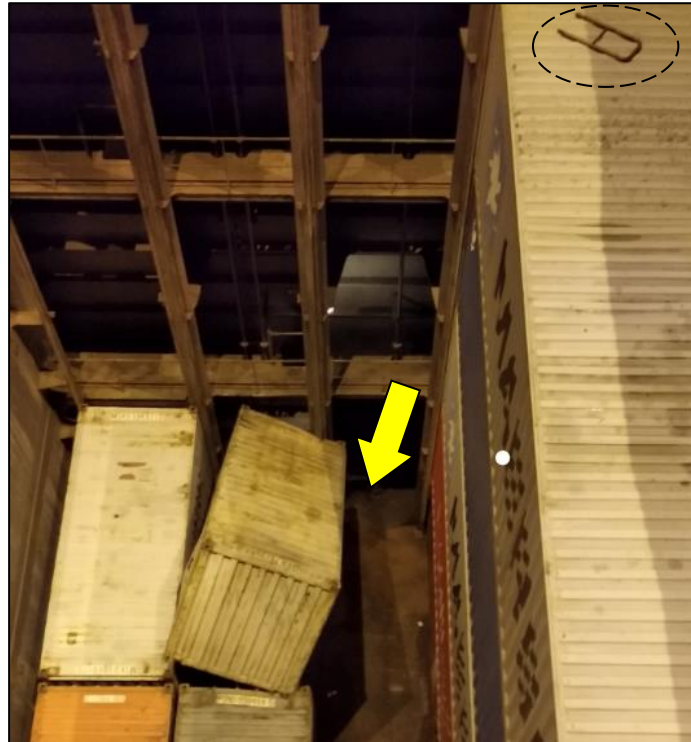
1.1.4 At the gangway, the cargo planner informed the 3O that one of the containers being discharged had fallen from the gantry crane's spreader back into the no. 3 cargo hold at bay 10 (see **Figure 2**).

- 1.1.5 The 3O took a camera from the gangway area and walked towards the bay together with the cargo planner to inspect. At about 2207H on arriving the location, the 3O noted⁴ that at the bottom of the cargo hold was a motionless body of a stevedore (indicated by a yellow arrow). A broken section of a railing was observed on top of another container, lying next to a clipboard with some papers.

Figure 2: Photograph taken on site indicating the fallen container and the approximate location where the stevedore was found

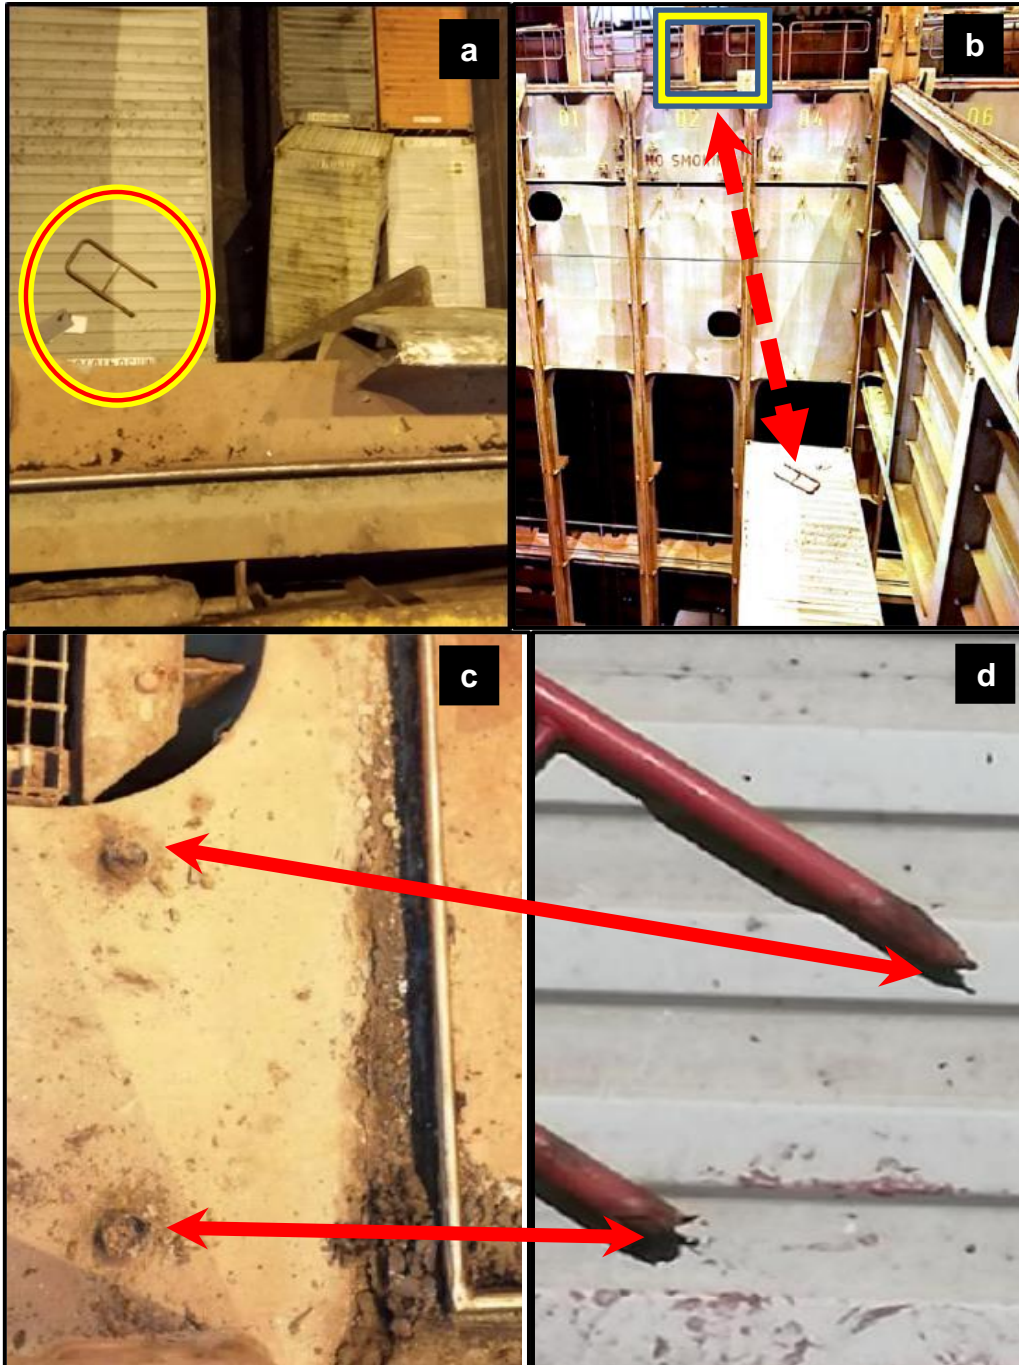
- 1.1.8 Together with the local authorities, the Master and CO went to the cargo hold. The railing that was noted to be on top of the container, was established to be from the cross-deck walkway, vertically in-line with the dropped container (See **figure 3**). The clipboard was confirmed belonging to the deceased. There were no witness accounts to the stevedore's fall. The height from the main deck to the location where the clipboard and railing was found was estimated to be 4 metres and to where the stevedore was found was estimated to be 20 metres.

Figure 3: (a) The location of the discovered clipboard and broken railing, with the fallen container in no. 3 cargo hold.
(b) The original position of the broken railing along the cross deck.
(c) and (d) the remaining parts of the broken railing on the cross deck

2.1.2 Noting the poor condition of the railing and that there were no warning signs (relating to the condition) or temporary safeguards put in place to warn personnel in the vicinity, it was plausible that the stevedore was unaware of the structural condition of the railing. The stevedore's action to lean over the railing would have likely caused the railing to give way, resulting in the fall into the cargo hold.

- 3.1 The fatal occurrence was highly likely due to the stevedore leaning on a corroded safety railing which gave way, while looking into the cargo hold to assess the condition of a fallen container.

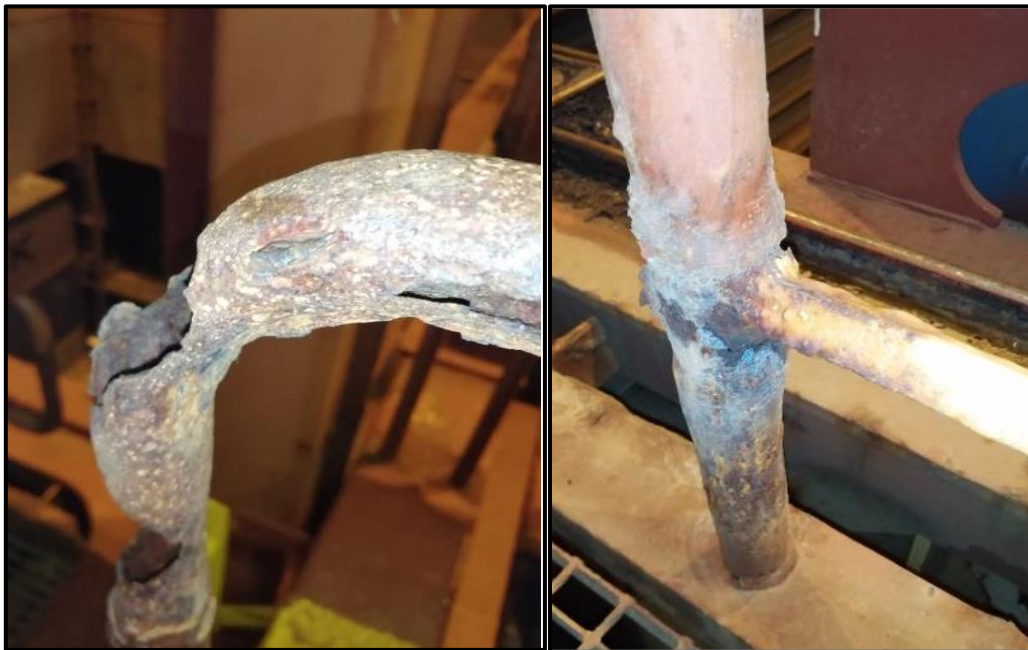
1.4.2 The surveyor's report listed several similar conditions of the railings at other cargo holds onboard CRM indicating localised corrosion (see **Figure 4**). The report concluded with the recommendation¹² for the broken railing to be repaired by 13 October 2019.

Figure 4: Some of the corroded and holed railings found along the catwalks and cross decks

- 4.1.1 Revised the scope and priorities of repair plans in accordance with condition reported for considerations of deploying riding repair teams. Repair works reflected in the occasional survey report were completed on 19 November 2019.

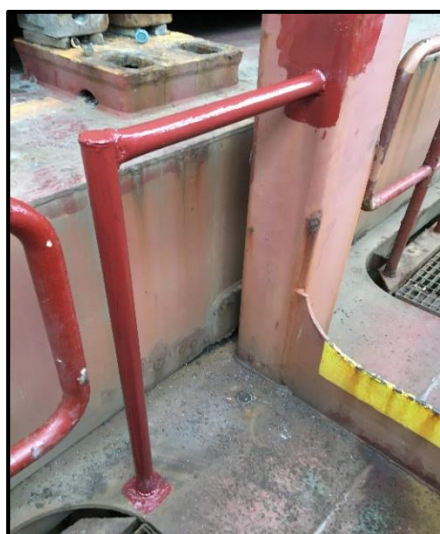
Figure 6: New installation of railing at cargo hold no.3
(Source: ZEABORN SHIP MANAGEMENT GMBH & CIE. KG)

- 4.1.5 All the corroded safety railings at the cargo bays onboard CRM replaced.
