# **Final Report**

## **MAN OVERBOARD FROM GREEK REGISTERED BULK CARRIER ANGELIC GLORY AT EASTERN SPECIAL PURPOSE ANCHORAGE, SINGAPORE ON 23 OCTOBER 2019**

MIB/MAI/CAS.074

Transport Safety Investigation Bureau  
Ministry of Transport  
Singapore

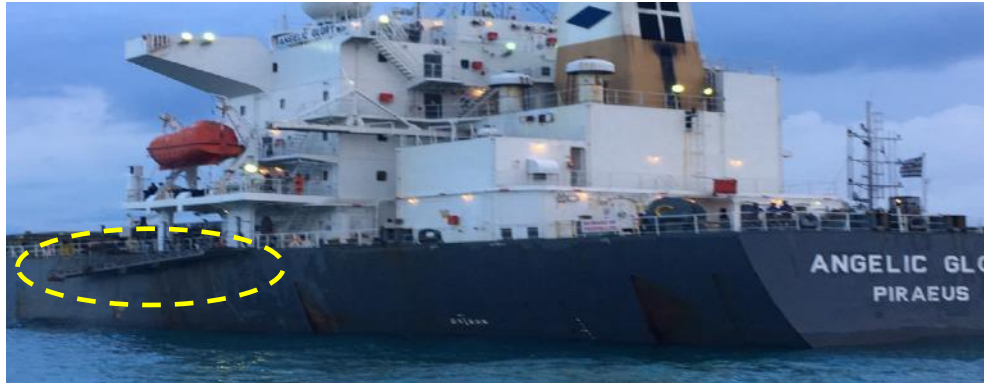
commenced<sup>8</sup> their descent with the Supervisor first in line. One able seafarer deck (ASD-1), who held the remote control of the accommodation ladder stood on the main deck, had a clear view of the bottom platform of the accommodation ladder.

Figure 1 – Port side accommodation ladder – *Annotations by TSIB*

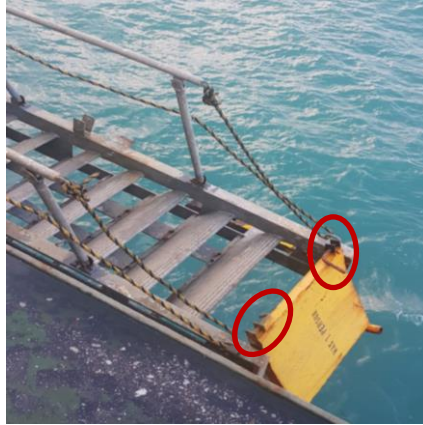
- 1.1.5 By the time the LS was making its approach, the ASD-1 and the technicians (two of whom were standing on the steps of the accommodation ladder) recalled that the Supervisor was standing on the bottom platform. Recalling further that the sea condition<sup>9</sup> was a bit choppy, the ASD-1 noted that the bow of the LS briefly touched the bottom platform. Within a split second, the bottom platform tilted downwards, causing the Supervisor to fall into the sea (see **figure 2**).

Figure 2 – Tilted bottom platform at the hinges and locations of locking pins (circled in red) – *Annotations by TSIB*

2.1.1 The Supervisor was standing on the bottom platform when the launch boat was approaching and fell into the sea when the bottom platform tilted downwards after being contacted by the launch boat. Post incident verification of the locking pins revealed no damages nor deformation of the pins and hence the failure of the locking pins was ruled out. It is likely that the locking pins had dislodged from the slots causing the bottom platform to tilt downwards.

2.1.3 The AG was 20 years old at the time of occurrence and local repairs may have been carried out for worn out fittings, such as the fabrication of the locking pins. However, as there is safety impact on proper locking of the bottom platform, it would have been desirable for the locking pins to either be procured from the manufacturer or if needed to be fabricated, to be as per the original specifications. This is to ensure that the replaced locking pins are fit for purpose and able to withstand the conditions under which the ladder was tested.

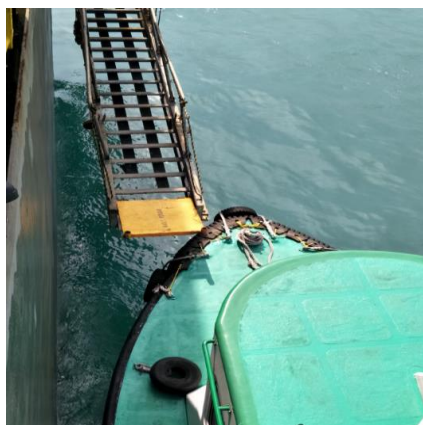
- 1.2.1 When the Supervisor was about to transfer from the accommodation ladder to the LS, the LS made a 'touch' contact with the bottom of the accommodation ladder in order to minimise the gap between LS and the accommodation ladder to allow the Supervisor to safely cross over to the bow of LS (see **figure 3**). Just about this time, the bottom platform (painted yellow) of the accommodation ladder tilted down causing the Supervisor to fall into the sea.

Figure 3 – Illustration of LS approaching the accommodation ladder before the occurrence – Simulated (according to the skipper’s account) during TSIB’s visit on the AG after the occurrence

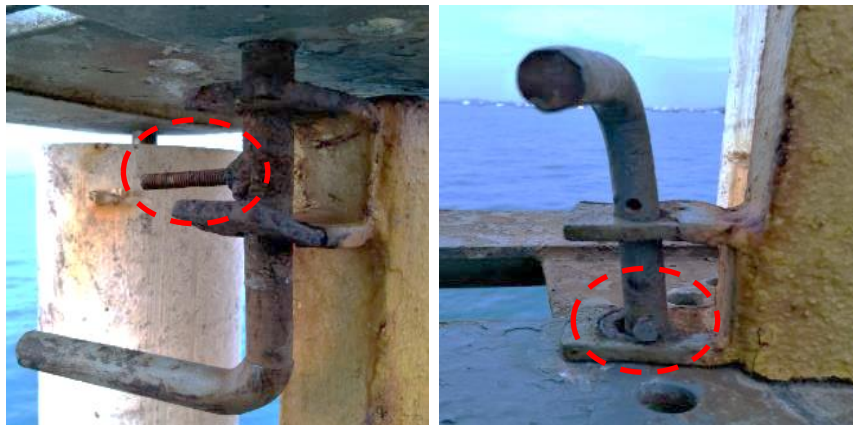
1.6.3 Both the locking pins of the port<sup>19</sup> accommodation ladder appeared to be in a reasonably good condition but were noted to be of a different size and type. The locking pins had a long tip each (circled in red in **figure 4**) that was essentially to prevent the locking pin from coming out of its housing position. A closer inspection of the locking pins by the investigation team indicated that the pins did not look original and may have been fabricated/modified. The fabricated locking pins did not seem to fit fully into the slots.

Figure 4 – Image on the left shows the outboard locking pin of the port accommodation ladder. Image on the right shows the inboard locking pin of the same ladder – *Annotations by TSIB.*

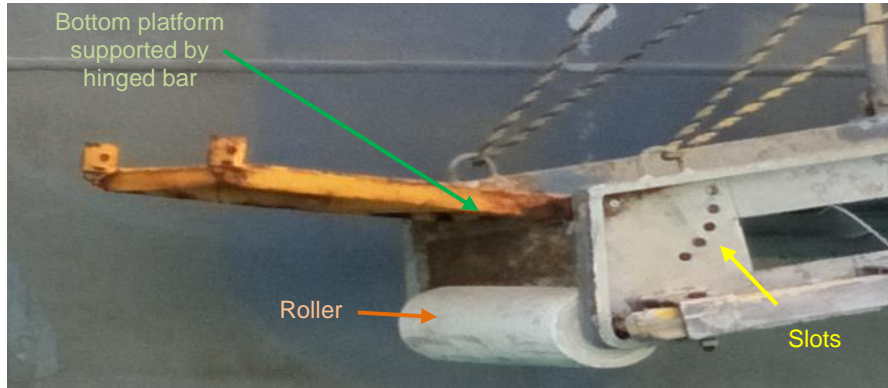
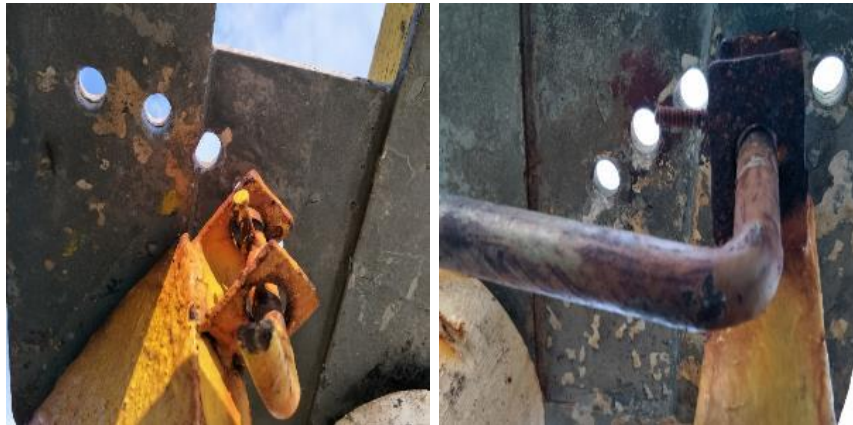
locking pins from dislodging from the slot<sup>20</sup> (see **figure 5**). It could not be established whether this design was a part of the original design that came with the accommodation ladder<sup>21</sup>.

Figure 5 – Clockwise from top – Side view of port accommodation ladder, slots for inserting the locking pin (port side and starboard side) – *Annotations by TSIB*

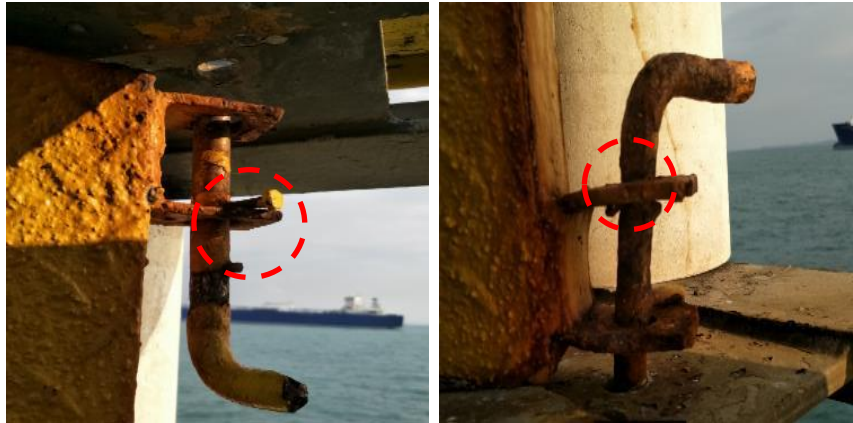
- 1.6.5 A check on the locking pins of the starboard accommodation ladder indicated that the locking pins appeared to be of a similar size, but in a poorer condition. The locking pins on this side too had a long tip each (circled in red in **figure 6**) that was essentially to prevent the locking pin from coming out of its housing. The long tips of these locking pins were shorter than those of the locking pins

Figure 6 – Image on the left shows the outboard locking pin of the starboard accommodation ladder. Image on the right shows the inboard locking pin of the same ladder – *Annotations by TSIB.*

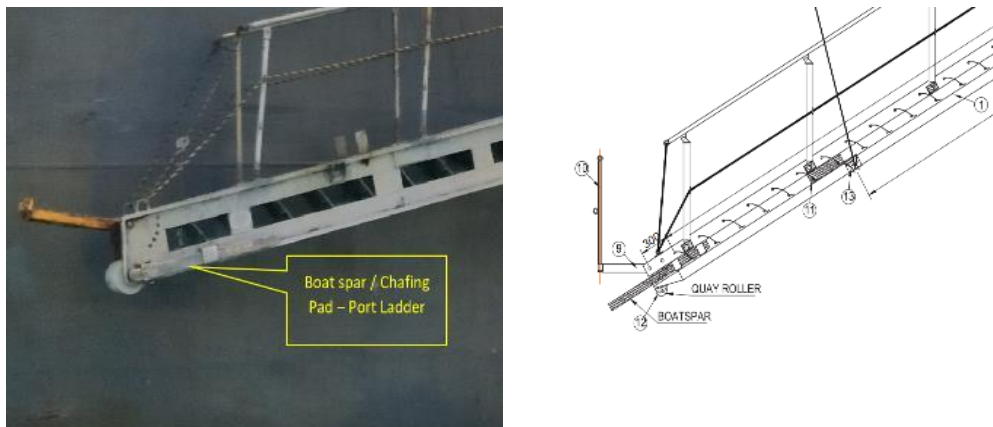
1.6.6 The accommodation ladder was fitted with a wooden fender, referred to as a boat spar / chafing pad which was typical on most designs of accommodation ladders in the marine industry (see **figure 7**). The primary purpose of the boat spar, when extended, was to allow launch boats to chafe along without directly contacting the accommodation ladder when coming alongside.

Figure 7 – Image on the left shows the boat spar of the port accommodation ladder. Image on the right shows the boat spar drawing of a typical accommodation ladder – *Annotation by TSIB*

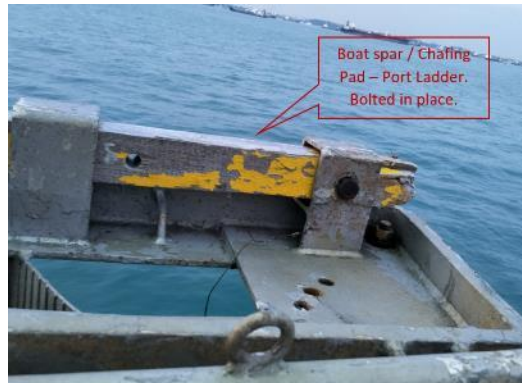
pin to be removed and the spar to be extended towards the sea. The investigation team noted that the boat spar on the AG had not been used during this occurrence. It could not be established whether this had been the practice in the past<sup>22</sup> (see **figure 8**).

Figure 8 – Boat spar of the port side accommodation ladder bolted in place –  
*Annotation by TSIB.*

- 2.4.4 As noted, by the results of the survey, the use of the boat spar / chafing pad was uncommon in the industry. This probably explains why the purpose of the boat spar / chafing pad had been underestimated on board the AG (see paragraph 1.9.2) resulting in its non-usage. While the boat spar / chafing pad may not have prevented the bottom platform from tilting downwards, as a result of the pins being dislodged, it could have reduced the probability of the boat coming close to the platform. The investigation team held the view that if the accommodation ladder is used, the boat spar / chafing pad should be extended when rigging the accommodation ladder to minimise any contact between the
