FATAL INJURY ON BOARD MATHU BHUM AT GULF OF MARTABAN ON 3 DECEMBER 2016

MIB/MAI/CAS.005

**Transport Safety Investigation Bureau
Ministry of Transport
Singapore**

13 February 2018

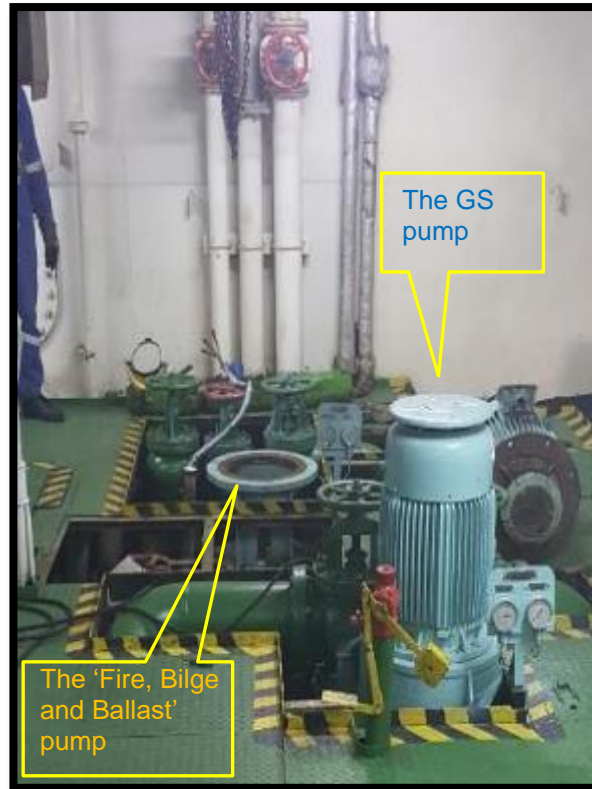
Fig.1 – FBB pump at engine room bottom platform

1.1.2 At about 0800H, the Second Engineer (2E) instructed the Fourth Engineer (4E) to open up the Fire, Bilge and Ballast (FBB) pump (see **Figure 1**), located at the bottom platform of the engine room¹, to take some photographs of the pump's condition for submission to the vessel's Class society for assessment under the Continuous Survey of Machinery (CSM) programme². A crew member, an Oiler³ (OL), was assigned to assist 4E.

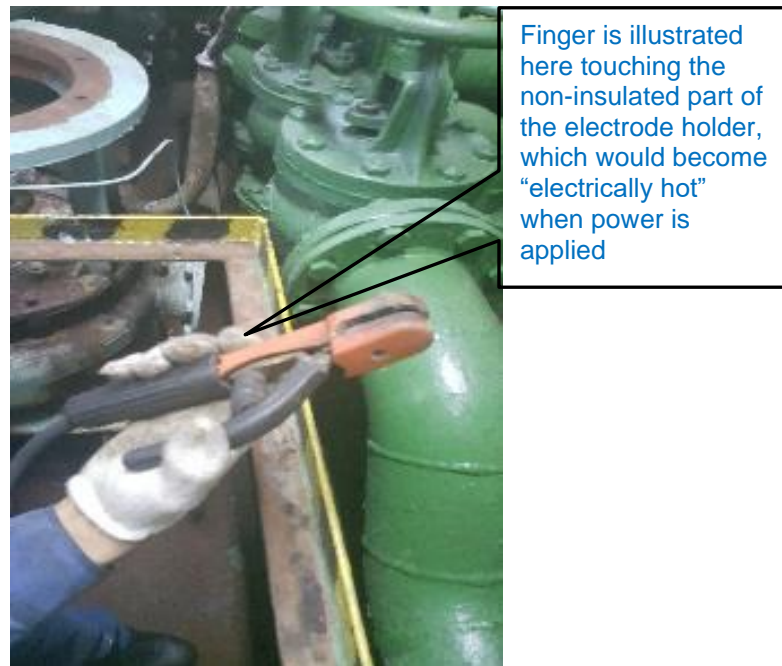
Fig. 4 – Illustration of how 4E was holding the electrode holder

- 1.1.13 At the FBB pump, OL heard 4E shouted suddenly that he was being electrocuted. At that time the 4E's hand was on the non-insulated part of the electrode holder (see **Figure 4**).

- 4E's wet right hand's contact with the "electrically hot" part of the electrode holder (see Fig. 3 in paragraph 1.1.13); and
- 4E's left leg's contact with the foundation of the FBB pump's base²².

- 2.2.4 The electrode holder was not very well maintained. While this condition did not affect its operational capability, the “electrically hot” parts of the holder contributed to the occurrence, when 4E inappropriately held the holder with wet cotton gloves.

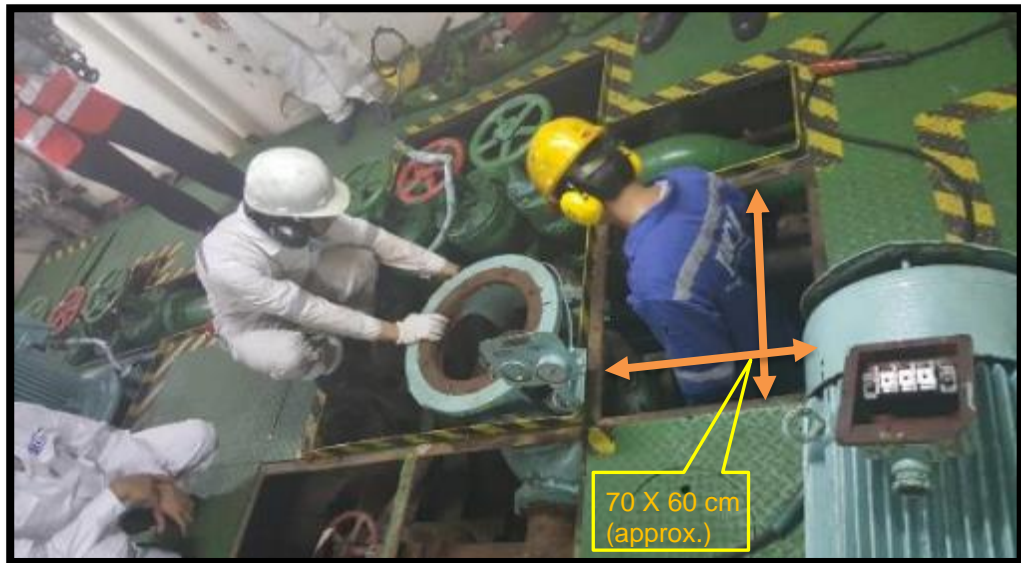
Fig. 6 – Illustration of the workspace around the FBB pump

- 1.2.3 As the pump base foundation sat on the engine room tank top, access for maintenance work was limited (see **Figure 6**).

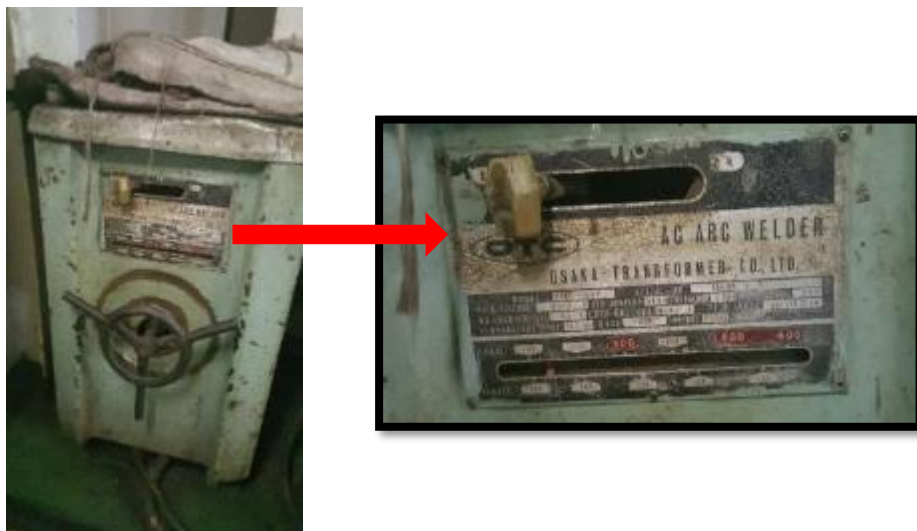
*Fig. 7 – (Left) Welding machine on board Mathu Bhum
(Right) Welding machine name plate*

- 1.3.1 The alternating current (AC) arc welding machine on board Mathu Bhum was made by Osaka Transformer Co. Ltd. in 1974. It had been on board since the delivery of the vessel.

- 1.3.5 The AC supply to the welding machine was stepped down to a lower voltage through a transformer. It had a Non Load Voltage¹⁰ of 80 volts as indicated on the welding machine name plate.

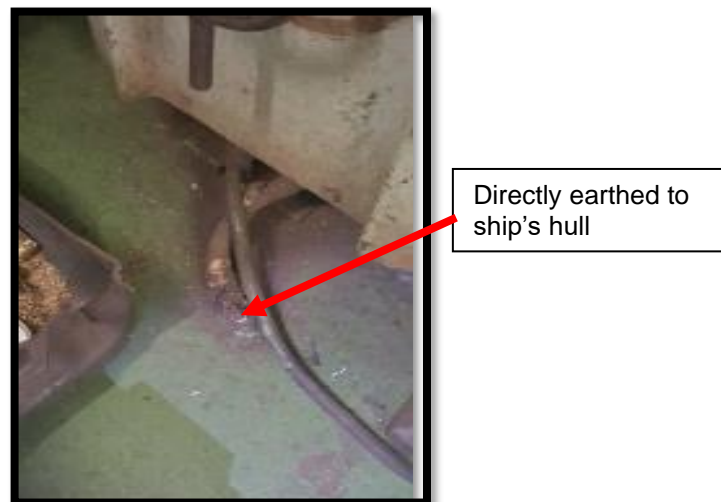
Fig.9 – Earthing of welding machine

1.3.3 However, the welding machine set-up on board Mathu Bhum was different from a typical welding machine set-up in that the machine was earthed directly to the ship's hull (see **Figure 9**), thus dispensing with the need of using a welding clamp to clamp the workpiece and then earthing the work piece.

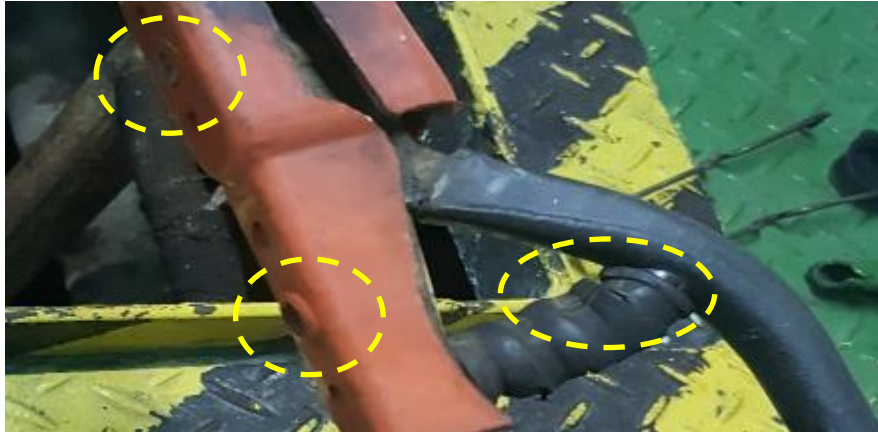
Fig. 11 – Welding electrode holder

- 1.3.8 Inspection of the machine post-accident showed that while the welding electrode holder's insulated handle was intact, certain parts of the holder were not well maintained - a couple of screws were not recessed or missing, and the sheath was cracked in some areas (See **Figure 11**).
