Final Report

Man Overboard

Lanpan 35

MIB/MAI/CAS.053

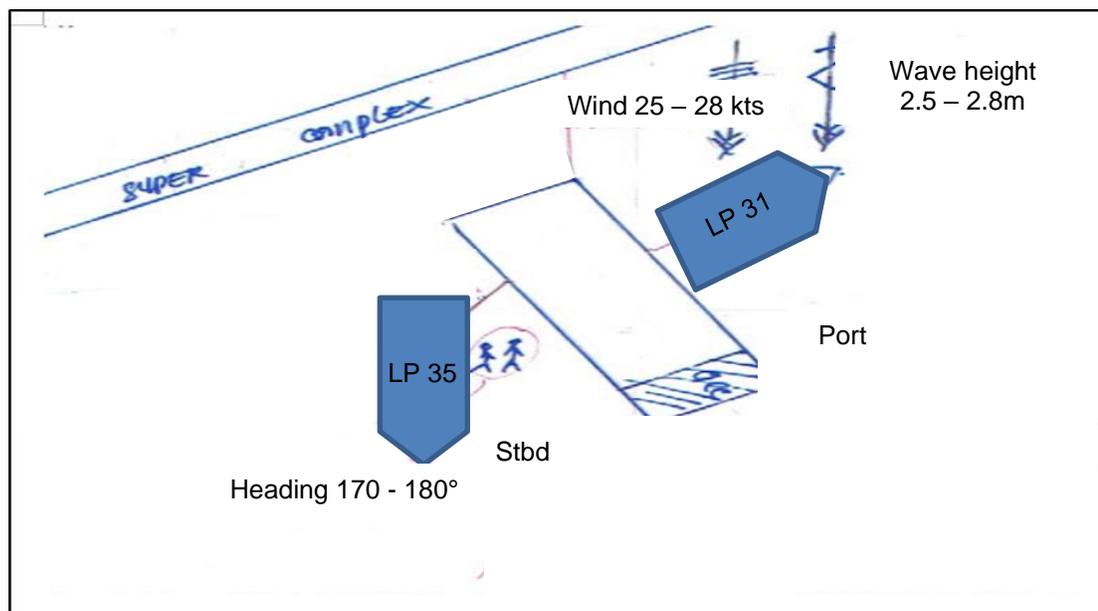
Figure 1 – Illustration of diagram representation provided by the Master of LP 35 showing the towing lines arrangement to HD-2500 – not to scale – annotated by TSIB

1.1.3 By about 1335H, LP 35 was connected to the barge using a line from LP 35's aft mooring deck. At about 1625H, another tug, Lanpan 31 (LP 31) arrived and connected her tow line to the HD-2500's port side. See illustration of arrangement according to the Master of LP 35 in figure 1.

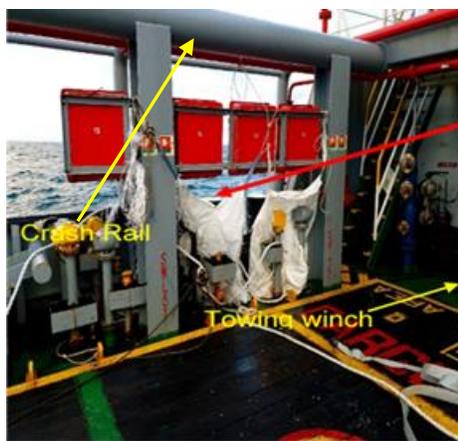
Figure 2a – Location of occurrence viewed from main deck – annotated by TSIB

1.1.6 The 2O was not aware of or informed that these four persons would be on deck. Once on deck, the CO noted that the lashings of the mooring ropes had come off from the support of the crash rail. The CO instructed the crew to secure the ropes on the bulwark⁵ (main deck). The ASD-2 recalled standing behind the staircase near the towing winch at that time (see **figures 2a** and **2b**).

Position where the CO and BSN were prior to the occurrence. The ASD-1 was standing next to them while the ASD-2 was standing behind the towing winch.

1.1.7 At about 1818H, both ASDs saw a wave wash over the main cargo deck suddenly causing the CO and BSN to be swept overboard. According to the Master's incident report, the weather conditions at that time were:

- 5.1.1 To ensure means of installing lifelines for crew usage when going on deck. **[TSIB-RM-2021-001]**
- 5.1.2 To include in the personal protective equipment matrix the requirement of donning an approved personal flotation device when working on deck, regardless of the weather condition. **[TSIB-RM-2021-002]**
- 5.1.3 To ensure proper training is carried out for the crew on the risk assessment process, especially in interpreting the risk matrix table, and implementing suitable control measures. **[TSIB-RM-2021-003]**
- 5.1.4 To review the definition of 'heavy weather' in the SMS as either a condition of wind force or wave height, in view of the low freeboard of an AHT, for the safety of the personnel on board. **[TSIB-RM-2021-004]**
