Final Report

B737-300, Registration PK-YGW Runway Incursion, Singapore Changi Airport

TIB/AAI/CAS.196

Transport Safety Investigation Bureau
Ministry of Transport
Singapore

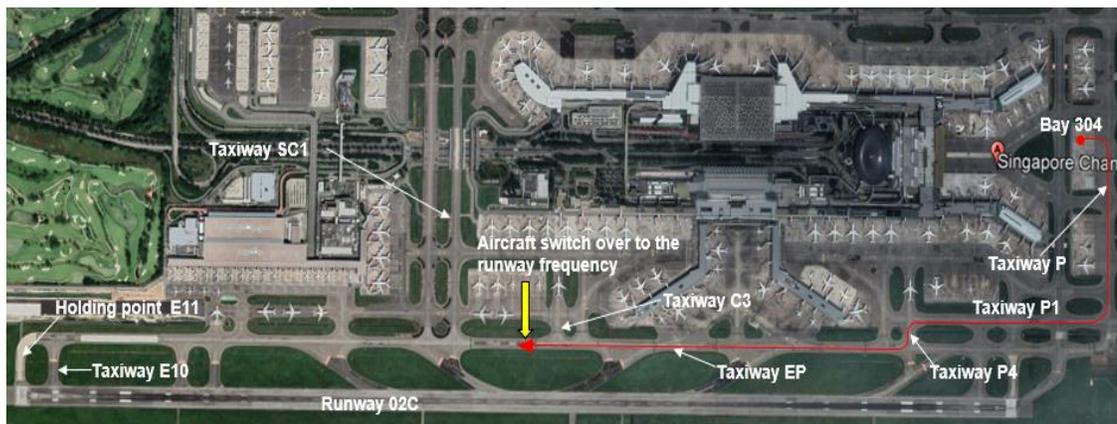
1.1.3 TMG019 was pushed back from Bay 304 at 0726LT. When the aircraft was ready for taxi, the flight crew requested for their taxi instructions from the Ground Controller. The Ground Controller instructed the flight crew to taxi via Taxiway P, Taxiway P1, Taxiway P4, Taxiway EP and to hold before Taxiway South Cross 1 (SC1) (see **Figure 1**).

Figure 1: Overview of TMG019's taxi route from Bay 304, holding short of Taxiway SC1 (Source: Google Earth, annotated by TSIB)

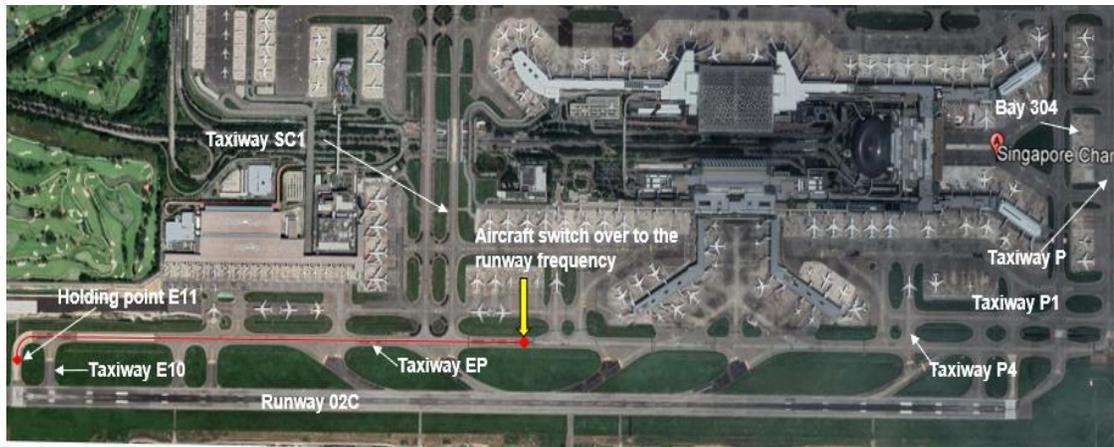
- 1.1.5 The Runway Controller then issued the instruction “TMG019 Singapore Tower ... continue holding point E11 hold short Runway 02C” to direct the flight crew to continue taxiing to the holding point of Runway 02C at Taxiway E11 and hold short of Runway 02C (see **Figure 2**).

Figure 2: Overview of TMG019’s taxi route continuing from Taxiway EP (near SC1) to holding point on Taxiway E11 (Source: Google Earth, annotated by TSIB)

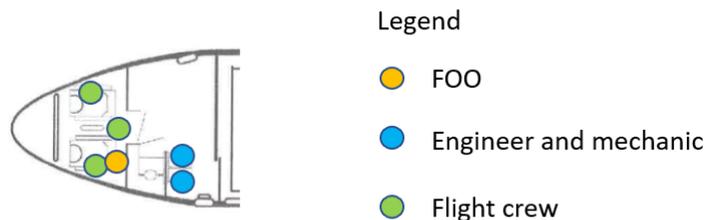
Figure 3: Aircraft seating arrangement

1.5.2.1 The cockpit has two pilot seats and two observer seats. There is a two-man seat at Door 1 Left outside the cockpit. During the taxi, the seating arrangement of the six people on board was as follows (see **Figure 3**):

- (a) PF was in the left pilot seat and PM was in the right pilot seat.
- (b) The AFCM was seated at the observer seat behind the control stand. The FOO was seated at the observer seat to the left of AFCM and behind the PF.
- (c) The Flight Engineer and the Mechanic were seated at the two-man seat⁹ at Door 1 Left.

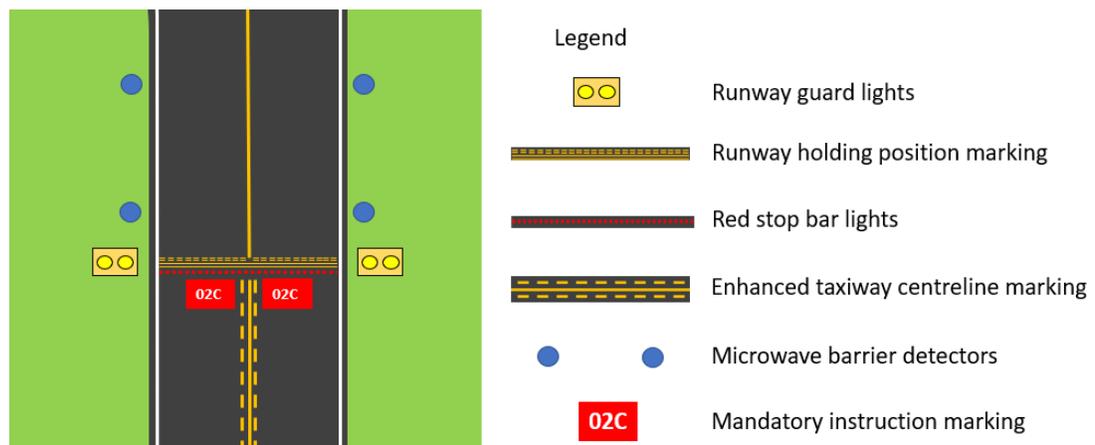
1.8.1 All taxiways leading into a runway have each in place a holding point. The holding point has the following features (see **Figure 4**) as visual aids to prevent runway incursions:

- (a) There are runway holding position marking and mandatory instruction marking on the ground across the taxiway.
- (b) There are red stop bar lights embedded on the ground at the runway holding position marking.
- (c) There are runway guard lights on each side of the taxiway.
- (d) There is enhanced centre taxiway centreline marking to visually warn flight crew that the aircraft is approaching the runway holding position marking and should be prepared to stop unless the aircraft has been cleared to enter the runway.
- (e) The MBDs are positioned a short distance beyond the red stop bar lights and runway holding position marking.

Figure 4: A typical holding position (*not to scale*)

1.8.3 In this incident, the red stop bar lights and runway guard lights were illuminated, the MBDs were active, and all the markings at the holding position were visible. There were no reported faults as regards the red stop bar lights and MBDs.
