# **Final Report**

## **RUNWAY INCURSION BY A CRANE VEHICLE AT CHANGI AIRPORT**

**24 OCTOBER 2021**

TIB/AAI/CAS.201

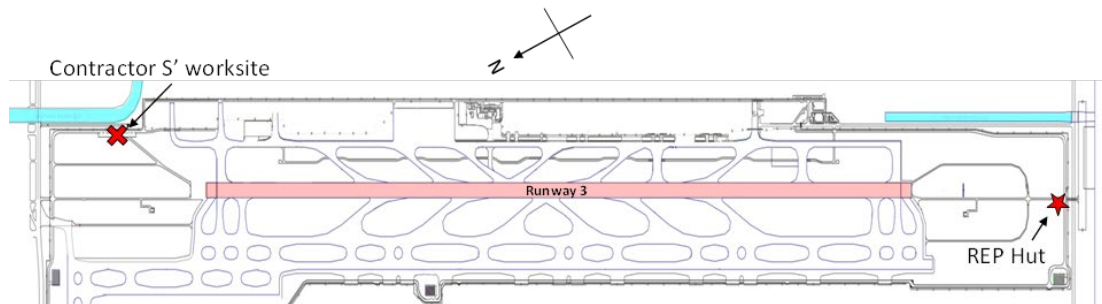
1.1.2 There was an obstacle lights installation work (not a part of the runway maintenance work) on a building located more than 500m beyond the northern end of Runway 3 (see **Figure 1**) outside the runway strip<sup>2</sup> and runway end safety area<sup>3</sup> (RESA). The work was being carried out by a contractor, Contractor S, on behalf of another Contractor, Contractor A.

**Figure 1:** Diagram showing REP Hut, Contractor S' worksite and Runway 3.

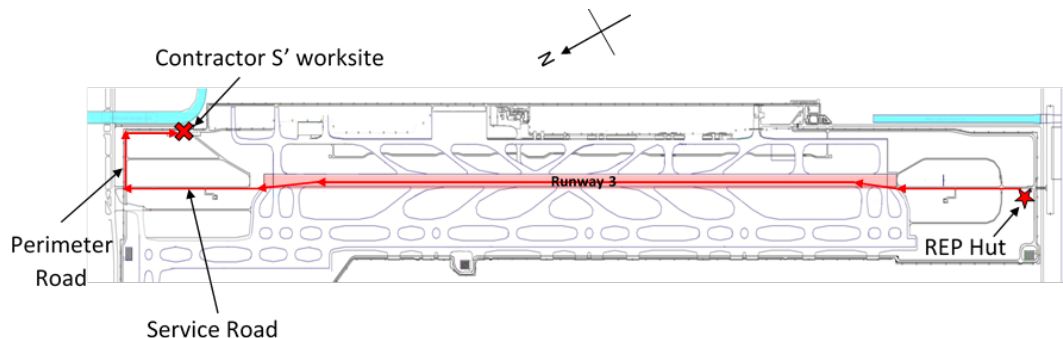
1.1.10 Runway 3 was closed at 0954LT. The Work Team's vehicle entered the runway and travelled to the northern end of the runway and then used a road (hereinafter referred to as the Service Road) to reach the perimeter road and then the worksite (see **Figure 2**).

**Figure 2:** Route taken by the Work Team to the worksite.

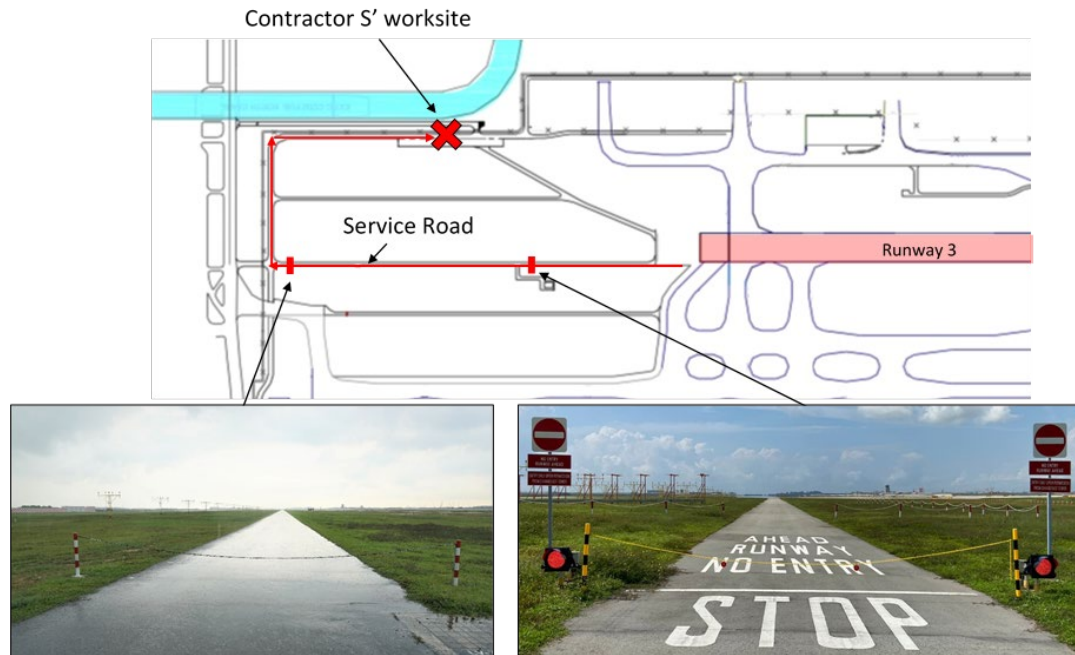
**Figure 3:** Locations and pictures of the chain barriers. (Note: The pictures were taken in the direction of the runway.)

1.5.3.1 As regard the Service Road, there are two chain barriers along the road (see **Figure 3**). The barrier nearer to the runway is located at the road holding position. A vehicle found beyond this point is considered to have entered the runway. The road holding position is accompanied by ground markings, flashing red lights and warning signs for warning drivers and other personnel that they are not allowed to cross the barrier into the runway without authorisation from ATC.

1.5.3.2 The barrier further away from the runway is not accompanied by any warning sign. According to the aerodrome operator, contractors, if authorised by the aerodrome operator to use the Service Road, may unhook the chains and hook them back as necessary. However, the aerodrome operator did not have procedure regarding how contractors could seek authorisation from the aerodrome operator and the circumstances under which the aerodrome operator may authorise contractors to use the Service Road.
