Final Report

RUNWAY INCURSION BY A VEHICLE IN CHANGI AIRPORT

29 OCTOBER 2020

TIB/AAI/CAS.194

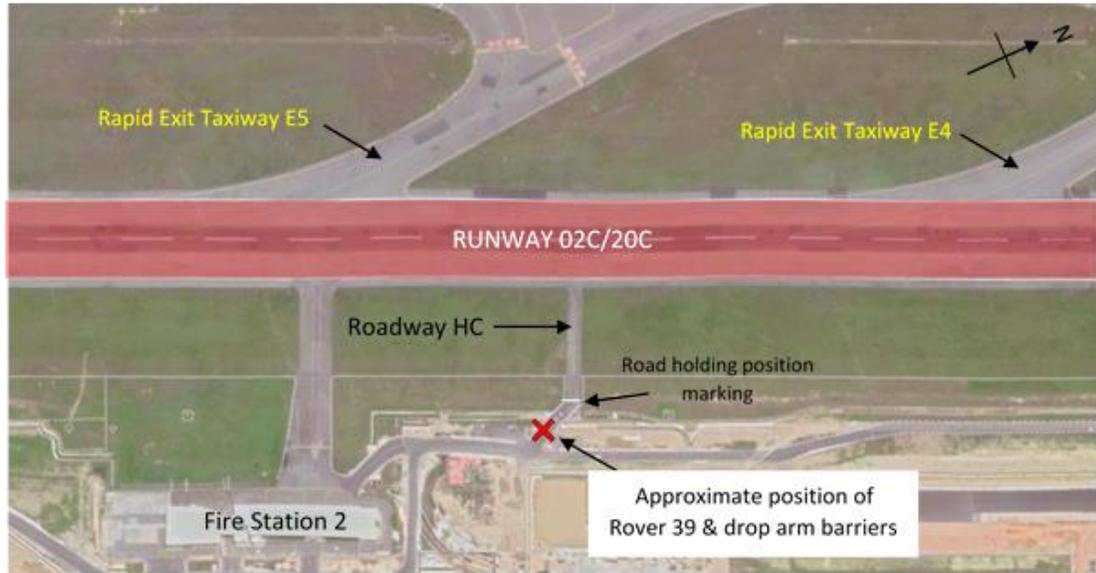
1.1.2 The Driver acknowledged the instruction from the OJT Controller. At this time, the maintenance vehicle was positioned on a roadway designated as Hotel Charlie (HC) which led to Runway 02C/20C (see **Figure 1**) before a set of drop arm barriers. Apart from the Driver, there was a co-worker in the maintenance vehicle.

Figure 1: Location of maintenance vehicle and roadway HC.

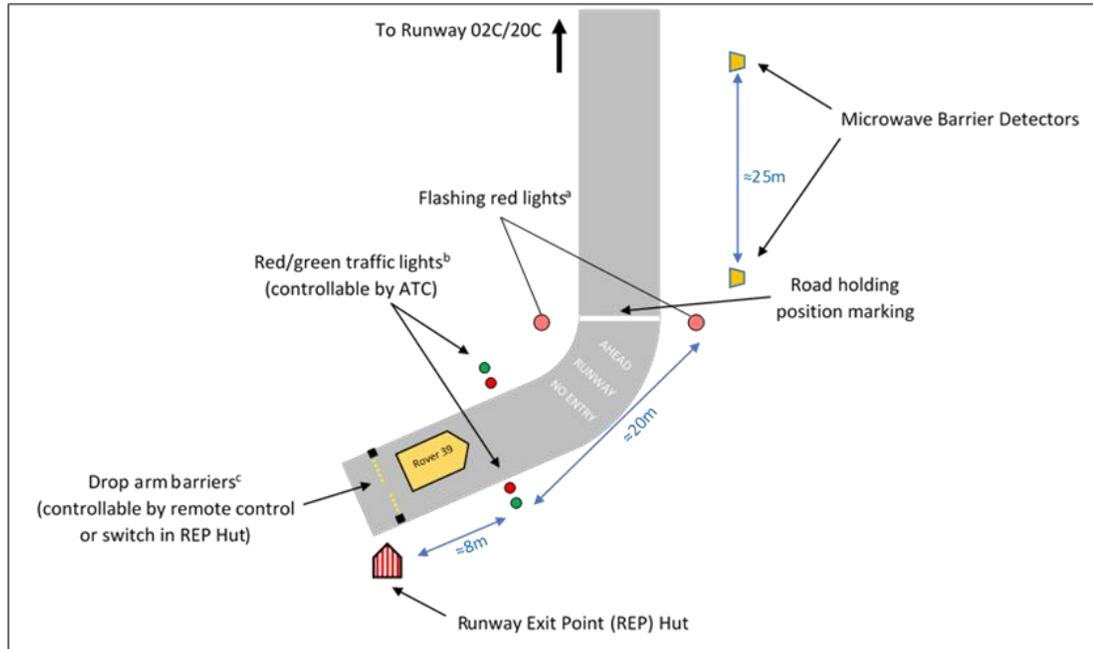
1.1.3 Shortly after the Driver had acknowledged the OJT Controller’s instruction, the co-worker raised the drop arm barriers on roadway HC using a remote control⁴. The Driver then drove onto the roadway and stopped just after passing the drop arm barriers and before a set of red/green traffic lights. The traffic lights are controllable by the Air Traffic Control (ATC) via the Airfield Ground Lighting Control and Management System (AGLCMS) and were indicating red at that time (see **Figure 2**).

^bThe red/green traffic lights are controllable by ATC and corresponded to their instruction. Red means no approval to enter the runway; green means approval has been given to enter the runway.

^cThe drop arm barriers were controllable using a remote control placed in the maintenance vehicle Rover 39 or a switch located in the REP Hut.

Figure 2: Illustration of vehicle roadway HC (not to scale).

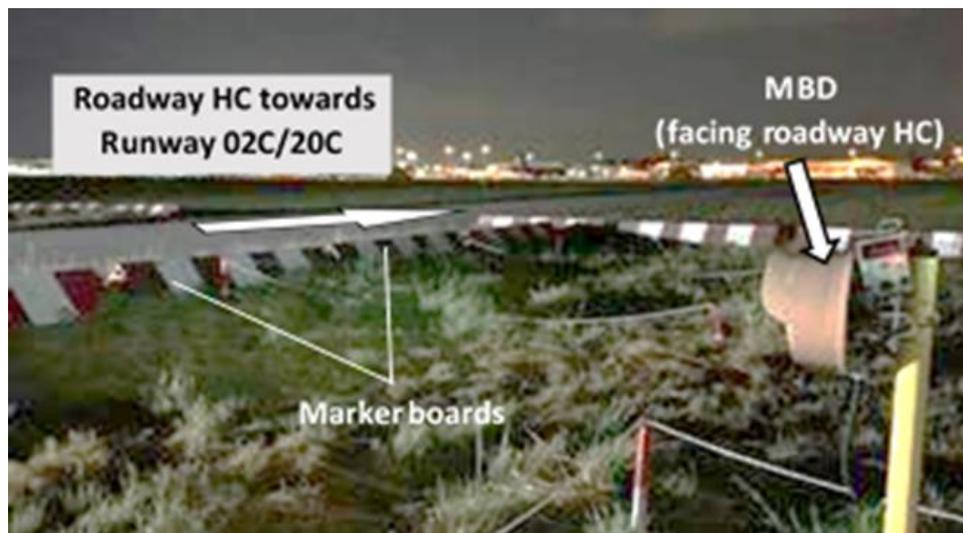
- 1.1.12 There are two microwave barrier detectors (MBDs) installed 25m apart by the aerodrome operator along the roadway HC to detect unauthorised entry into the runway (more on MBD in paragraph 1.5.6). During this incident, the MBD system did not detect the runway incursion during this occurrence. Post-occurrence tests showed that the MBD that was nearer the flashing red lights was affected by the presence of marker boards (see **Figure 3**) erected by the aerodrome operator⁸ (see paragraph 1.5.7).

Figure 3: Position of marker boards during the incident.

- 2.4 MBD detection of runway incursion
 - 2.4.1 In this incident, the MBD did not detect the runway incursion by the Driver and did not trigger an alert on the AGLCMS. Its detection capability was compromised by marker boards that were placed in front of the MBD.

- 3.3 The MBD did not trigger an alert to warn the ATC of the runway incursion because its detection capability was compromised by the presence of marker boards in front of the MBD.

- (a) Moved the marker boards and checked that marker boards elsewhere are not blocking the MBD (see **Figure 5**);

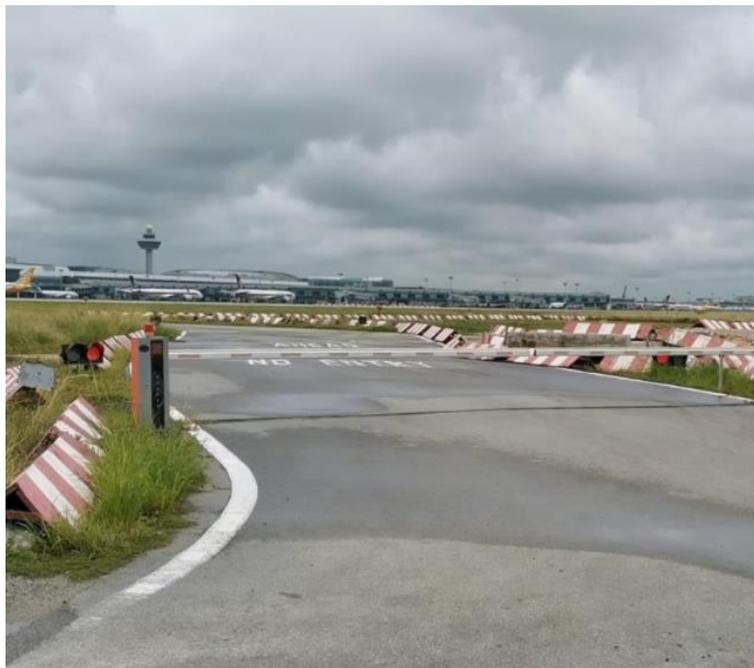
1.5.5.1 A set of two drop arm barriers (see **Figure 4**) was installed by the aerodrome operator about 8m before the traffic lights.

Figure 4: Drop arm barriers (for illustration).

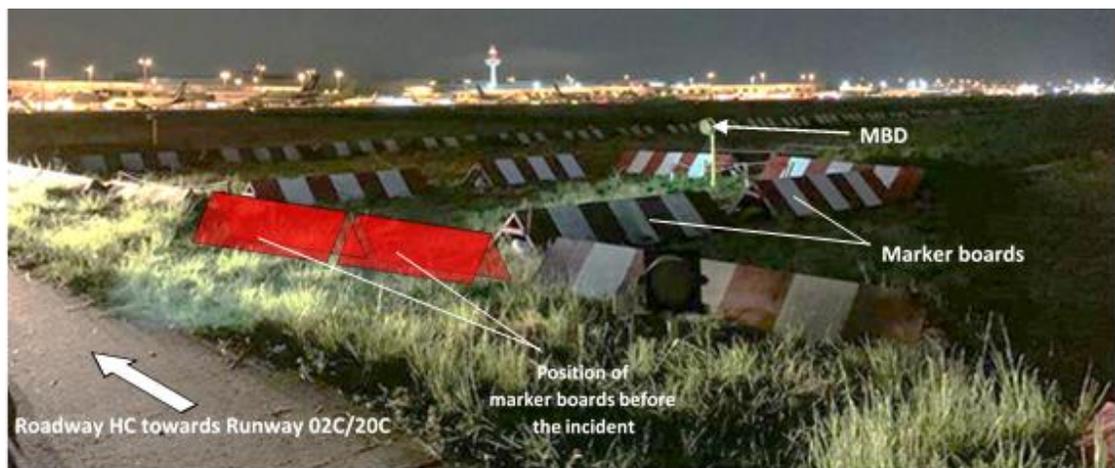
Figure 5: New marker boards positioned at roadway HC behind MBD.

- (b) required its officers to conduct visual checks during runway maintenance to ensure there is no obstruction in front of MBDs;
- (c) included MBD in the list of items to be inspected by its construction safety inspectors; and
- (d) revised the testing methodology in the MBD to include walk test in addition to the existing vehicle test.
