Final Report

RUNWAY INCURSION BY A VEHICLE IN CHANGI AIRPORT

3 JUNE 2022

TIB/AAI/CAS.208

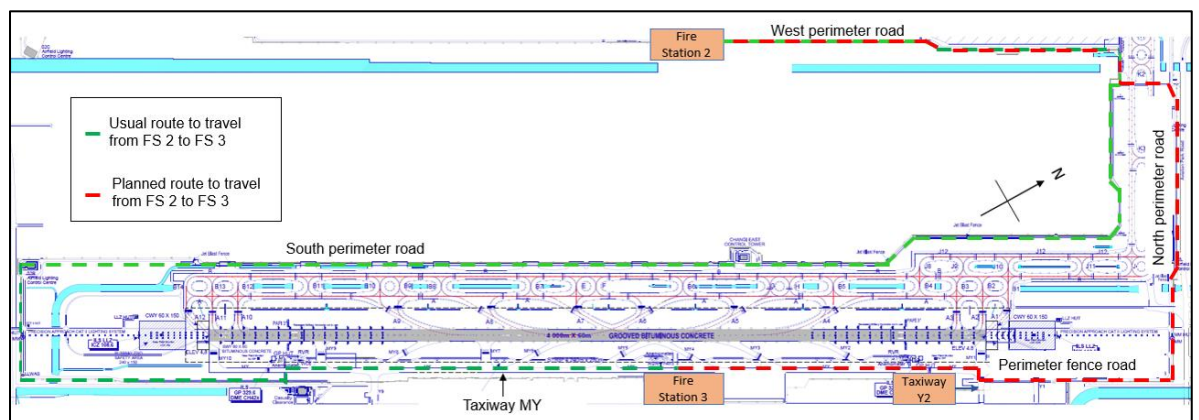
Figure 1: UV's planned route and usual route from FS 2 to FS 3

1.1.2 This route of west perimeter road-north perimeter road-perimeter fence road that the UV driver planned to use was recently opened in February 2022 after the completion of construction works. The UV driver learnt about this alternative route by word-of-mouth from some of his colleagues who had attended some ARFF trials for this routing and the UV driver understood that using this route, from the north perimeter road onwards, would involve the following:

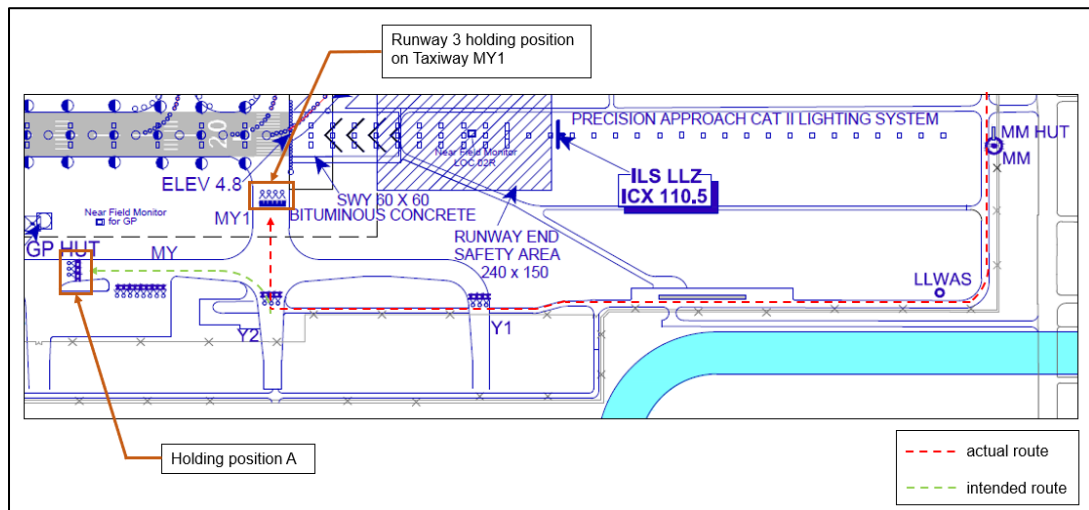
Taxiway Y2 but he did not turn left onto Taxiway MY, whose taxiway edge lights were not turned on as no aircraft had been expected to use the taxiway that night. Instead, he travelled on Taxiway Y2 towards a line of red stop bar lights on Taxiway MY1 (see **Figure 2**). (Note: Taxiway MY1 leads to Runway 3 and the red stop bar lights are located at the runway holding position. See paragraph 1.6.1.1.) The UV driver's understanding was that he should look out for the red stop bar lights at the holding position A⁴. He had mistaken the red stop bar lights on Taxiway MY1 for the red stop bar lights at the holding position A. There are markings on the ground and signs on either side of the red stop bar lights at the runway holding position on Taxiway MY1 to indicate that Runway 3 is ahead. However, the recording of the in-vehicle camera showed that the UV driver was checking his handphone on the procedure for communicating with the RWC and that he did not look out for the signs and markings.

Figure 2: UV driver mistaking Taxiway MY1 for Taxiway MY

2.1.1 As mentioned in Footnote 2 in paragraph 1.1.2(b), going from the perimeter fence road to Taxiway MY involved turning right from the perimeter fence road onto Taxiway Y2 and, almost immediately, turning left from Taxiway Y2 onto Taxiway MY. However, it was the first time the UV driver took this route and he was not familiar with the roadways around the area of Taxiways Y2/MY. He did not immediately turn left onto Taxiway MY after entering Taxiway Y2. Instead, he went straight from Taxiway Y2 towards Taxiway MY1.

2.1.2 The UV driver knew that, on the way to FS 3, he needed to stop at the holding position A which was co-located with red stop bar lights. He was expecting to see red stop bar lights at holding position A. However, he was not aware that the red stop bar lights were facing south and that he would not see any lit red stop bar lights if he was travelling on Taxiway MY from the north (i.e. towards FS 3). Had he been aware, he would not have needed to look out for the red stop bar lights at the holding position A and would have realised that he was not on the right track when he saw the red stop bar lights at the runway holding position on Taxiway MY1.

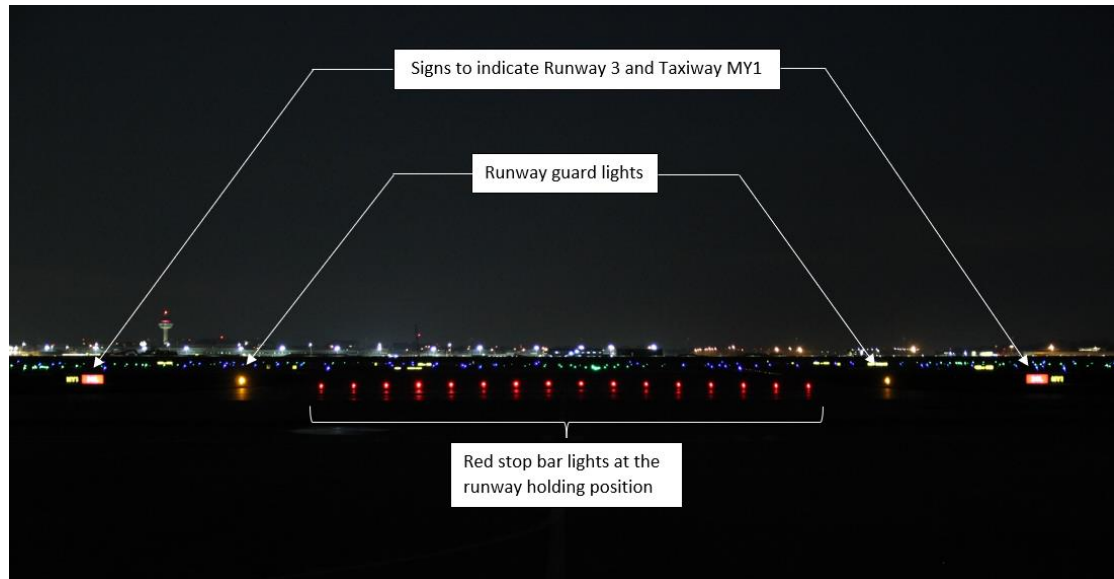
Figure 4: Lightings and signs at Taxiway MY1 runway holding position

- 1.6.1.3 The investigation team visited Taxiway MY1 and established that the location signs, the runway guard lights and the stop bar lights, when lit, can be seen by a vehicle driver as he or she approaches the red stop bar lights.

2.1.3 There were markings on the ground and signs on either side of the red stop bar lights at the runway holding position on Taxiway MY1 to indicate that Runway 3 was ahead. However, the UV driver did not look out for them as he was busy

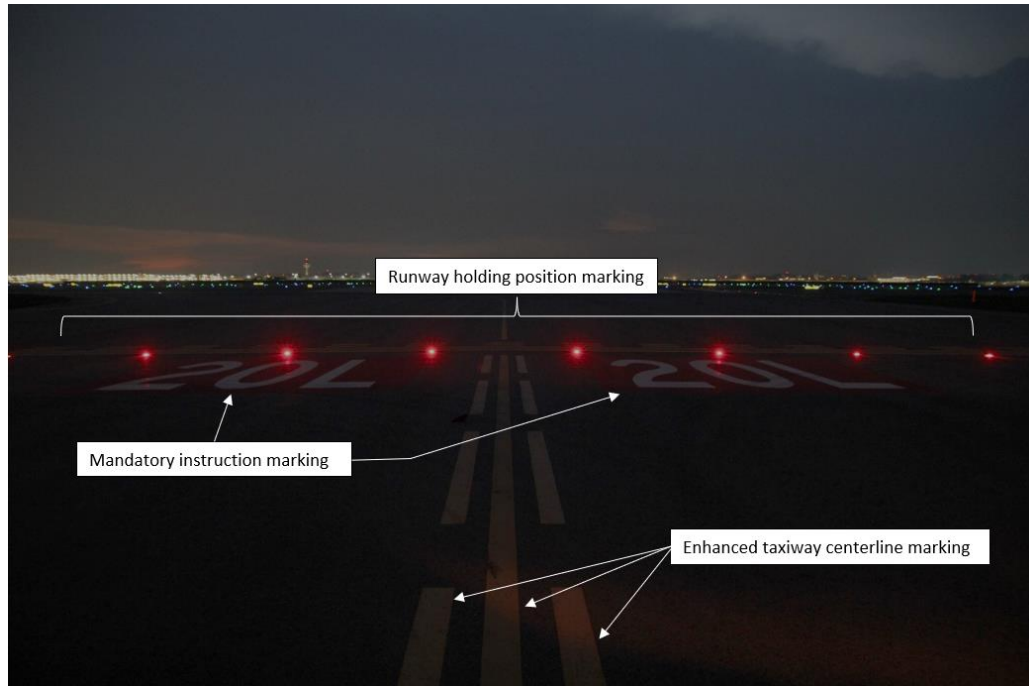
1.6.1.2 There are also ground markings to indicate that the runway is ahead of the runway holding position (see **Figure 5**):

- (a) Runway holding position markings and mandatory instruction markings on the ground across the taxiway
- (b) Enhanced taxiway centreline marking

Figure 5: Ground markings at the runway holding position

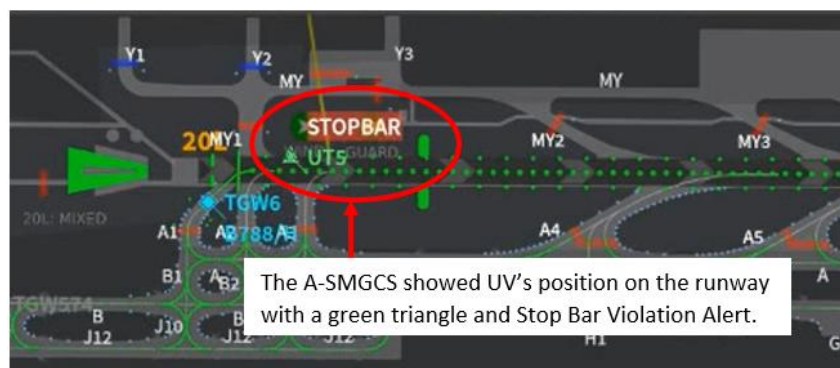
- (a) The recording of the A-SMGCS visual display showed that there was a STOPBAR visual alert (see **Figure 6**) and alert message triggered by the UV when it passed the runway holding position at Taxiway MY 1 (see **Figure 3**). According to the RWC, she did not notice the visual alert and alert message.
- (b) CET cabin ambient recordings registered a corresponding aural warning¹³ for the runway incursion by the UV.

Figure 6: The A-SMGCS display at 22:46:13LT

¹³ In the opinion of the investigation team, the "Runway Incursion" annunciation is rather soft and lacks forcefulness.

2.4.2 The CET Leader and the RWC also failed to notice the aural warning in the form of an annunciation of "Runway Incursion, Runway 3". As mentioned in Footnote 13 in paragraph 1.7.1, the annunciation appeared rather soft and lacked forcefulness.

2.4.3 Thus, the A-SMGCS warning system seemed to have limited effectiveness in alerting the RWC and the CET Leader of a runway incursion occurrence. It would be desirable to have a more distinct annunciation of "Runway Incursion" or to have a repetitive annunciation to ensure that a runway incursion occurrence will not be missed.
