FINAL REPORT

RUNWAY INCURSION IN SELETAR BY VEHICLE

7 APRIL 2018

AIB/AAI/CAS.162

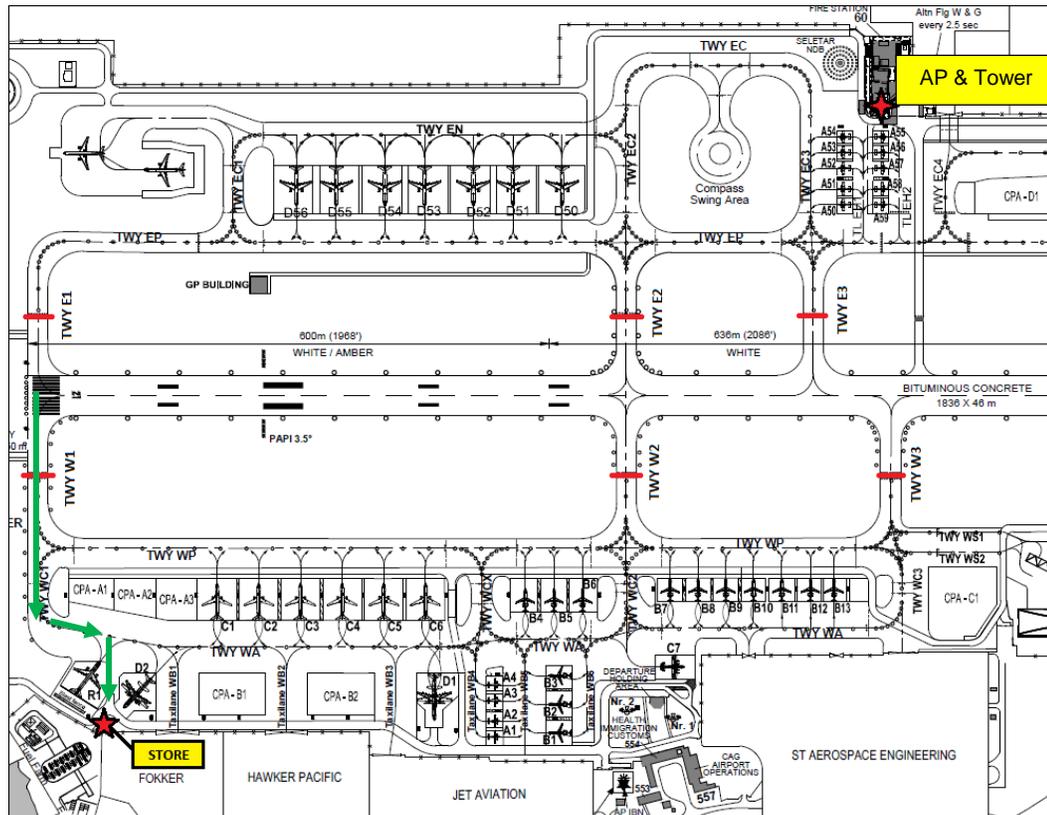
Figure 2: Route taken by Mobile 75's team of vehicles (indicated in green)

1.1.16 At about the same time, Mobile 75's team of three vehicles, after having collected the white cross markers at Runway 21 threshold, exited the runway via Taxiway W1, instead of via E3 as they had been briefed. They were proceeding to the store, which was located to the west of the runway, to return their equipment⁶ (see **Figure 2**). Mobile 75 chose to exit via W1 because it was the shortest route to the store. However, Mobile 75 did not inform anybody that his team was proceeding to the store to return their equipment.

- 1.1.22 As mentioned in paragraph 1.1.16, Mobile 75’s team of three vehicles were proceeding to the store to return their equipment. After returning his equipment, and while his colleagues on the other two vehicles were still in the process of returning their equipment, Mobile 75 decided that he should return to the AP without them. He collected the vehicle number tags from them so that he could return the number tags to the REPO on their behalf. He reminded them to exit the airside via the perimeter road after they had returned their equipment⁷, while he himself would return to the AP by crossing the runway from Taxiway W2 (hereinafter referred to as W2) to E3 as it was a shorter route⁸ as compared to using the perimeter road.

broadcast in an attempt to contact the unknown vehicle. This was to no avail. Tower saw the vehicle entering the runway via W2⁹, travelling on the runway, vacating the runway via E3, and proceeding to the AP. The vehicle was subsequently identified to be Mobile 75.

2.1.3 Mobile 75 returned to the AP via the runway, entering via W2 and exiting via E3, instead of using the perimeter road. He chose to do so because this was a shorter route and he believed that the runway was still closed.

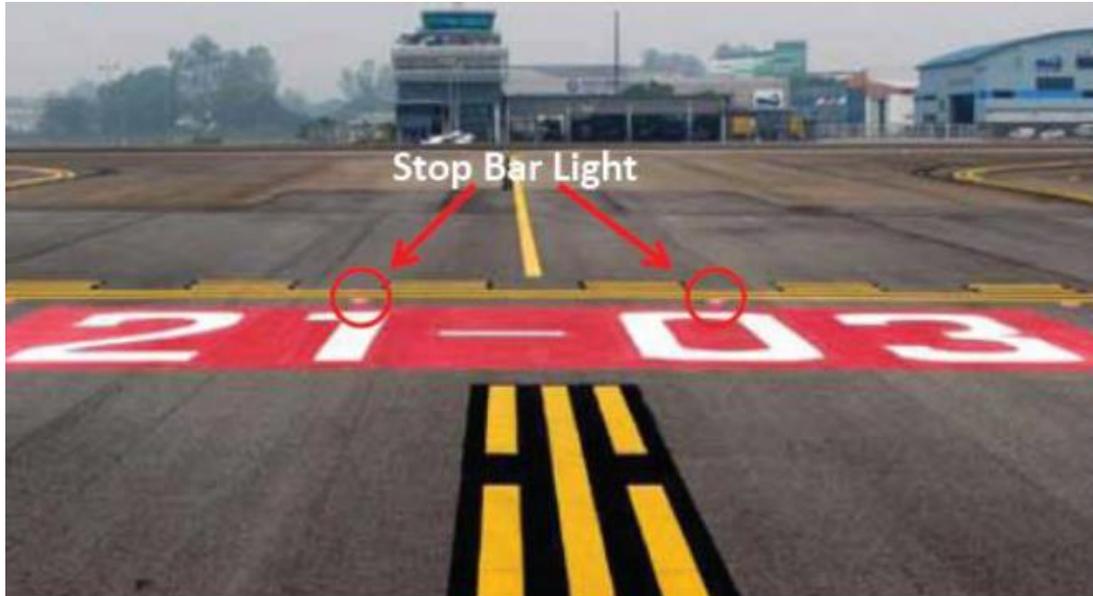
Figure 3: Stop bar lights at runway holding position

1.6.1.1 During normal runway operations, the red runway holding position stop bar lights (hereinafter referred to as stop bar lights) would remain ON to remind pilots and vehicle drivers not to enter the runway even if clearance had been given by Tower. After issuing a clearance, Tower would turn off the appropriate stop bar lights to allow the aircraft or vehicle to enter the runway. The stop bar lights would come ON again automatically after 40 seconds. **Figure 3** shows the stop bar lights at a runway holding position.

1.6.1.2 During scheduled runway maintenance, as in this incident, the stop bar lights at all the runway holding positions, including E3, would remain ON. Nevertheless, vehicles were allowed to enter the runway via E3 while the stop bar lights remained ON.

- 2.2.2 On the other hand, Tower would leave the stop bar lights ON during runway closure for maintenance works but would allow the vehicles and personnel involved in the runway maintenance works to nevertheless enter the runway via E3. While this practice of leaving the stop bar lights ON could be an expedient measure (as otherwise Tower would have to turn the lights OFF every time a vehicle driver requested Tower for permission to enter the runway even when the runway had been closed for maintenance works), it was not congruous with the safety consciousness that the aerodrome operator had been promoting.

- 2.2.3 Had Tower been adopting consistently the “red stop bar lights ON means no crossing under any circumstances” approach, it was likely that Mobile 75 would have stopped at the runway holding position at W2 to await Tower’s clearance to cross the runway.

- 4.1 Tower has reviewed its procedures and adopted in August 2018 the “red stop bar lights ON means no crossing under any circumstances” approach when the runway is closed for maintenance works. Even when a clearance has been given, maintenance vehicles will have to wait for Tower to turn off the stop bar lights before entering the runway.
