T-50 RUNWAY EXCURSION DURING TAKE-OFF FROM CHANGI AIRPORT

6 February 2018

AIB/AAI/CAS.156

Transport Safety Investigation Bureau
Ministry of Transport
Singapore

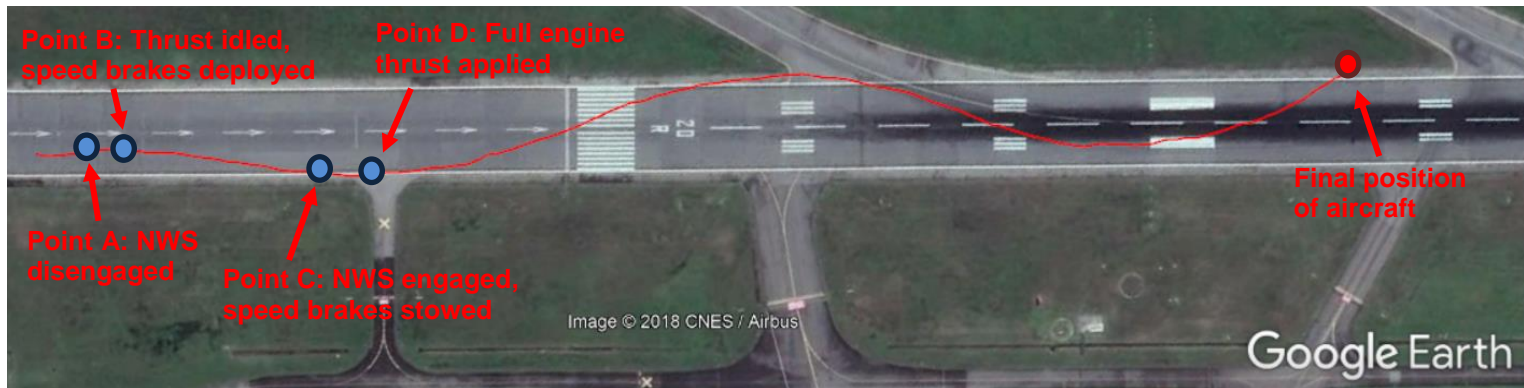
Figure 2: Path of event aircraft along runway

- 1.1.4 The three aircraft in the second group were able to stay in formation during the initial take-off roll. After rolling for approximately 350 metres, the pilot of the aircraft on the right of the formation disengaged the nose wheel steering (NWS) system (**Point A in Figure 2**) to switch to using the rudder for directional control¹. The aircraft started to veer towards the right edge of the runway.

- 1.1.5 Shortly after, the pilot reduced the engine thrust to idle, deployed the speed brakes and provided full left rudder pedal input to attempt to steer the aircraft back towards the runway centreline (**Point B in Figure 2**).

- 1.1.6 As the aircraft approached the right edge of the runway, the pilot re-engaged the NWS and stowed the speed brakes (**Point C in Figure 2**). As the aircraft started to move to the left (back towards the runway centreline), the pilot applied full engine thrust (**Point D in Figure 2**) to resume the take-off.

- 1.1.7 Thereafter, the aircraft skidded along the runway in a zigzag manner for approximately 750 metres (see **Figure 2**). The aircraft eventually skidded off the left edge of the runway and flipped over, coming to rest on the grass turf beside the runway (see Error! Reference source not found.). Shortly after, the tail section of the aircraft caught fire.

2.1.1 The aircraft started to veer towards the right edge of the runway as soon as the NWS was disengaged. This was because the nose wheel was not perfectly aligned with the aircraft's nose, having been set at 1.31° to the right at the time of NWS disengagement.

2.2.1 The pilot managed to prevent the aircraft from veering further off the right edge of the runway by re-engaging the NWS. When he re-engaged the NWS, he was providing full left rudder input. This caused the aircraft to swing abruptly towards the left of the runway (see paragraph 1.6.3) after NWS re-engaged.

2.2.2 With the NWS remaining engaged, the pilot's subsequent directional control inputs resulted in over-correction of the aircraft's path of travel, which led eventually to the zigzag motion of the aircraft before it exited the left side of the runway.

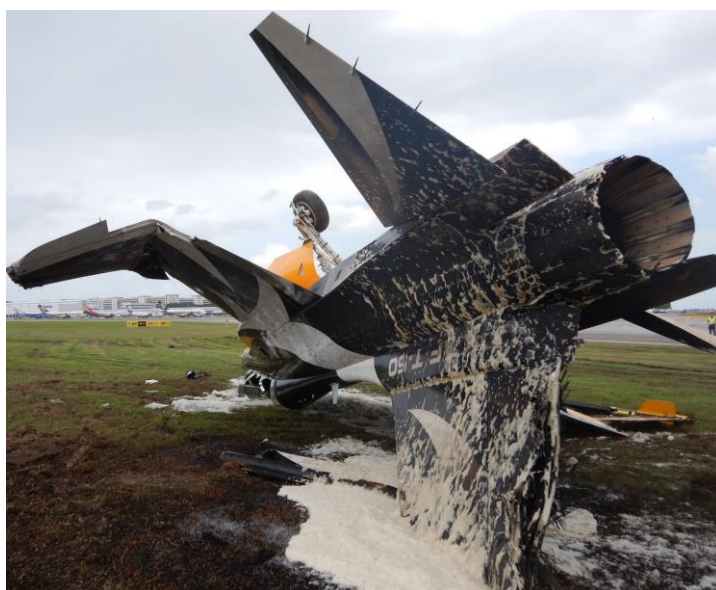
Figure 3: Final position of the aircraft

- 1.3 Damage to aircraft
 - 1.3.1 The aircraft was destroyed.
 - 1.3.2 The TSIB investigation team, together with the ROKAF SIB investigators², performed a preliminary inspection of the aircraft on 8 February 2018 before
