Final Report

Man Overboard

Supply Vessel LEO 38

And Tanker AGIOS NIKOLAS

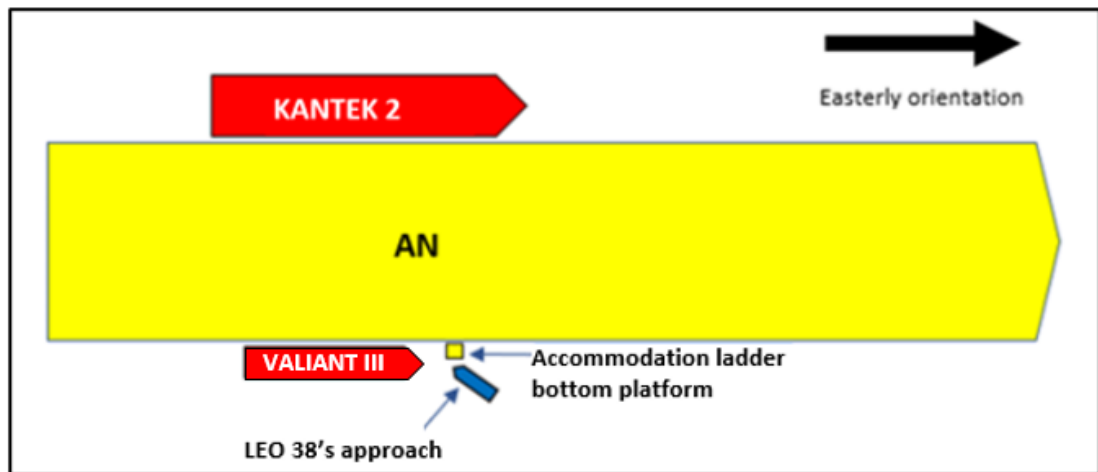
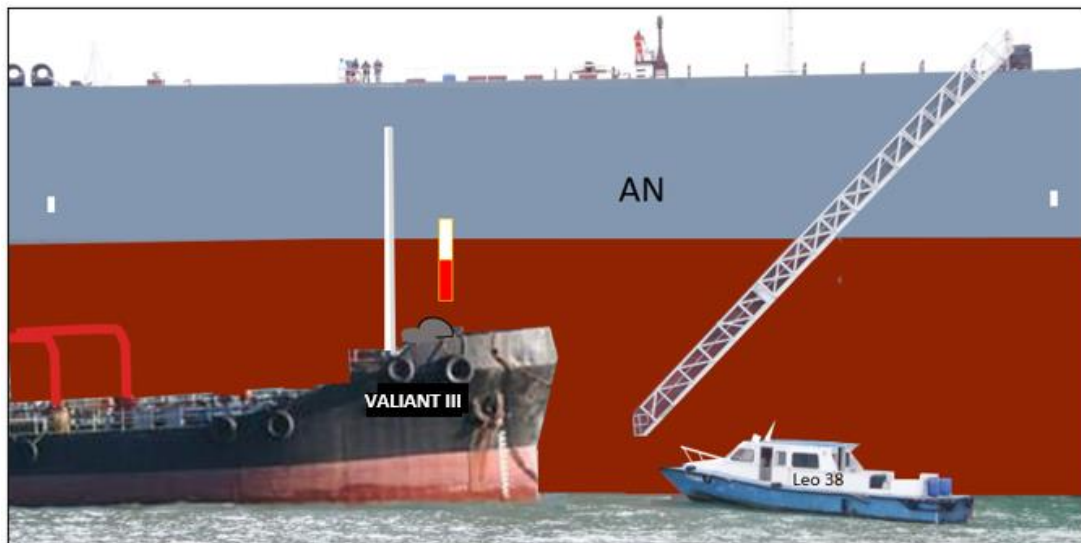
2-3m aft of the bottom platform of the accommodation ladder. See **figures 3 and 4**. The accommodation ladder was used instead of a combination ladder.

Figure 3 – Plan view of graphical representation of vessels involved and LEO 38's approach (Not to scale).

Figure 4 – Profile view of the vessels involved and LEO 38's approach (Not to scale). Valiant III's Image *Source*: Marine Traffic (annotation by TSIB)

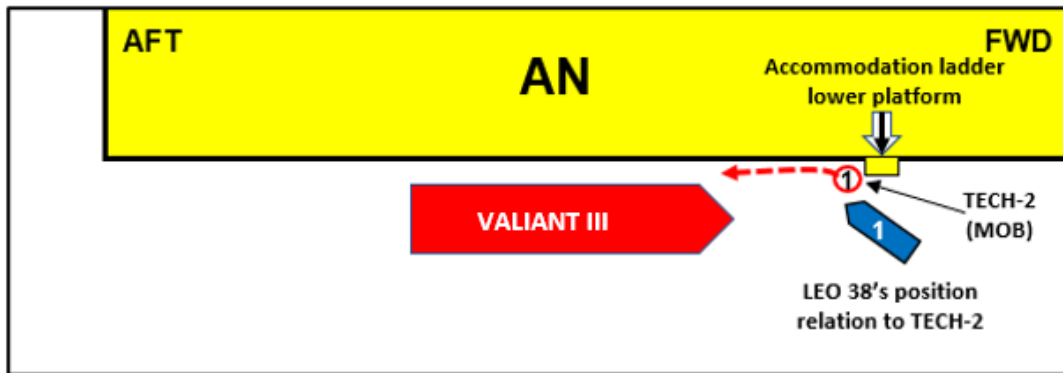
- 1.1.14 The Skipper witnessed the fall of TECH-2 into the water and shouted MOB. TECH-1, who was inside the boat's cabin, upon hearing the MOB call from the Skipper, ran out to the forward of the boat and saw TECH-2 in the water trying

Figure 6 - Depicting LEO 38's positions in relation to TECH-2's drift (Not to scale)

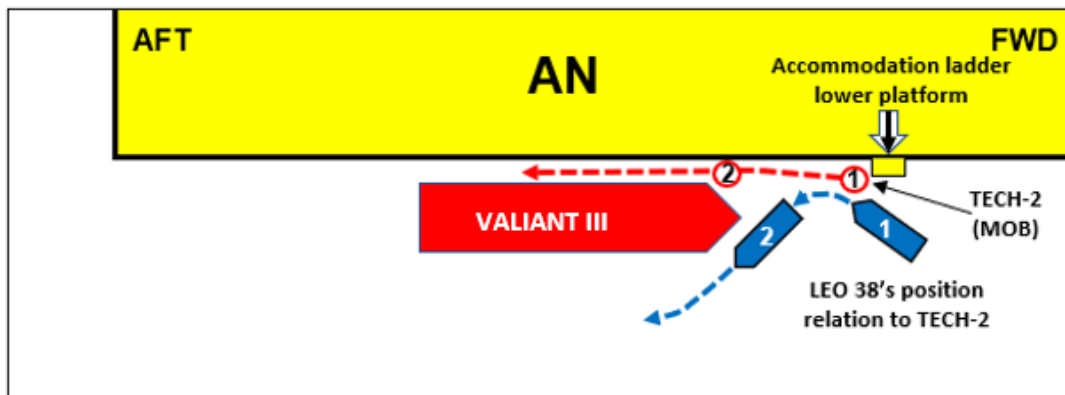
- 1.1.15 Meanwhile, TECH-3 seeing the occurrence during his descent, also shouted MOB. TECH-3 then ran up the accommodation ladder and requested the crew of AN for assistance. During this time, TECH-3 saw TECH-2 was drifting between AN and Valiant III.
- 1.1.16 The Skipper instructed TECH-1 to grab a lifebuoy from the aft part of the boat and throw it to TECH-2, as he manoeuvred LEO 38 towards TECH-2 while keeping clear of the accommodation ladder and the bow of VALIANT III. TECH-1 threw the lifebuoy to TECH-2, who was conscious, but TECH-2 did not grab it (See **figure 7**).

Figure 7 - Depicting LEO 38's positions in relation to TECH-2's drifting (Not to scale)

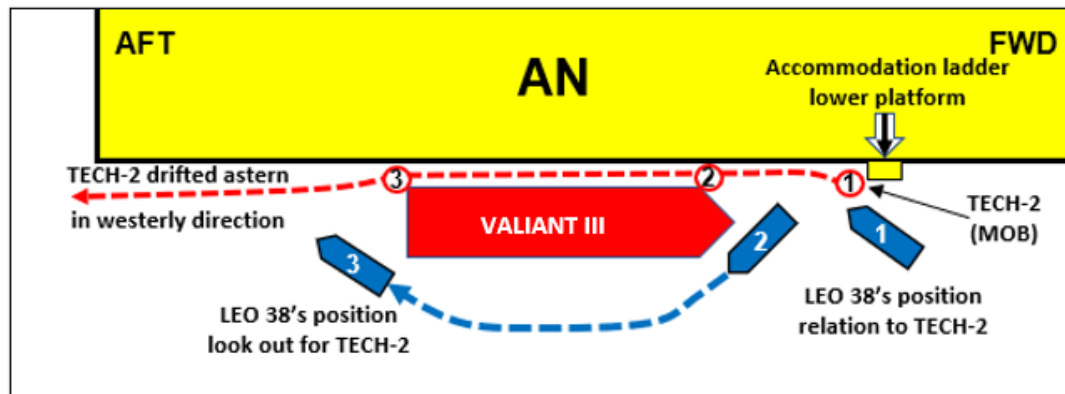
- 1.1.17 Meanwhile, the crew of AN shouted to VALIANT III's crew on deck to assist TECH-2. Subsequently VALIANT III's crew too, threw a lifebuoy (with line) towards TECH-2, who again did not grab it¹⁶.
- 1.1.18 Witness accounts recalled that TECH-2 was drifting between AN and VALIANT III, in a westerly direction. The Skipper then manoeuvred LEO 38 and headed towards the stern of VALIANT III, to look out for TECH-2 (See **figure 8**).

Figure 8 - Depicting LEO 38's positions in relation to TECH-2's drifting (Not to scale)

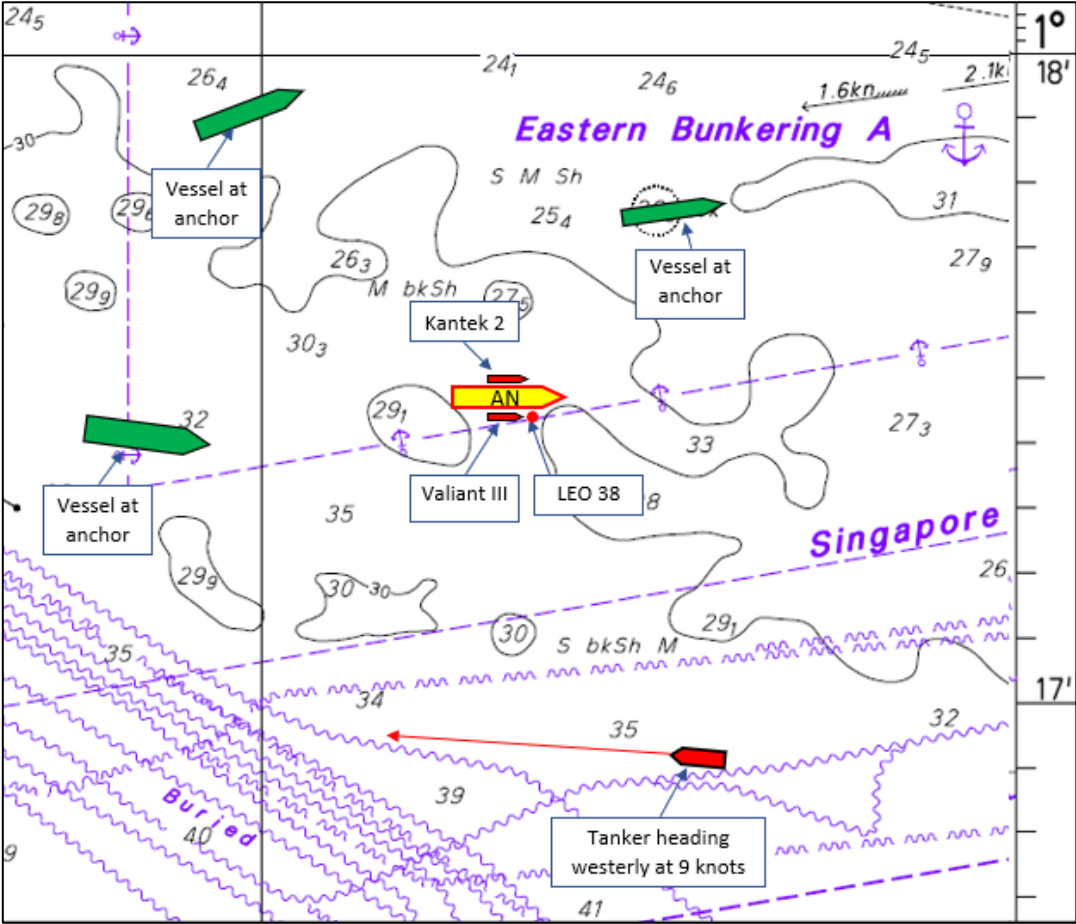
1.5.3 Prior to the occurrence, at about 2119H, with AN and several other vessels at anchor within the anchorage, a West bound tanker²⁷ with a speed of about 9 knots was passing at about 0.55 nautical mile to the south of AN (See **figure 14**).

Figure 14 – AN at anchor while a west bound tanker (in red) was passing south at about 0.55 nautical miles (not to scale).

- 2.1.6 The swaying and rolling of LEO 38 was due to the sudden swells which were likely caused by a passing vessel. Notwithstanding, the investigation team held the view that, as far as practicable, efforts must be made to carry out transfers on the leeward side.

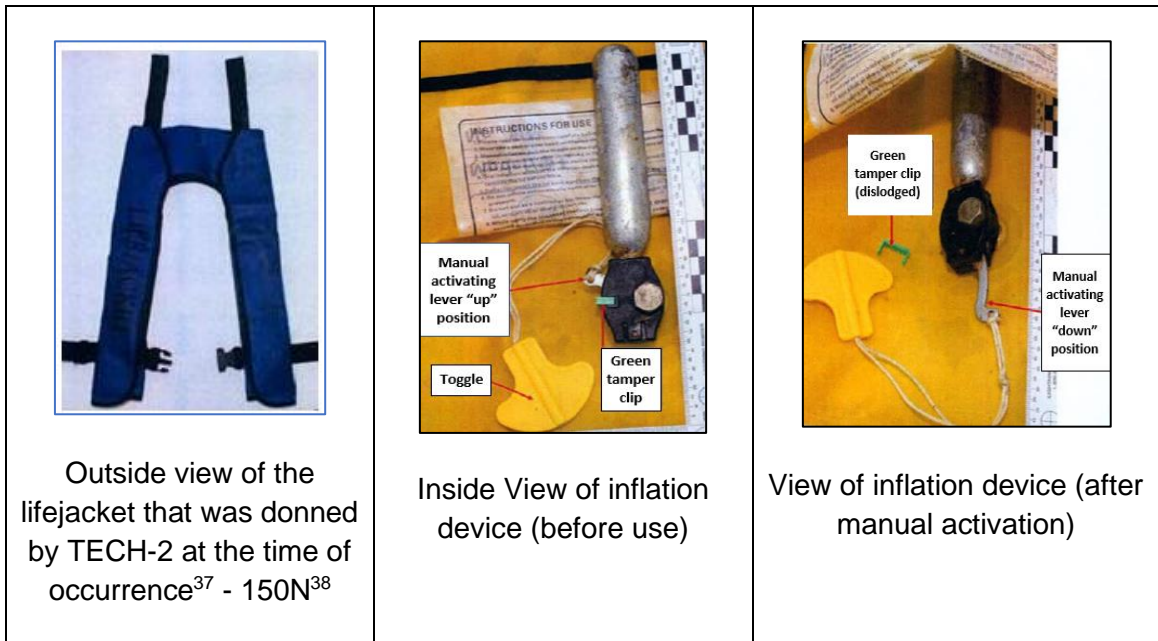
- (i) On the exterior section of the lifejacket, a label titled "Instructions for Use" indicated the following:
 - a. the lifejacket was to be used with a 33g CO₂ cylinder;
 - b. for manual inflation, pull the toggle at the base of the lifejacket; and
 - c. for automatic inflation, inflation would begin automatically after immersion in water for 5s.
- (ii) On the interior section, the inflation device was connected to a manual activating lever. The following was found on the inflation device and gas cartridge:
 - a. A gas cartridge was found screwed onto the inflation device. The cartridge was found to be intact and weighed 145g.
 - b. A green tamper clip was found secured onto the inflation device and the manual activating lever in a "up" position, indicating that the device had not been used.

Figure 16 – Lifejacket donned by TECH-2 and its inflation device.

- 2.2 TECH-2's lifejacket
- 2.2.1 The inspection and test confirmed that the lifejacket donned by TECH-2 was in a working condition, and of a manual inflation type i.e. requiring manual activation by the user.

5.1.1 To consider in its review of the existing PMC 34 of 2020, recommending users to use a working SOLAS type-approved lifejacket or a lifejacket meeting international ISO 12402 of at least performance level 150 with automatic inflation capability. **[TSIB-RM-2023-01]**

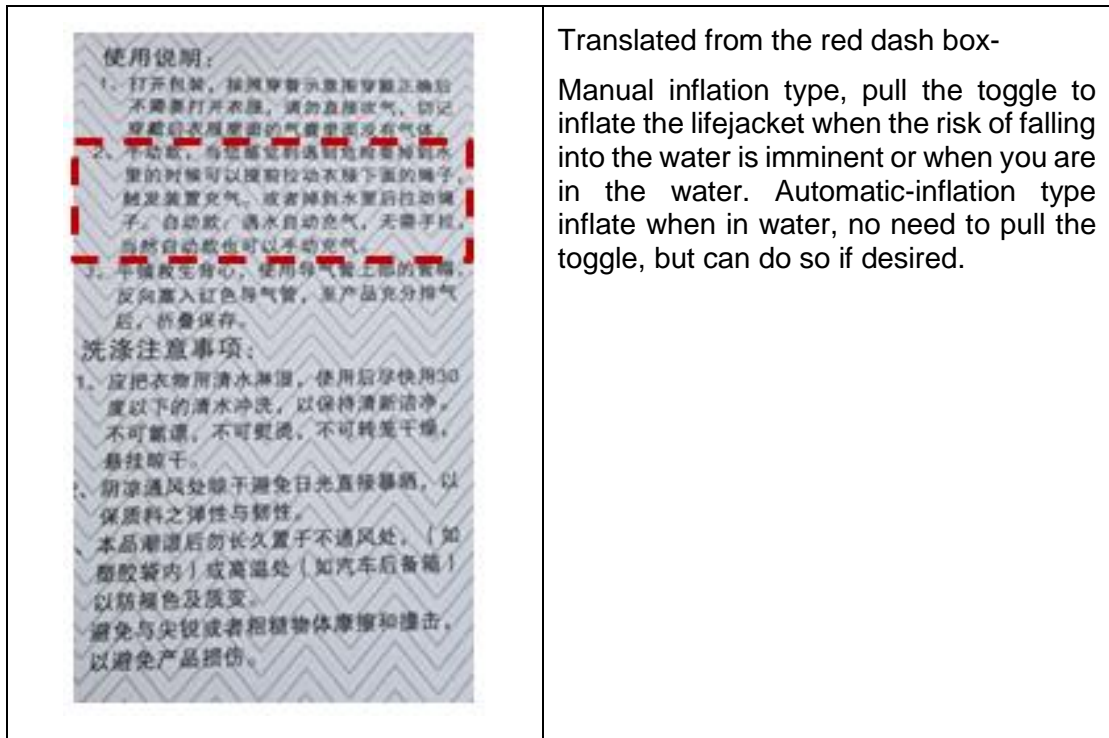
- (ii) The label (user guide) accompanying the lifejacket (see **figure 18**) advised the user to pull the toggle to inflate when there is a danger of falling is imminent or when in the water; and that pulling of toggle is not needed for automatic-inflation type. There was no indication on the lifejacket or in the user guide on the type of lifejacket (that is, manual or automatic).

Figure 18 - Label (user guide) accompanying the lifejacket (Annotated and translated by TSIB)

- TECH-2 was not familiar with the inflation method of the lifejacket.
- 2.2.4 The lifejacket worn by TECH-2 was a manual inflated lifejacket. However, the label on this lifejacket had instructions and a depiction which were common for both automatic and manual activated lifejacket, which can be misleading. It is unclear if TECH-2 had been influenced by the unclear depiction on the label of the lifejacket.
