FATALITY OF HARBOUR PILOT AFTER FALLING INTO WATER DURING TRANSFER IN SINGAPORE ON 11 FEBRUARY 2023

TIB/MAI/CAS.139

Transport Safety Investigation Bureau
Ministry of Transport
Singapore

22 April 2024

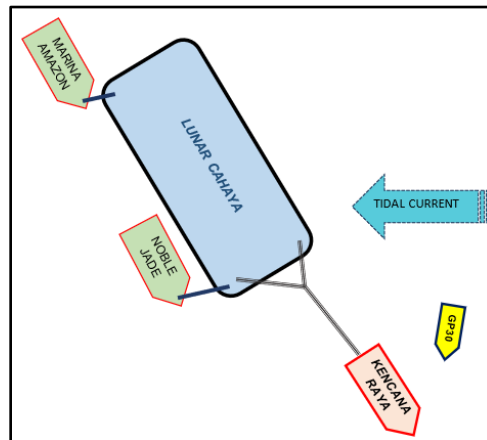
- 1.1.4 Between 0200H and 0220H, as the convoy transited south-easterly towards the pilot disembarkation ground at a speed of about 3.0kts. The pilot launch, GP 30, arrived near the port side (from the east) of KR in preparation for the Pilot's disembarkation. The tidal current was westerly and the lay of LC relative to KR's heading was to the starboard (see **figure 2**).

Figure 2: The lay of LC when GP 30 arrived near KR. – *Illustration not to scale.*

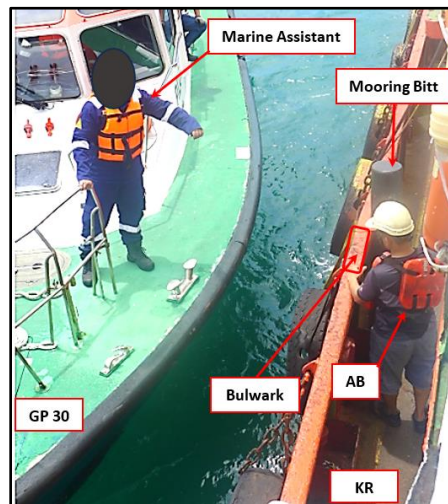
- 1.1.9 While approaching KR, the LM and MA saw the Pilot climbing from the deck of KR on top of the bulwark and subsequently squatting on the bulwark using the mooring bitt as a support. As GP 30 approached closer to the tyre fenders of KR¹², the Pilot was seen to stand up on the bulwark. The MA recalled stretching his arm for the Pilot to grab (see **figure 3** and paragraph 1.2.4 regarding the Pilot's transfer process). At this moment, the gap between GP 30 and KR became wider. The Pilot, who was in the midst of crossing over to GP 30, fell into the water through the gap between the two vessels.

Figure 3: The approximate gap between the two vessels when the Pilot attempted to cross from KR to GP 30 while standing on the bulwark - for illustration only.
(Note: the occurrence took place during the hours of darkness)

2.1.3 This wider gap could be explained by the effect of bow waves generated by KR and GP 30 when both vessels were propelling forward. As KR has larger bow area and was ahead of GP 30's bow due to its longer length, the wave generated by KR could likely push the bow of GP 30 away. Although GP 30 had increased speed to 2.5 – 4 kts, would take a while for GP 30 to counteract the wave effect from KR. The bow waves could have caused GP 30's LM be confronted with difficulties (being the lighter watercraft) to manoeuvre the launch towards, and get closer to, the intended point for alongside with KR. This effect could be minimised if both vessels were not making way.

- 5.3.2 To remind all its crew on safe transfer operations such as reducing speed to a minimal while maintaining steerageway and stopping engine to allow pilot launch to remain alongside. [TSIB Recommendation RM-2024-006]

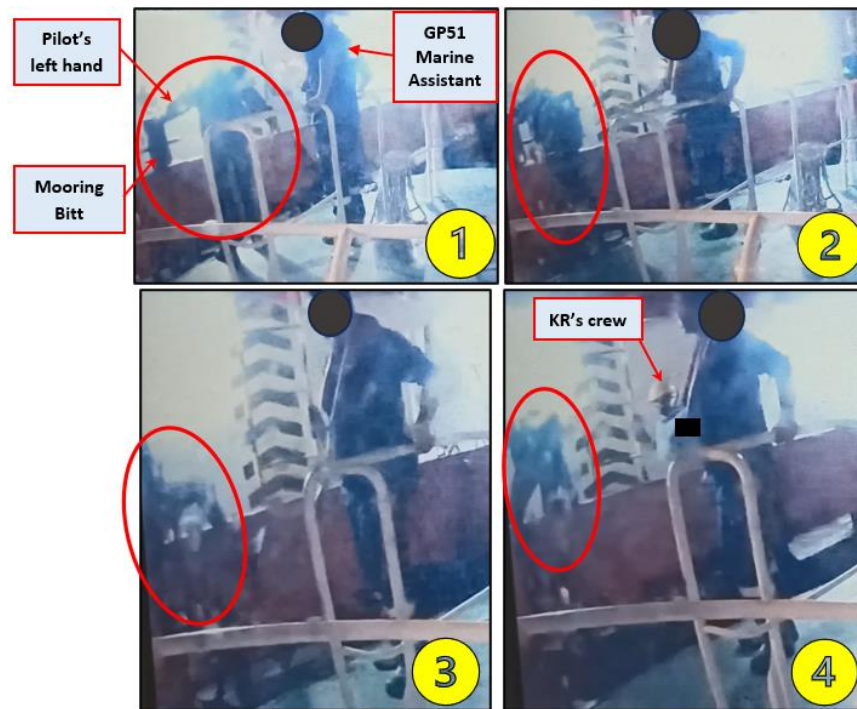
1.2.1 The PSAM's pilot launches are equipped with a forward-facing CCTV camera¹⁶. GP 51, which transferred the Pilot to KR at the PSA Brani terminal, had a footage showing the process of the Pilot's embarkation (see **figure 4**) prior to the incident.

Figure 4: The CCTV camera footage regarding the transfer of the Pilot (circled in red) from GP 51 to KR.

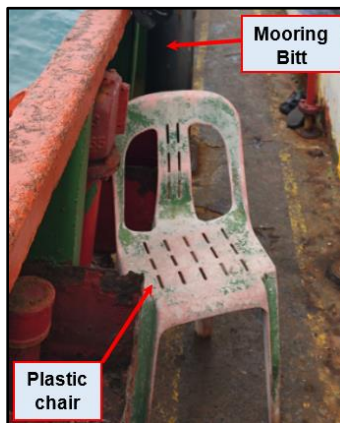
1.2.3 The investigation team also gathered from the crew of KR that when both the legs of the Pilot were over the bulwark, the Pilot stepped onto a plastic chair (see **figure 5**) that was placed (unsecured) on KR's starboard walkway near the mooring bitt, before stepping on the deck of KR.

Figure 5: The plastic chair which the Pilot stepped on during embarkation.

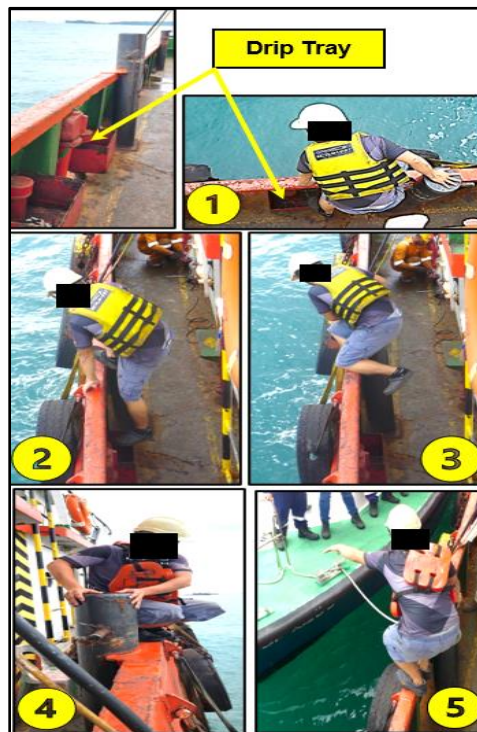
- 1) The Pilot used his left foot to step on the drip-tray near the mooring bitt on the starboard bulwark of KR. His right hand was resting on the mooring bitt while the left hand was on the bulwark.
- 2) The Pilot then pushed his weight from these supporting points and placed his right foot on the bulwark.
- 3) The Pilot then lifted his left foot onto the bulwark.
- 4) The Pilot then squatted on the bulwark, with both hands now on the mooring bitt, awaiting GP 30 to make its approach nearer to KR.
- 5) When GP 30 was approaching KR, the Pilot stood up (in a half-squat position), stretched the left arm and hand (moving it away from the bulwark) towards the MA before stepping off the bulwark of KR for GP 30.

Figure 6: The enactment by the AB for the transfer process of the Pilot from KR to GP 30

1.2.5 Both the MA and AB recalled that the overboard took place within 2-3 seconds from the time the Pilot stood up while in the midst of crossing over to GP 30. In addition, they recalled that the Pilot was wearing safety shoes, a raincoat (windbreaker) and had a backpack strapped on the shoulders underneath the

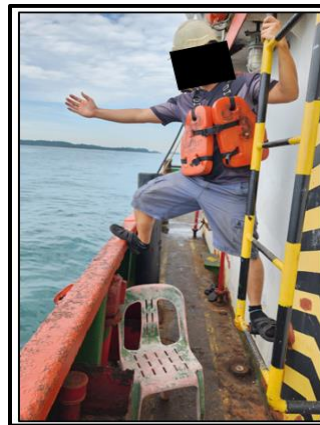
1.3.6 The operator provided general instructions for its crew to oblige to pilots' choice for the transfer point onboard KR and added that the embarkations were usually carried out by stepping on the tyre fender(s) and then climbing over the bulwark, while the disembarkations were usually done by standing on the bulwark while holding on to the fixed vertical ladder from the deck to wheelhouse deck (see **figure 8**). These instructions were corroborated by KR's crew.

Figure 8: Picture to show the method of disembarkation from KR.

- 5.3 For the Operator of KR (the Lunar Shipping Sdn. Bhd.)
 - 5.3.1 To ensure all its non-convention vessels calling the Port of Singapore are provided with safe pilot transfer arrangements as required by the Port regulator. [TSIB Recommendation RM-2024-005]

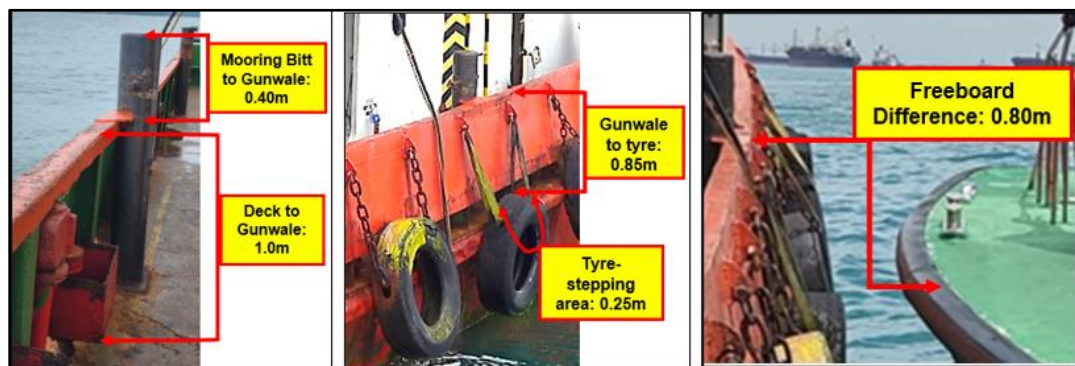
1.3.8 The measurements of the relevant fittings at the transfer point onboard KR and the freeboard difference with GP 30 are shown in **figure 9**.

Figure 9: The measurements of the relevant fittings at the transfer area onboard KR and the freeboard difference between KR and GP 30

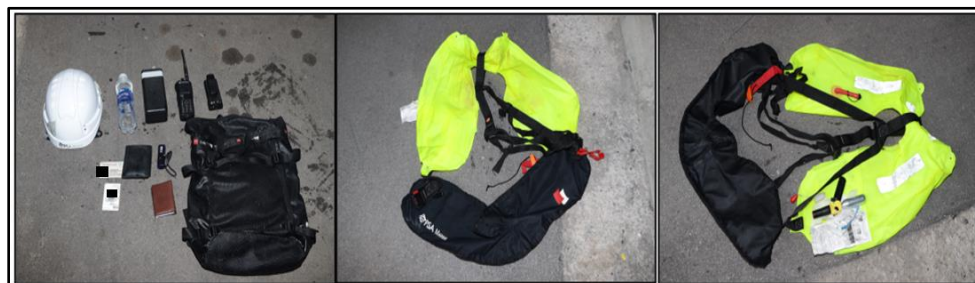
1.4.1 The backpack of the Pilot (see **figure 10**) was weighed by the PCG to be about 4.6kg containing essential items for pilot's work.

Figure 10: The backpack and lifejacket. (from left – the backpack and the items found inside. The front and back of the lifejacket – after being intentionally deflated)
(Source – PCG)

1.4.3 The laboratory report stated that there was no sign of damage on the safety shoes other than signs of normal wear of the grooves on the soles. The lifejacket’s fluorescent yellow bladder was inflated by the discharge of CO₂ gas cylinder through the auto-firing mode. The two sets of buckles were found to be in proper condition. Scratches and abrasions were found on the surface of the lifejacket which did not affect the functionality of the lifejacket.

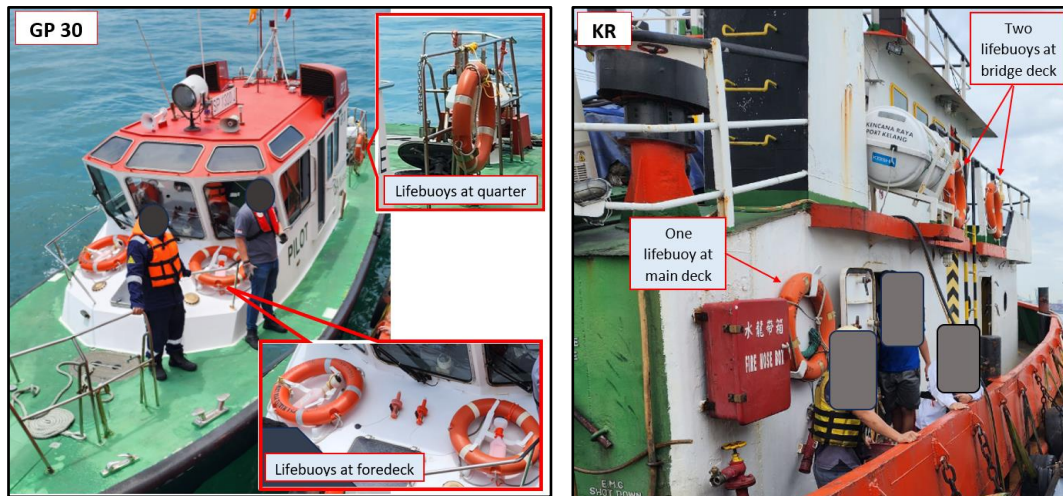
1.10.5 There were lifebuoys available⁴⁹ in the vicinity of the pilot transfer location onboard GP 30 and KR and could be released quickly (see **figure 12**). According to the MA of GP 30 and the AB of KR, they did not release the lifebuoy because the Pilot was already a distance away (more than 10m) from their vessels (which were making way at about 2.4kts) after he fell into water and the distance was increasing due to the forward movement of both vessels.

Figure 12: The location and placement of the lifebuoys on GP 30 and KR
