Final Report

FATALITY OF DECK CADET ONBOARD SRS BAO SUCCESS AT SEA ON 25 NOVEMBER 2022

TIB/MAI/CAS.134

Transport Safety Investigation Bureau
Ministry of Transport
Singapore

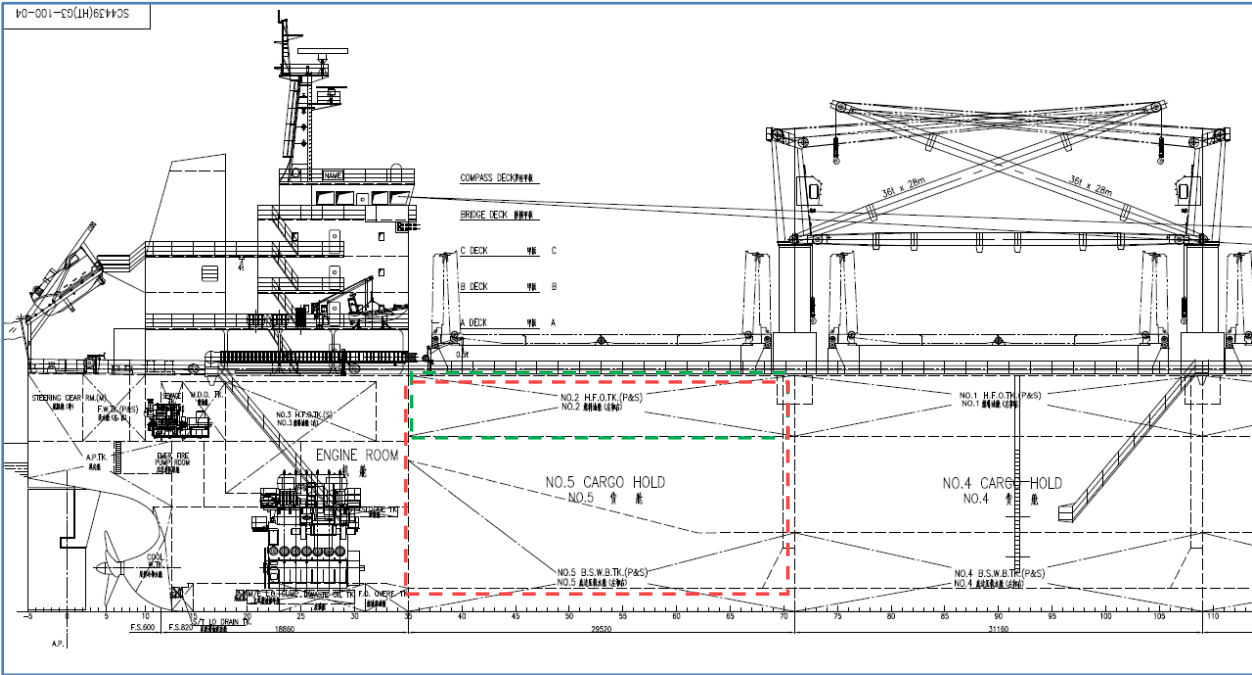
1.2.2 The vessel has 6 bunker tanks namely No. 1 HFO tank (Port & Starboard), No. 2 HFO tank (Port & Starboard) and No. 3 HFO tank (Port & Starboard). No. 3 HFO tanks are located closer to the accommodation. No.1 HFO tanks are in line with No. 4 cargo hold while No. 2 HFO tanks are in line with No. 5 cargo hold (see **figure 2**). At the time of the incident the vessel had about 520 MT of fuel oil, of which 170 MT was inside No. 2 HFO tank (Port).

Figure 2 – Partial profile view of Bao Success – green dashed line indicates no. 2 HFO tank (as viewed from starboard side) (Source: The Company – annotated by the TSIB)

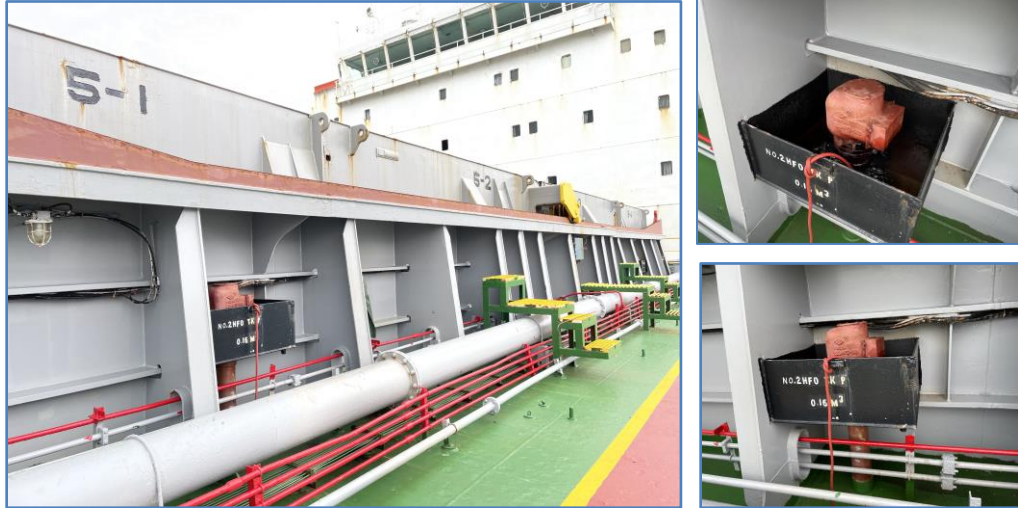
1.2.3 No. 2 HFO tank (Port), like most bunker tanks, has two vents to release vapour when fuel is loaded into the tank. The vents are about one metre in height and have a tray (typically referred to as a drip tray) to collect any small spills due to oil overflow from the tank (see **figure 3**).

Figure 3 – View of the forward vent for No.2 HFO tank (Port) - (Source: The Company)

- 1.2.4 It is normal for vapour or fumes to be emitted from such vents, especially when the tank is being heated. According to the Chief Engineer the fuel tank temperature was normally maintained at about 45 degrees Celsius. No. 2 HFO tank (Port) contained low Sulphur fuel (0.49% of Sulphur content) which was taken at a port from Luanda, Angola (Africa).

- 1.2.6 According to the SDS, protective mask is recommended for respiratory protection. At the time of the occurrence, the DC was not wearing any respiratory protection while assisting the Fitter from outside the cargo hold.

- 3.1 When the DC was assisting the Fitter from the main deck to perform some work inside the cargo hold, he inhaled some fumes from the HFO tank vent in the vicinity. The DC did not wear any respiratory mask for the duration he was assisting the Fitter, and the inhalation caused the DC to feel unwell.
