Final Report

ALLISION OF DUTCH FLAGGED VOX MAXIMA AND SINGAPORE FLAGGED MARINE HONOUR, PORT OF SINGAPORE ON 14 JUNE 2024

TIB/MAI/CAS.169

Transport Safety Investigation Bureau
Ministry of Transport
Singapore

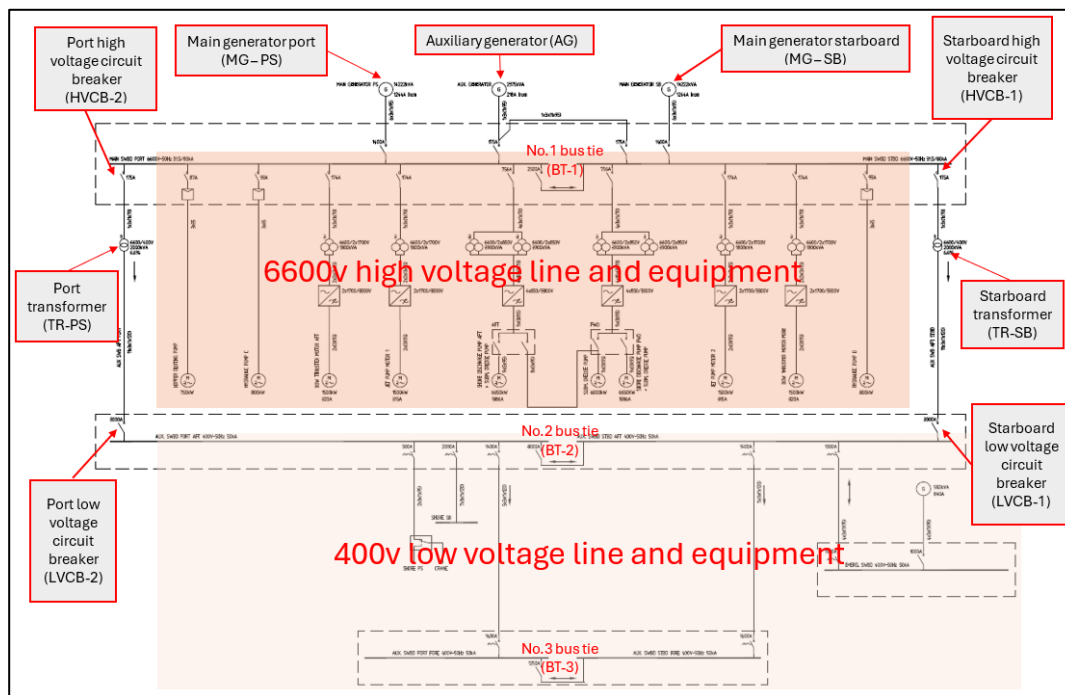
Figure 1 – High and low voltage line diagram
(Source: the VM-Company, annotated by the TSIB)

- 1.1.3 As per the Electrician's request, VM-2E-2 and VM-2E-3 opened both the starboard high-voltage circuit breaker (HVCB-1, on the 6600v starboard side) and the starboard low-voltage circuit breaker (LVCB-1, on the 400v starboard side) (see **Figure 1**). VM-2E-2 and VM-2E-3 also closed no. 2 bus tie (BT-2 – 400v), to allow the auxiliary generator (AG) to support the entire 6600v main switchboard and the 400v switchboard as both the HVCB-1 and LVCB-1 had been opened.

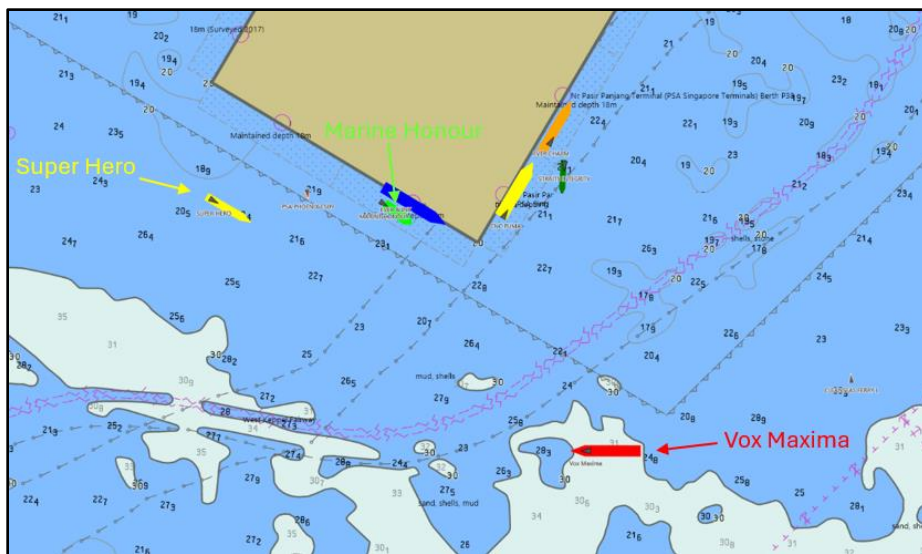
Figure 3 – Position of VM, SH and MH at 1412H18S
(Source: the TSIB, MADAS Replay Pro)

- 1.1.21 At 1412H18S, hydraulic power unit B (HPU-B) was also started by VM-20 to speed up the emptying of sea water. The moment HPU-B was started, an immediate blackout¹⁹ occurred on board VM. Alarms of all navigation equipment, steering, propeller controls and other equipment sounded on the bridge. VM was at a speed of 10.4 knots with a heading of 269.6°. SH at a speed of 8.4 knots continued approaching VM from about 0.77nm (see **Figure 3**). VM's radar indicated SH would pass on her starboard side at 0.27nm in about 2.4 minutes.

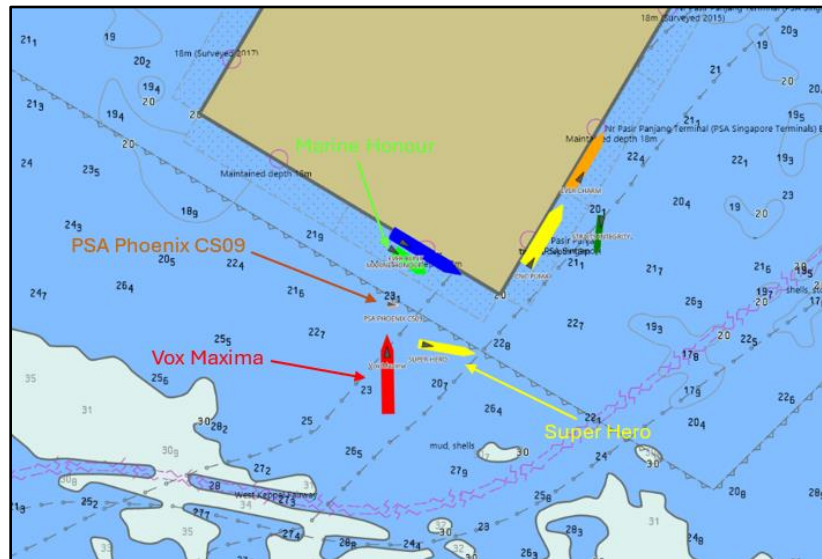
Figure 4 - The positions of VM, SH and MH at 1415H15S
(Source: the TSIB, MADAS Replay Pro)

(about 65m). After SH had passed, a harbour tug, PSA Phoenix CS09 (CS09) was seen in the vicinity²⁵ of VM and was nearly right ahead of VM's bow. At this time, the distance from VM to MH was about 0.12nm (about 220m, see **Figure 4**). VM-Pilot called the tug service providers (PSA Marine, the same company as the pilot service provider) through VHF for urgent harbour tug's assistance. Few seconds later, VM-Pilot again urgently requested VM-Master to drop anchor. VM-2O at the forecandle deck, kept trying to release the port anchor but was unsuccessful. VM's speed was at 8.3 knots.

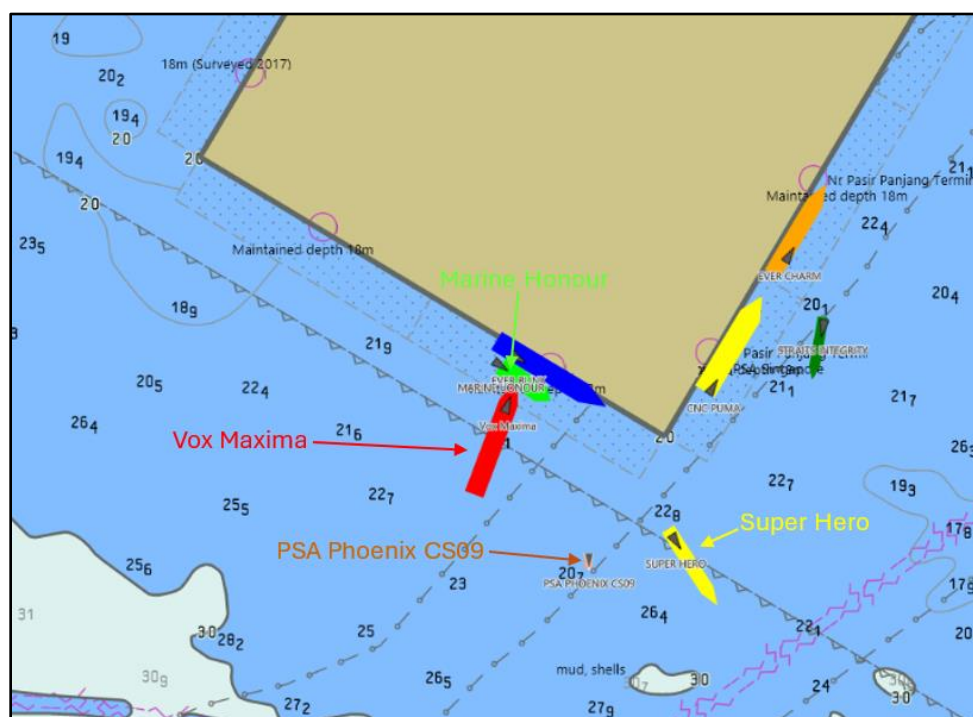
Figure 5 – The positions of MH, VM, SH and CS09 at the time of allision
(Source: the TSIB, MADAS Replay Pro)

- 1.1.35 At 1415H45S, VM continued turning towards MH, the engineers at the ECR managed to regain port side controls for the CPP. VM-Master, observing that the allision could not be avoided, made a public announcement to alert ship's crew that VM was going to impact (crash with) MH. VM-2O and VM-ASD at the forecastle deck ran away from where they stood to a safe position.
- 1.1.36 At 1416H05S, VM impacted the midship of MH (see **Figure 5**) at 8.3 knots and 020.3° heading. The hull of MH was breached, and cargo oil spilled into the sea.

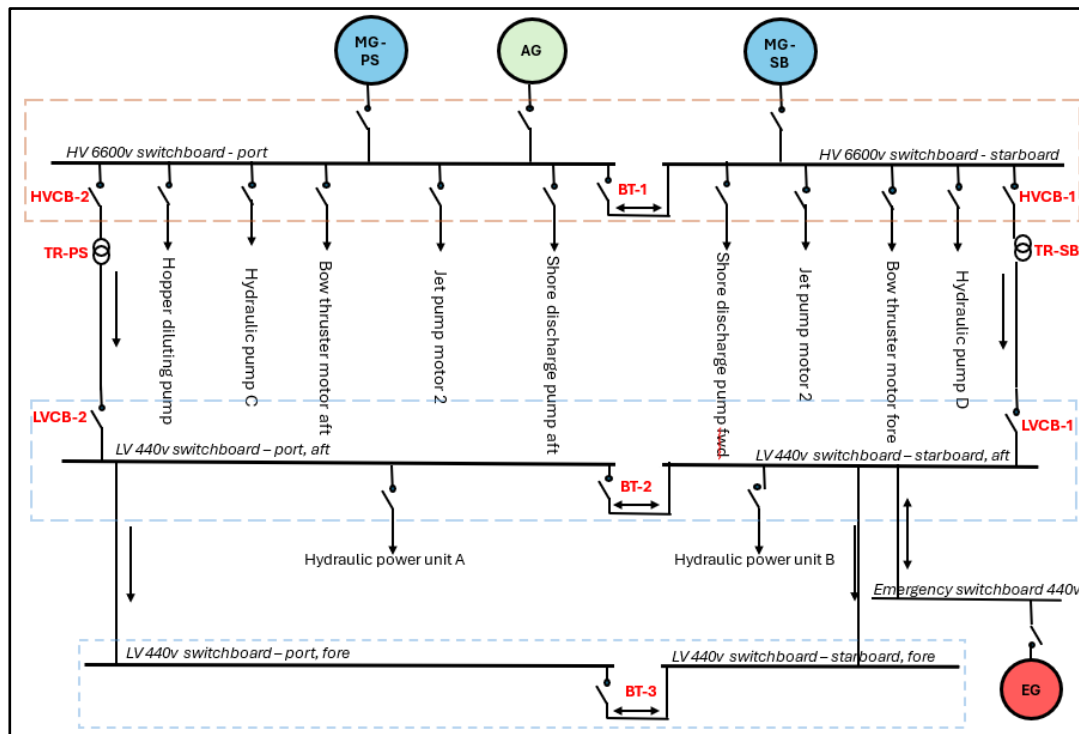
Figure 8 – VM's electrical power distribution

- 1.4.1.4 The electrical power distribution system (see **Figure 8**) allowed the engineers to configure and run different generators supplying electrical power to different machinery and equipment consuming high-voltage (6600v) or low-voltage (440v) electrical power. The high voltage power supplied directly to machinery such as hopper diluting pump (750kW), hydraulic pump C (800kW), forward and aft bow thruster motor (1500kW each) and forward and aft shore discharge pumps (6650kW, each) and submersible dredge pump (6000kW each), etc. The low-voltage electrical power, stepped down from 6600v by two transformers (TR-PS and TR-SB), supplied to equipment such as HPU-A, HPU-B, CPP systems and steering pumps, main engine sea water cooling pumps, bow thruster auxiliary supply and control systems and hydraulic pumps (HPU-A and HPU-B) for anchor windlass system.

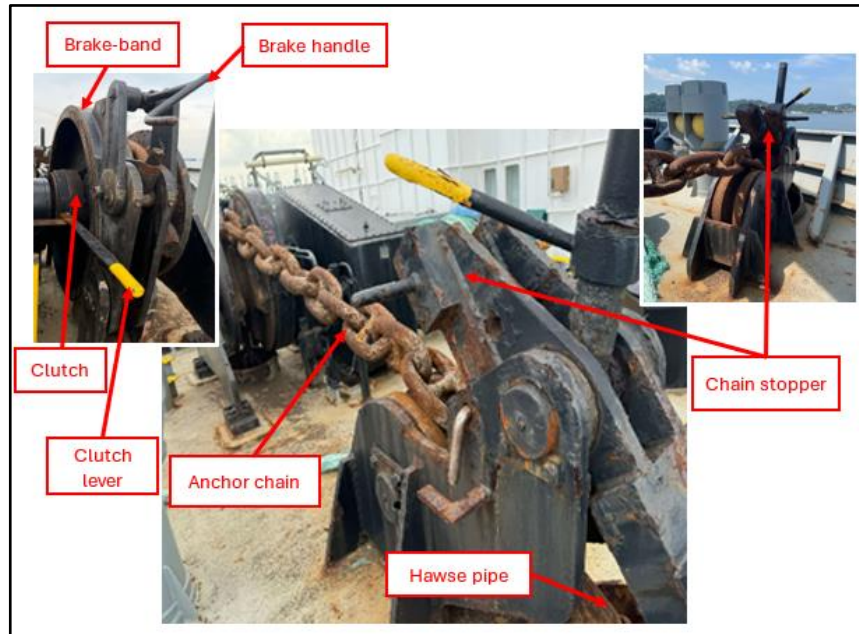
Figure 10 – VM's port anchor and its key components, same design for the starboard anchor (*Source: the TSIB*)

- 1.4.3.2 When departing AWW, the starboard anchor was heaved up to the hawse pipe and secured with its chain stopper down and windlass gear clutched in. The chain stopper was not able to swing open as the anchor weight was held in tension to the chain stopper. To ease the tension, hydraulic pump was required to operate the windlass to heave up the anchor chain slightly to free it from the chain stopper. It was not a common practice to keep the windlass gear clutched in after an anchor was secured home.

- 1.4.3.3 At the time of the blackout, the port anchor was not able to be released. It was discovered post incident that the anchor shank was stuck in the hawse pipe (see **Figure 11**) preventing the port anchor to be released from its stowed position. Releasing the windlass brake completely did not help the anchor shank to clear from the hawse pipe. Ship's records indicated that the port anchor was last used on 16 April 2024 and was secured on the same day. It remained in secured condition till the occurrence day.

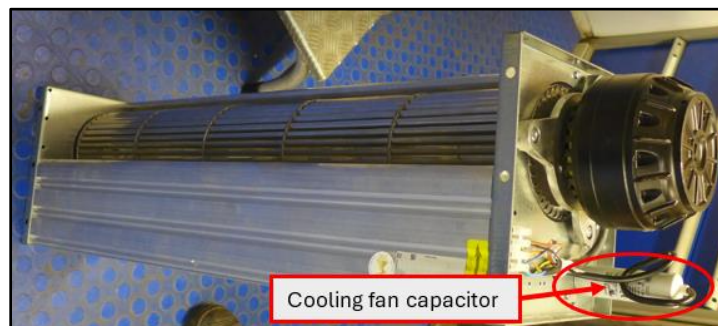
Figure 12 – Sample of the cooling fan capacitor shown by the Electrician
(Source: the TSIB)

1.5.1 VM was scheduled to enter the shipyard to carry out some modifications in preparation for her next deployment to the middle east. In anticipating hot climate, the Electrician planned for a preventive maintenance work to inspect the condition of cooling fans and vents of the electrical transformers, and to verify if the spare capacitors (see **Figure 12**) on board were suitable for the cooling fans.

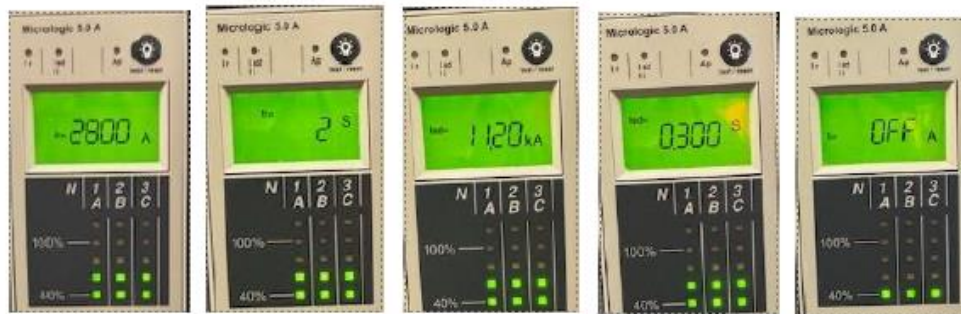
Fig 1 : Protection setting of Micrologic 5.0A at Incoming Feeder Aux Swbd AFT PS ACB

- Long time ($I_r = 2800A$), Long time delay ($t_r = 2s$), Short time ($I_{sd} = 11.20KA$), Short time delay ($t_{sd} = 0.3s$) and Instantaneous ($I_i = OFF$) trip settings at Incoming Feeder Aux Swbd AFT PS breaker

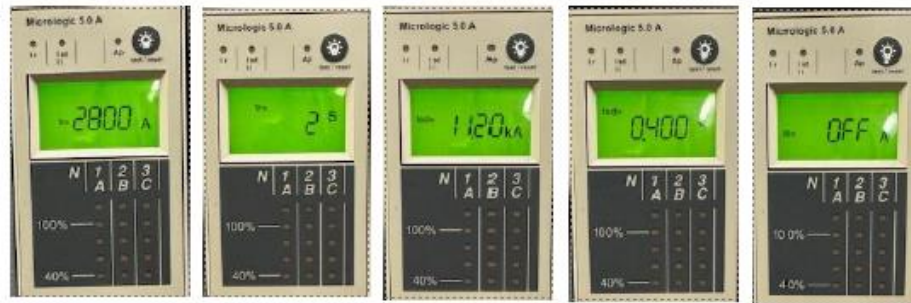
Fig 3 : Protection setting of Micrologic 5.0A at Incoming Feeder Aux Swbd AFT SB ACB

- Long time ($I_r = 2800A$), Long time delay ($t_r = 2s$), Short time ($I_{sd} = 11.20kA$), Short time delay ($t_{sd} = 0.4s$) and Instantaneous ($I_i = OFF$) trip settings at Incoming Feeder Aux Swbd AFT SB breaker

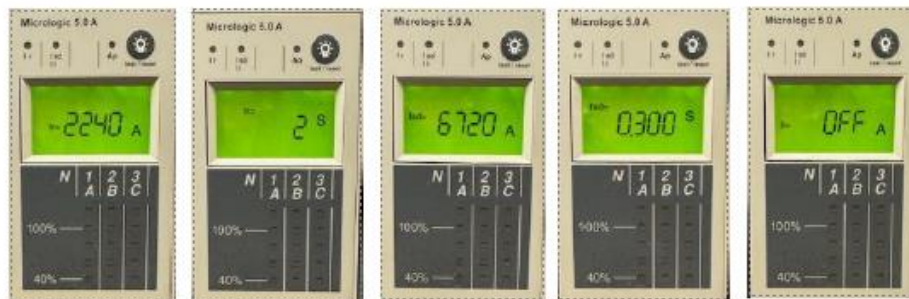
Fig 5 : Protection setting of Micrologic 5.0A at Bus Tie

- Long time ($I_r = 2240A$) , Long time delay ($t_r = 2s$) , Short time ($I_{sd} = 6720A$) , Short time delay ($t_{sd} = 0.3s$) and Instantaneous ($I_i = OFF$) trip settings at BusTie breaker

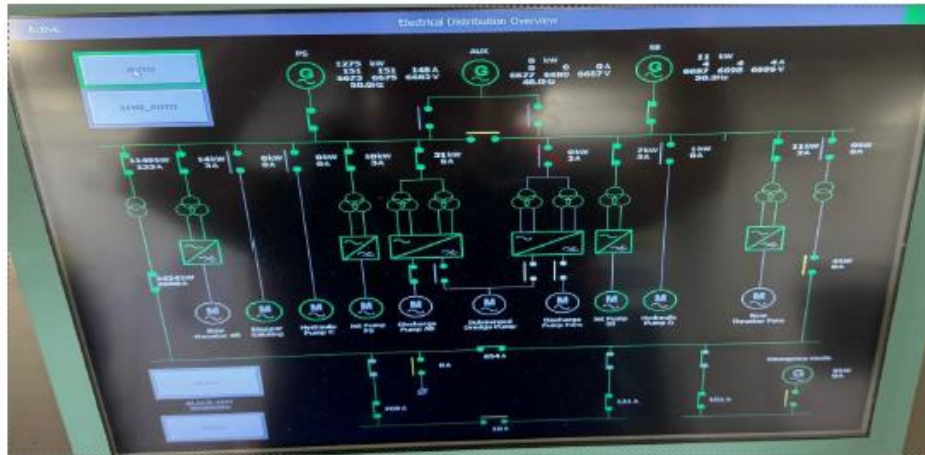
Fig 7 : Electrical Distribution Overview

- As per overview of electrical distribution, Incoming Feeder Aux Swbd AFT PS breaker and Bus Tie breaker are closed. Incoming Feeder Aux Swbd SFT SB breaker is opened. Recorded time is 10:33am.

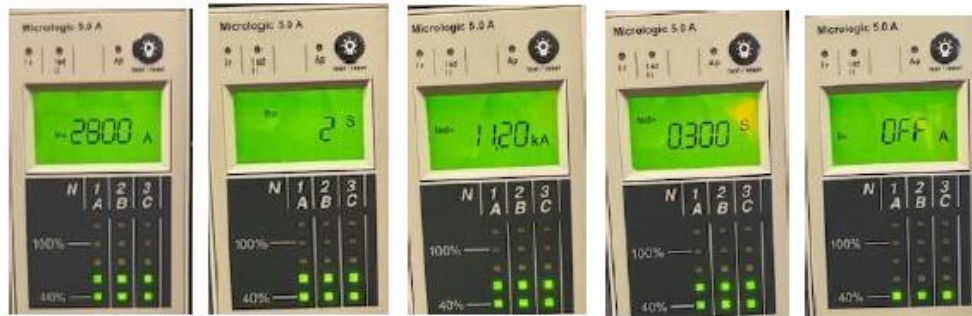
Fig 1 : Protection setting of Micrologic 5.0A at Incoming Feeder Aux Swbd AFT PS ACB

- Long time ($I_r = 2800A$) , Long time delay ($t_r = 2s$) , Short time ($I_{sd} = 11.20KA$) , Short time delay ($t_{sd} = 0.3s$) and Instantaneous ($I_i = OFF$) trip settings at Incoming Feeder Aux Swbd AFT PS breaker

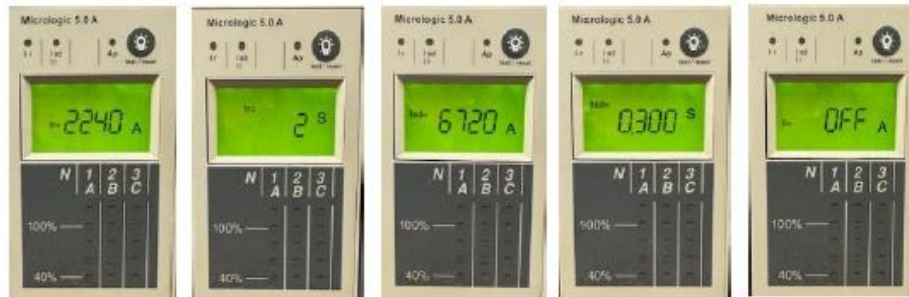
Fig 3 : Protection setting of Micrologic 5.0A at Bus Tie

- Long time ($I_r = 2240A$), Long time delay ($t_r = 2s$), Short time ($I_{sd} = 6720A$), Short time delay ($t_{sd} = 0.3s$) and Instantaneous ($I_i = OFF$) trip settings at BusTie breaker

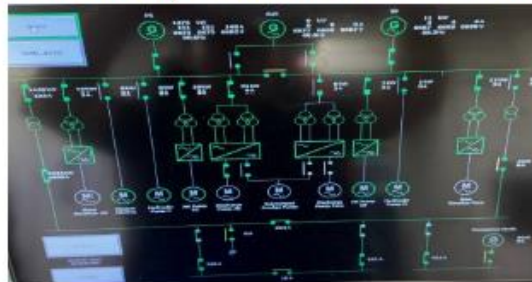
Fig 5 : Electrical Distribution Overview

- As per overview of electrical distribution, Incoming Feeder Aux Swbd AFT PS breaker and Bus Tie breaker are closed. Incoming Feeder Aux Swbd SFT SB breaker is opened.
