# **Final Report**

## **EAST-WEST LINE FAULTY TRAIN INCIDENT**

**25 SEPTEMBER 2024**

TIB/RAI/CAS.014

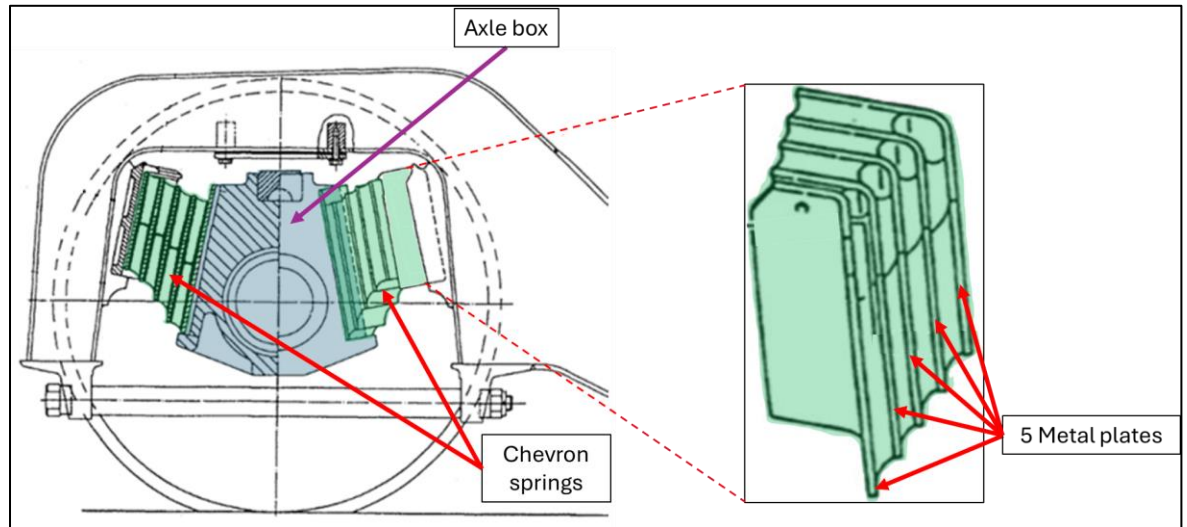
Figure 2: Diagram of an axle box (left) and its chevron springs (right)

- 1.2 Injuries to persons
- 1.2.1 No one was injured in the incident.
- 1.3 Damage
- 1.3.1 The missing axle box from the second axle of Car 2065 was axle box 19 on T310 (more on axle box numbering in paragraph 1.5.1).
- 1.3.2 **Figure 2** shows a diagram of an axle box and its chevron springs (each made up of 5 metal plates, bonded together by rubber material) and **Figure 3** shows the damage to axle box 19 and its chevron springs. The temperature stickers on axle box 19 (more on temperature sticker in paragraph 1.5.2.2), as well as the grease in the bearings of axle box 19, were burnt off.

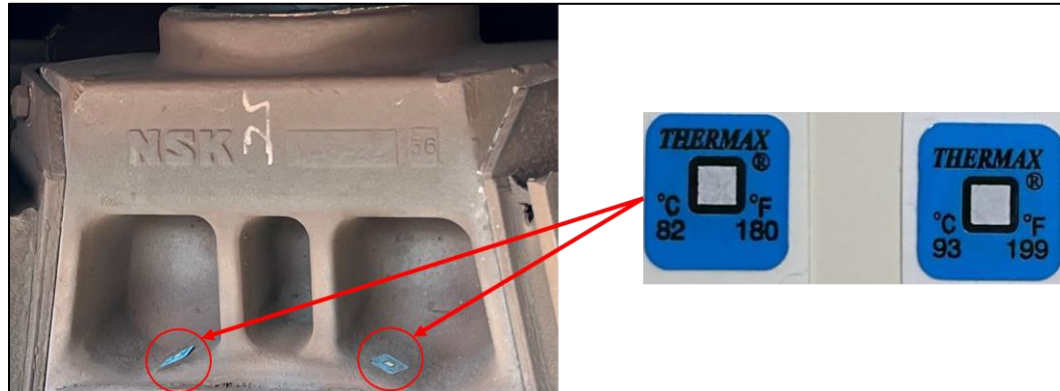
Figure 7: Temperature stickers (not on incident train)

- 1.5.2.1 Each train car has two bogies; each bogie has two axles; and each axle has an axle box on each end of the axle, i.e. a total of eight axle boxes per train car. Each axle end rotates on greased bearings which are sealed in each axle box. Axle boxes are used to transfer the load of the train car to the wheels.
- 1.5.2.2 On its own initiative, the rail operator affixed on each axle box two temperature stickers (see **Figure 7**) that will irreversibly blacken if the axle box exceeds predefined temperatures (82°C and 93°C). The rail operator's experience was that the typical operating temperature range for axle boxes was 30°C – 65°C.

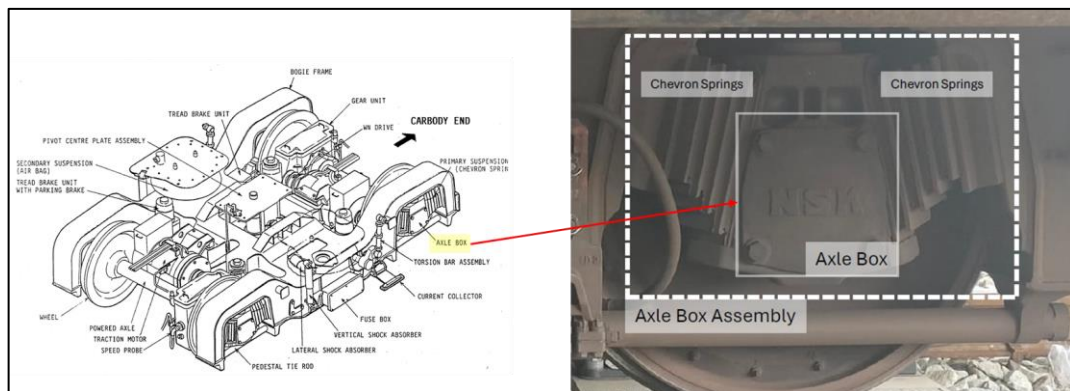
Figure 8: Axle box assembly on the bogie

- 1.5.2.3 Bogie frames are mounted on axle boxes via chevron springs, which are the primary suspension of the train (see **Figure 8**). The chevron springs dampen vibrations and impact forces experienced by the train. They consist of metal plates bonded together by rubber material.

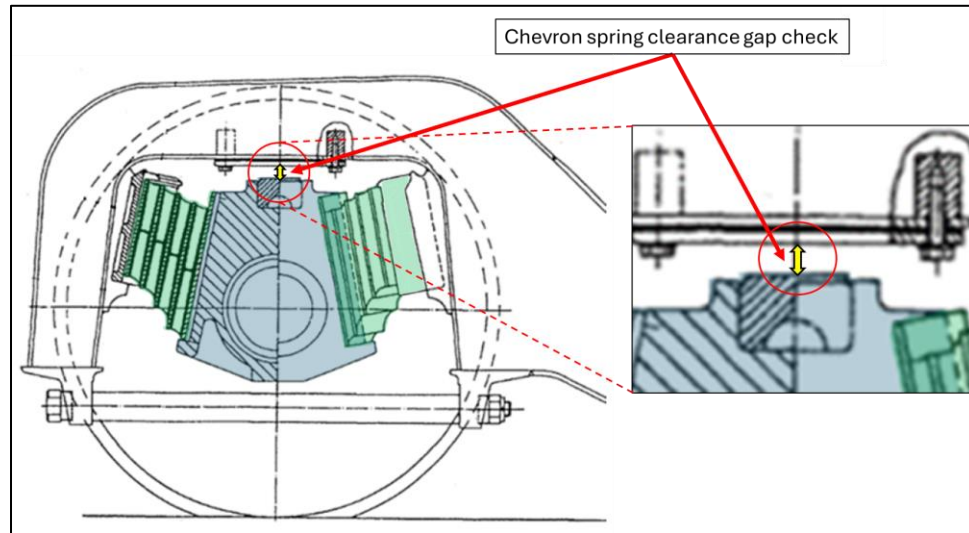
Figure 9: Chevron spring clearance gap check

- 1.5.2.4 The functionality of the chevron springs is checked by measuring the clearance gap between the top of the axle box and the bogie frame (the check is hereinafter referred to as the chevron spring clearance gap check - see **Figure 9**). The acceptable range for the gap is 27 – 30 mm. This clearance gap check is to determine whether a train car is drooping because of the weakening of one or more of the chevron springs.

1.5.2.5 The 3-weekly chevron spring clearance gap check on T310 was last carried out on 10 September 2024. According to T310's maintenance records, the clearance was within the acceptable range.
