FINAL REPORT

BOEING B777-200 REGISTRATION OE-LPC COLLISION WITH AN AEROBRIDGE AT SINGAPORE CHANGI AIRPORT ON 17 JANUARY 2006

AIB/AAI/CAS.031

**Air Accident Investigation Bureau of Singapore
Ministry of Transport
Singapore**

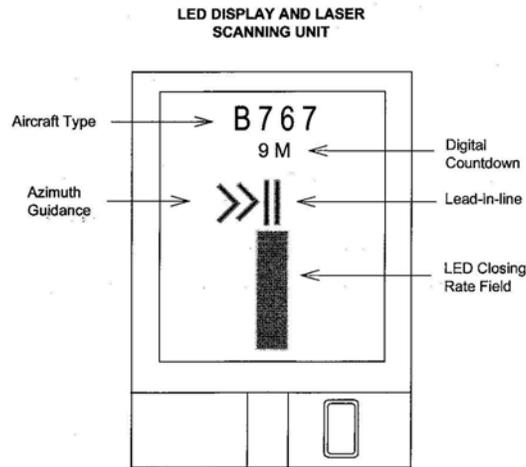
Figure 4. T1 ADGS indications

- 1.9.2 The ADGS in Terminal 1 was upgraded to the laser-based system in September 2004. The laser-based system could recognise the type of aircraft that is docking and measure the closure rate of the gap between the aircraft and the stop line. At the time of the incident, Changi Airport was in the process of upgrading the two ADGS in Terminal 2 to a similar laser system. The Terminal 1 ADGS consists of a lead-in line azimuth indicator, a digital count down of the distance from the stop line, and a closing rate field (Figure 4). The lead-in line azimuth indicator will display arrows to the left or right of the lead-in line to guide the aircraft back to the centre line. The closing rate field is a bar that decreases in length as the aircraft approaches the stop line, the digital count down also provides information to the flight crew as to the distance remaining to the stop line. When the aircraft reaches the stop line the digital count down is change to a 'stop' indication and the closing rate field will disappear.

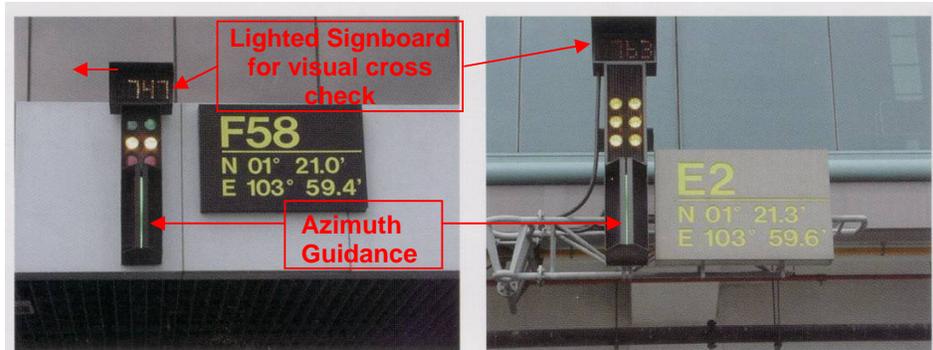
1.9.2 The manual types of ADGS used in Terminal 2 were Robert Louis Gaugenmaier (RLG) Type B (Figure 5a) and RLG Type C (Figure 5b). RLG Type B had one pair each of green, amber and red lights. RLG Type C was similar to Type B except that it had three pairs of amber lights instead of just one. Correspondingly, on Type B's console panel, the rotary knob used to select the lights had one amber light detent whereas on Type C's control panel, the rotary knob had three amber detents (for selecting one, two or three pairs of amber lights).

Figure 5a. RLG Type B

Figure 5b. RLG Type C

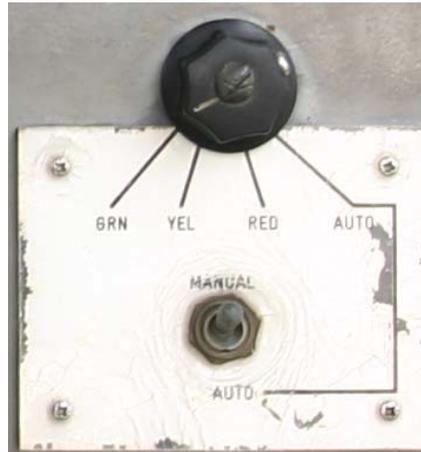
Figure 6. Type B rotary knob

- 1.9.5 In the manual mode, the operator had to judge the speed and closure rate of the aircraft with reference to ground markings. The operator had to manually turn the rotary knob to the corresponding detent to change the colour of the ADGS lights. (Figure 6).

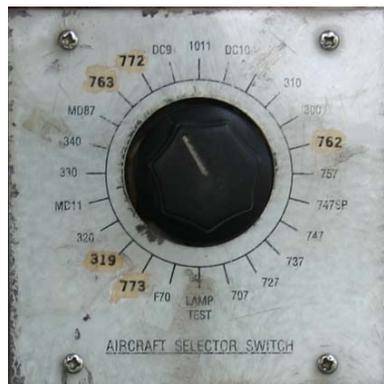
Figure 7. RLG types B and C aircraft type selector knob

- 1.9.6 All three types of ADGS required the operator to manually enter the aircraft type into the control panel. The aircraft type information would be displayed on the lighted sign board above the azimuth indications. The pilots of a docking aircraft would be able to see the aircraft type information and verify its correctness. The laser-based ADGS in Terminal 1 used buttons to select the aircraft type, whereas the RLG ADGS in Terminal 2 used a rotary knob to select the aircraft type (Figure 7).
