# **FINAL REPORT**

## **AIRBUS A320, REGISTRATION 9V-TRH FAN COWL DAMAGE DURING TAKE-OFF**

**16 October 2015**

**AIB/AAI/CAS.117**

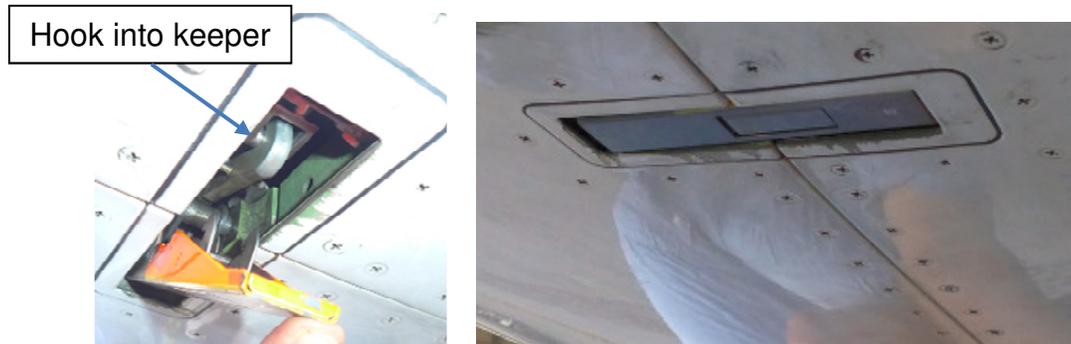
1.4.2 To fasten the latch, the hook is placed into the keeper and the latch handle is closed flush with surface (**Figure 7**).

Figure 7: Fastened latch with hook into keeper, and handle closed flush
