FINAL REPORT

B737-800, REGISTRATION 9V-MGM PUSHBACK INCIDENT

6 December 2015

AIB/AAI/CAS.118

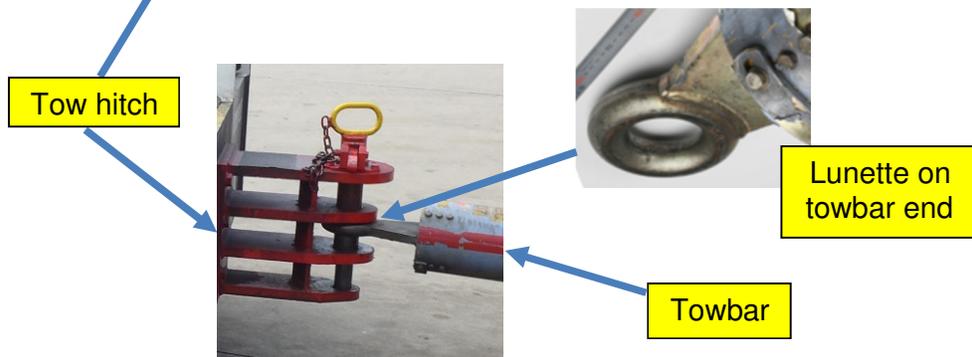
Figure 2: Towbar - tow hitch connection (typical)

1.1.1 On 6 December 2015, a B737-800 aircraft was departing for Phuket from Singapore Changi Airport. The aircraft was parked at Bay F41. A ground operation crew from a ground service provider (GSP) of the airport was to push back¹ the aircraft using an airtug (see **Figure 1**). The airtug was connected to the aircraft's nose wheel with a towbar. One end of the towbar (with a lunette ring) was hooked up to the airtug's tow hitch (see **Figure 2**).

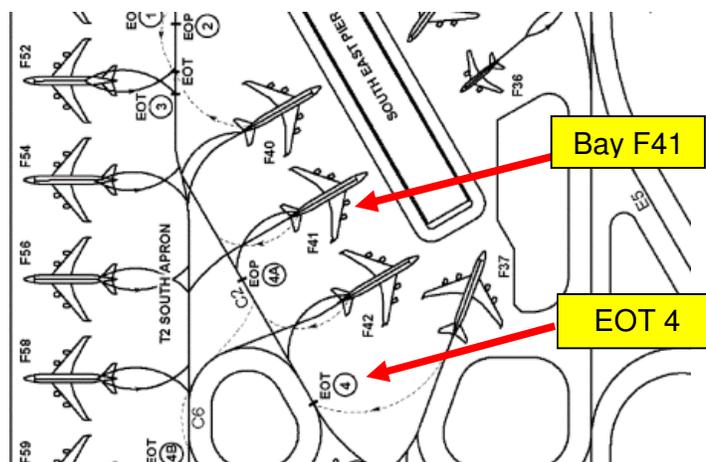
Figure 3: Location of Bay F41 and EOT 4

aircraft tail out onto Taxiway C2 (and, in so doing, turning the aircraft tail out to the right). Thereafter, the crew had to pull the aircraft forward to a stop point marked as EOT² 4 on Taxiway C2 (see **Figure 3**). In the course of the forward pull, the crew would have to steer as necessary to align the aircraft with the centreline of Taxiway C2.
