# **FINAL REPORT**

## **B777-300ER, REGISTRATION 9V-SWB ENGINE FIRE**

**27 JUNE 2016**

**AIB/AAI/CAS.122**

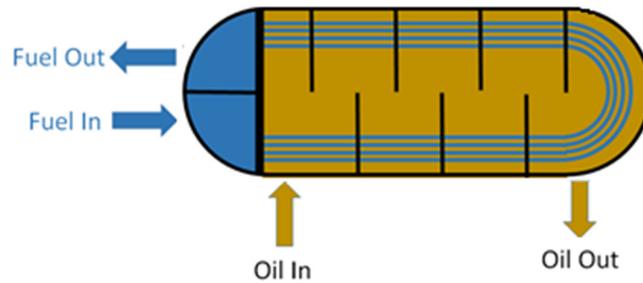
Figure 12: Schematic diagram of MFOHE

- 1.6.1.1 As fuel was found in the booster spool cavity, oil tank, all bearing sumps, accessory and transfer gearboxes; the main fuel oil heat exchanger (MFOHE), a component that is used by both the engine fuel and oil system, was examined for the presence of an internal leak. The MFOHE contains a series of tubes. Fuel flows in these tubes, while oil used for lubricating the engine flows around the tubes (**Figure 12**). This allows oil to be cooled through heat transfer to the fuel through the tubes. The design of the MFOHE is such that the oil and fuel flow paths will not cross and the oil and fuel will not come into contact with each other.

Fuel flows in the tubes while oil flows in the cavity around the tubes for heat exchange

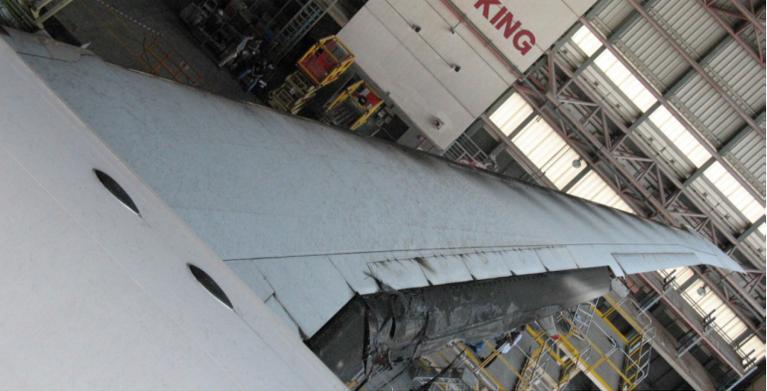
S/No	Description	Damage
3	Wing rear spar area and system components installed immediately behind and outboard of the right hand engine sustained fire damage

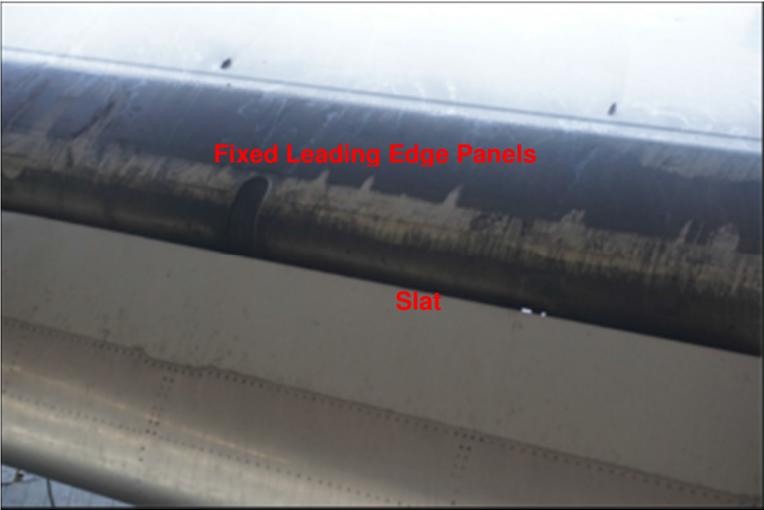
S/No	Description	Damage
6	Leading edge slats outboard of the engine found with varying degrees of heat damage

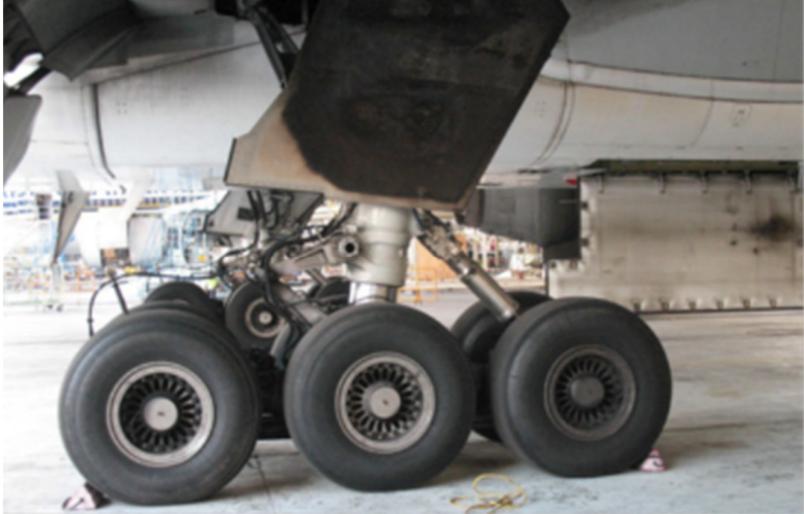
<p data-bbox="760 1224 1279 1255">Inner portion of right hand outboard flap</p>
8	Outboard facing side of right main landing gear shock strut door sustained heat damage
