FINAL REPORT

**RUNWAY EXCURSION INVOLVING
BOEING 777-200, REGISTRATION 9V-SRN
SINGAPORE CHANGI AIRPORT**

AIB/AAI/CAS.057

**Air Accident Investigation Bureau of Singapore
Ministry of Transport
Singapore**

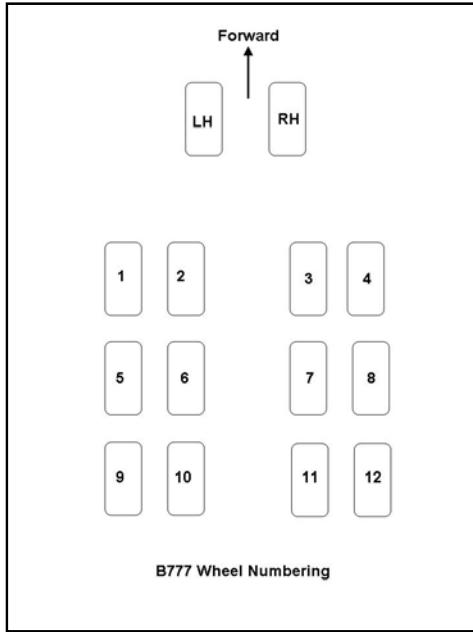
Figure 5: B777 wheel numbering system

- 1.3.1 Wheel tyres # 4 and # 11 sustained deep cuts (**Figures 5, 6 and 7**). There was no deflation of any tyre. There was no sign aquaplaning.
