FINAL REPORT

MAN OVERBOARD (LOSS OF LIFE)

FROM SUPPLY BOAT OPL 66

MIB/MAI/CAS.077

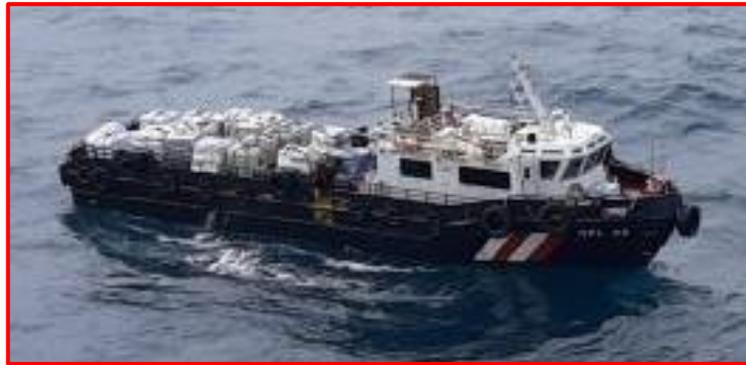
- 5 Qty of IBC tank;
- 1 pallet of mineral water
- 7 pallets of sawdust
- 4 pallets of PE liner bags
- 2 pallets of provisions
- 1 pallet of ship store
- 1 PE liner bag of cooking gas
- 1 PE liner bag of ship store

- 1.1.10 The first lift was an IBC tank at the second row of cargo (indicated as A in **figure 1**), which was uneventful. For the second lift, according to the marine assistant, the Chief Officer of FLC requested¹⁷ for two pallets of stores and provisions (indicated as Bs in **figure 1**) in the fourth row to be lifted together. From the CCTV footage, the investigation team noted that both the engineer and marine assistant had climbed on top of the cargo. According to the marine assistant, the duo was struggling to put the slings of the two pallets onto the crane hook while holding on to the safety latch of the crane hook.
