Final Report

Missing of Fitter From SRS RTM Zheng He At Sea On 26 December 2024

TIB/MAI/CAS.187

Transport Safety Investigation Bureau
Ministry of Transport
Singapore

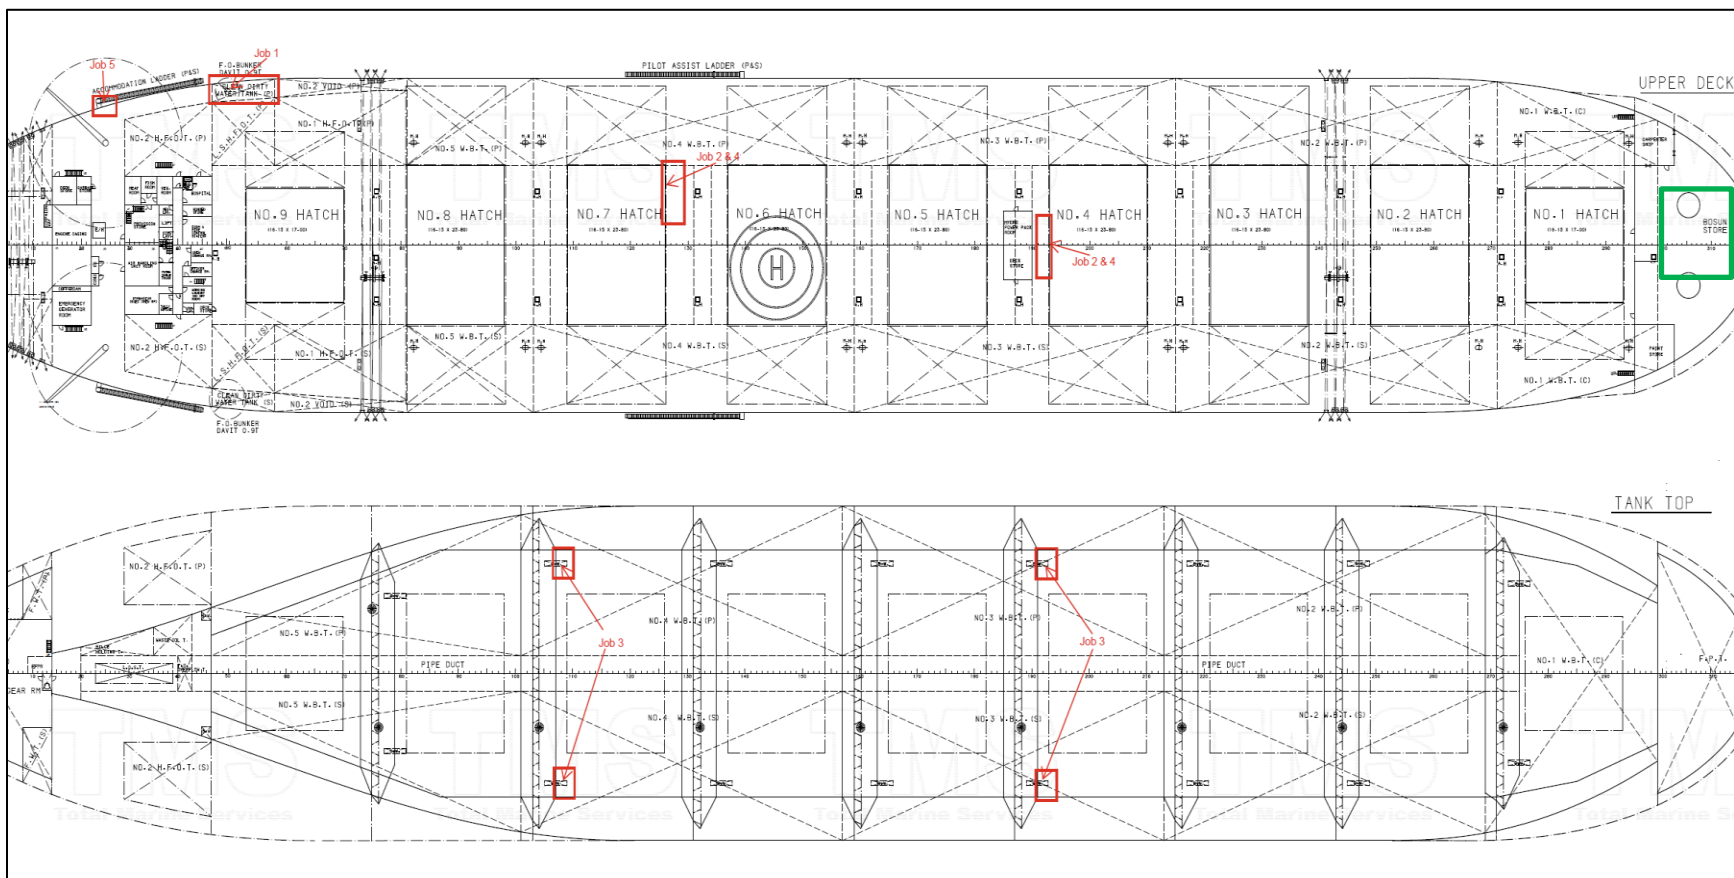
Figure 1b – Location of tasks assigned to deck crew in red annotations.
(Source: the Company. Green annotation of Bosun Store by TSIB)

1.1.3 From 0800H to 0815H, the Chief Officer (CO) conducted a Toolbox Talk (TBT) for the deck crew¹ for five tasks (**Figure 1a**) to be carried out and the locations of their tasks (**Figure 1b**).
