Final Report

SINKING OF TWO HARBOUR CRAFT OSHIO AND YAKUSHI MARU NO 3 RESULTING IN TWO FATALITIES ON 4 SEPTEMBER 2024

TIB/MAI/CAS.179

Transport Safety Investigation Bureau of Singapore
Ministry of Transport
Singapore

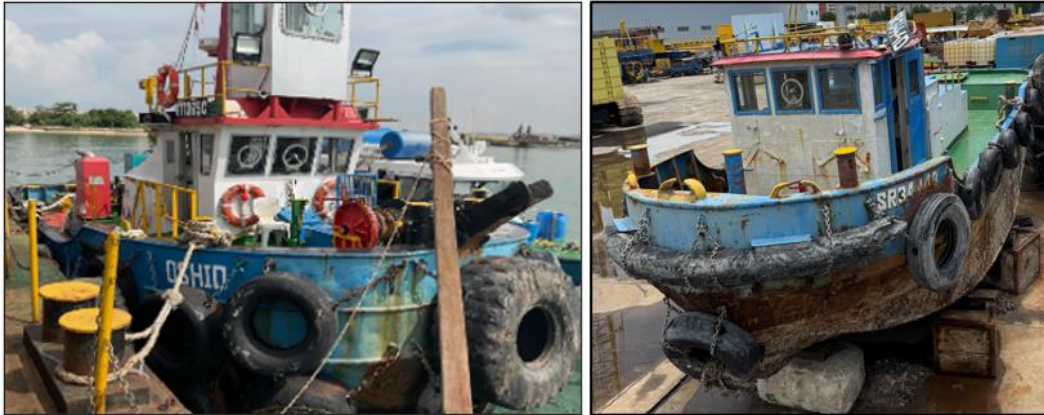
VIEW OF TWO HARBOUR CRAFT

Oshio (left) and Yakushi Maru No 3 (right) (Source: the Operator)

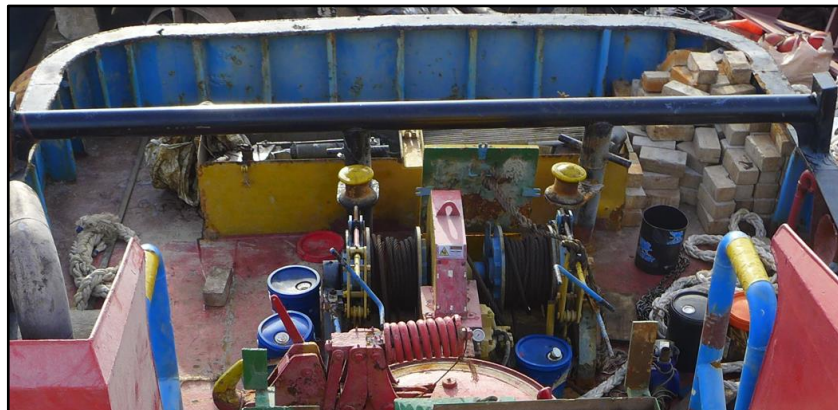
- 1.2.1.4 According to the Operator, Oshio had undergone a docking from 12 February 2020 to 2 March 2020. During the docking, both its port and starboard hull were renewed and re-painted, engines were fully overhauled, tail shaft and propeller were repaired and reinstalled.
- 1.2.1.5 Oshio, as a tugboat, had a towing system (see **figure 3**) comprising two winch drums, driven by hydraulics, for connecting a tow line, and a quick release arrangement for disconnecting the tow line in an emergency. The towing system was tested and found in operational condition at the last docking. The tugboat was capable of towing harbour craft like YM3.

Figure 3 - View of the towing system located at the aft of Oshio (*Source: the TSIB*)

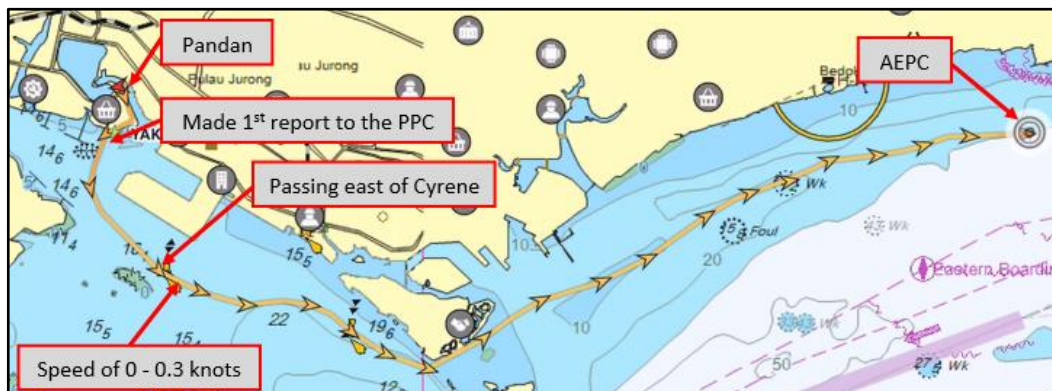
1.6.1.1 Oshio's AIS track records indicated that its highest speed was at about 8.7 knots between 1101H and 1103H, the rest of journey was frequently adjusted at between 2.8 knots and 5.9 knots.

1.6.1.2 The relatively low draft, about one meter and less, allowed Oshio and YM3 to navigate in most places within the port waters. The passage (see **figure 7**) to Tekong typically followed the common route, which involved crossing several anchorages at the eastern side on a north-easterly route.

Figure 7 – Overview of the passage taken during the side-tow operation (the light orange coloured track line with arrows) (Source: the MarineTraffic)
