FINAL REPORT

AIRBUS A330-300, REGISTRATION 9V-SSE

ENGINE FAILURE DURING CLIMB

AIB/AAI/CAS.157

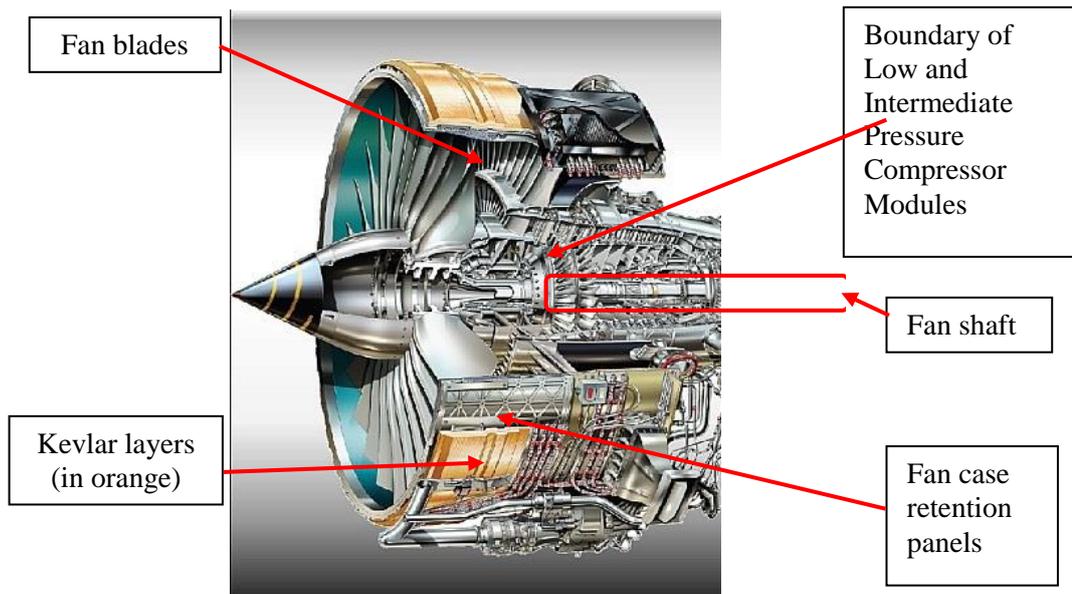
Figure 1: Cutaway view of Trent 700 engine fan case

1.3.1 Post-flight inspection of the No. 1 engine revealed damage to all the fan blades, the fan case and the nose cowl of the engine (see **Figure 1** for a cutaway view³ for illustration and comparison purpose).
